ISIS Target Station 2 – Horn Water Pre-Moderator Failure, Investigation, and Redesign

ISIS Neutron and Muon Source

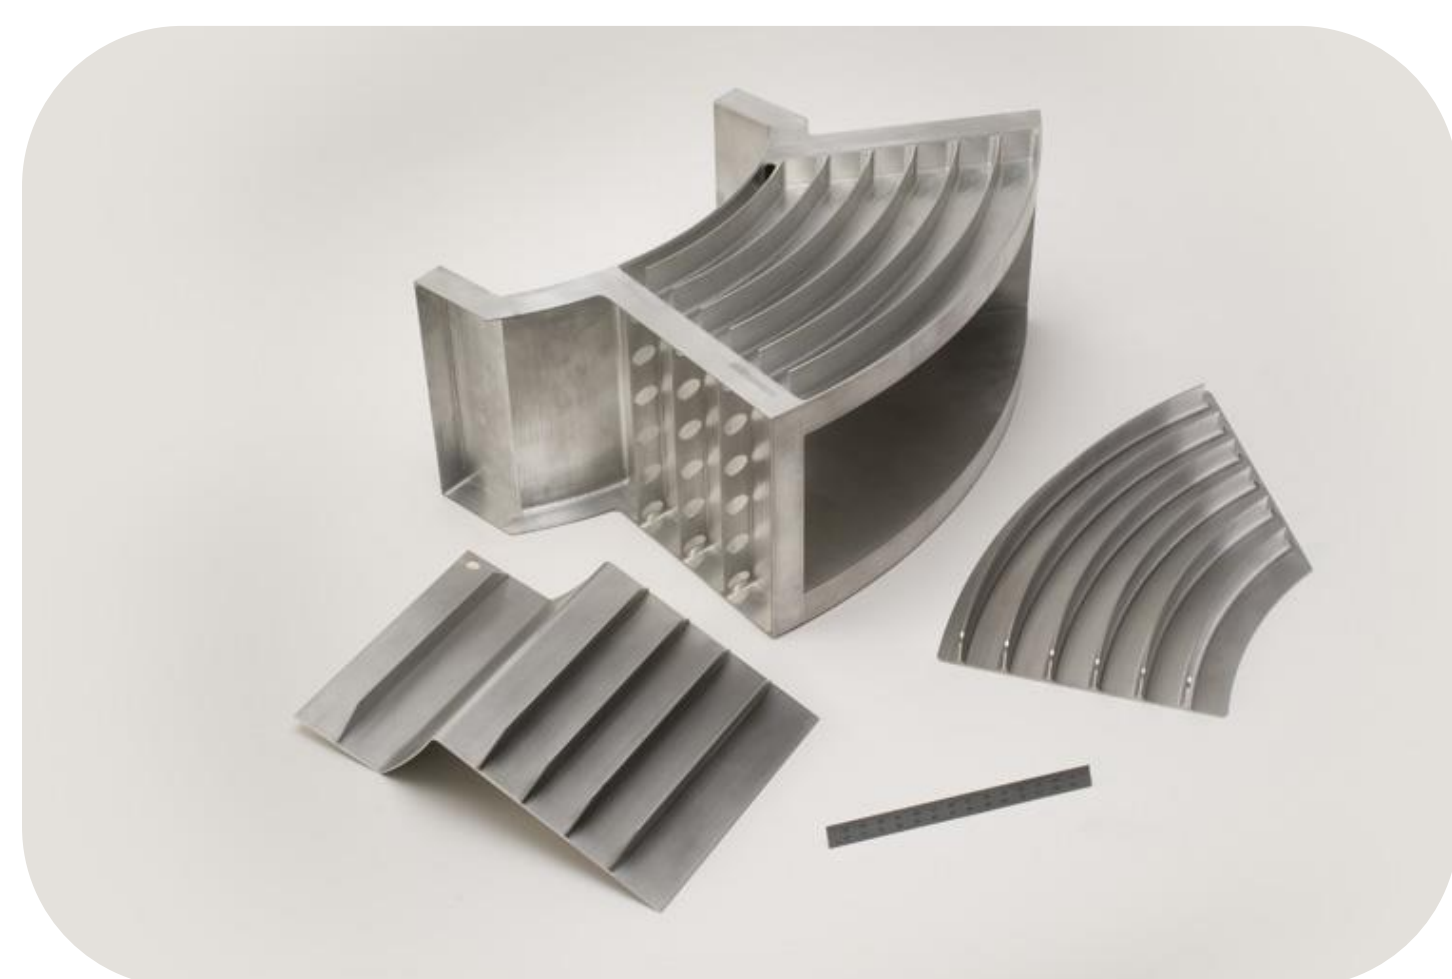
(a) Original manufacture parts of the horn pre-moderator first iteration

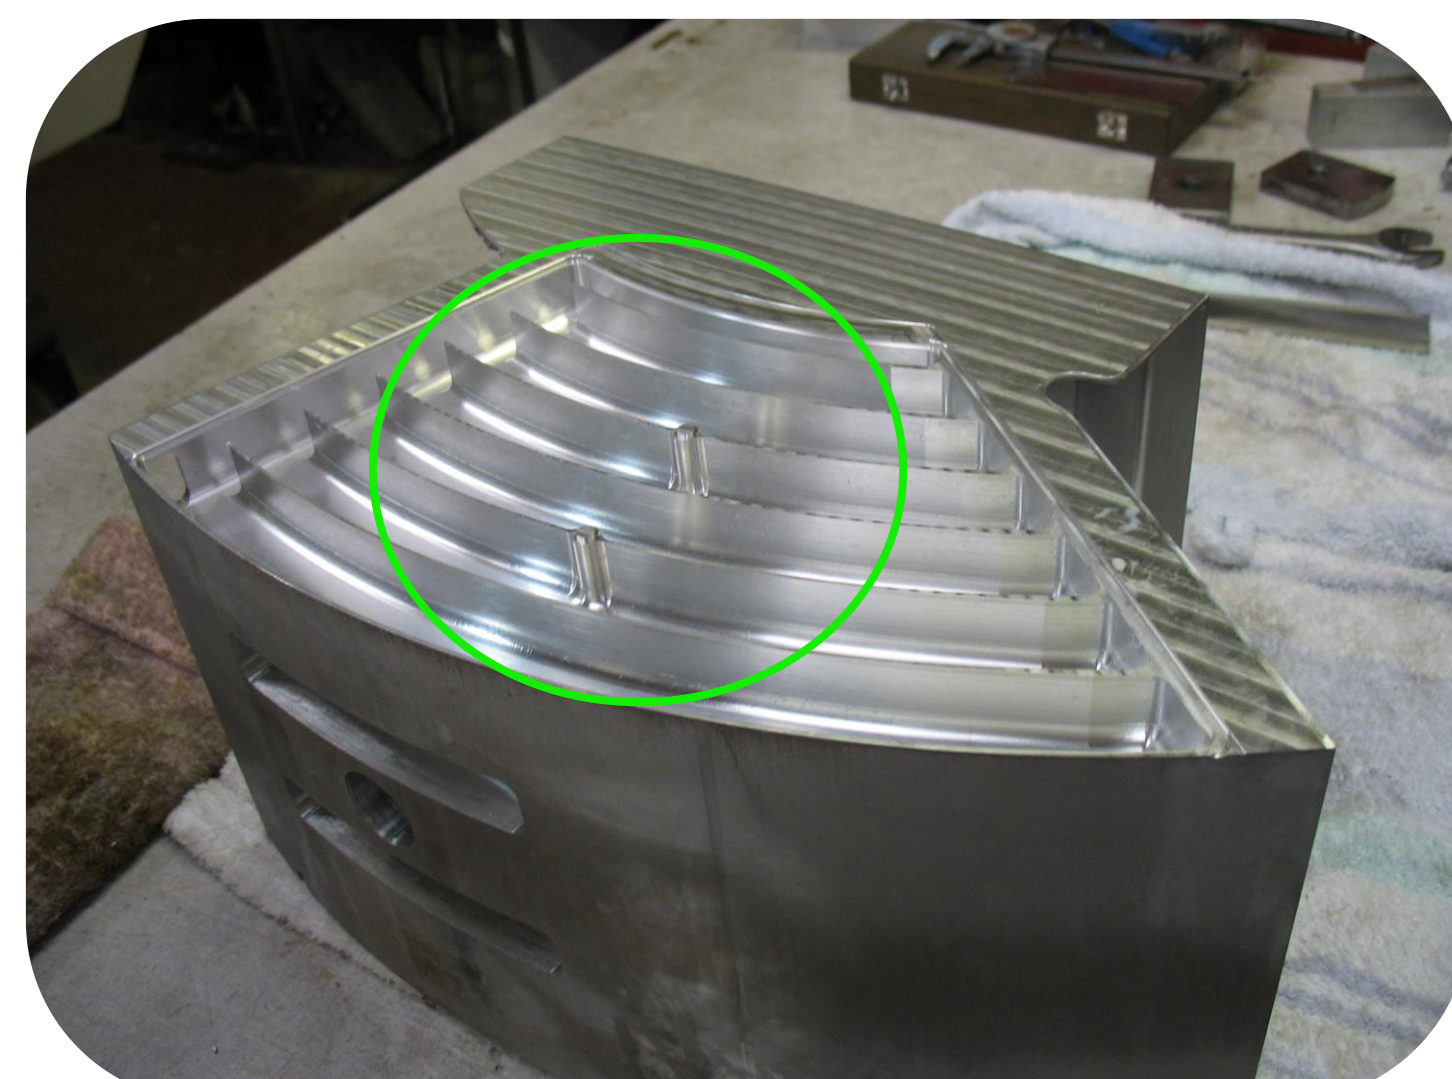
(b) Second iteration with the additional welded "pips" for structural rigidity.

- Design parameters:
 - 3.5 L/min
 - Negatively pressurised
 - Water "pulled" through
- The original Horn pre-moderator in 2009 was manufactured using Aluminium 2014-T6 due to its high strength. However, a leak was discovered, and the hypothesised fault was pitting corrosion; 2014-T6 has poor corrosion resistance.
- This led to a redesign using aluminium 5083-O and increasing the wall thickness from 1mm to 1.5mm.
- Electron beam welded "pips" were added to the lid for increased strength.
 - Circular weld profile
- The new pre-moderator was installed in 2013 and ran for eight years.

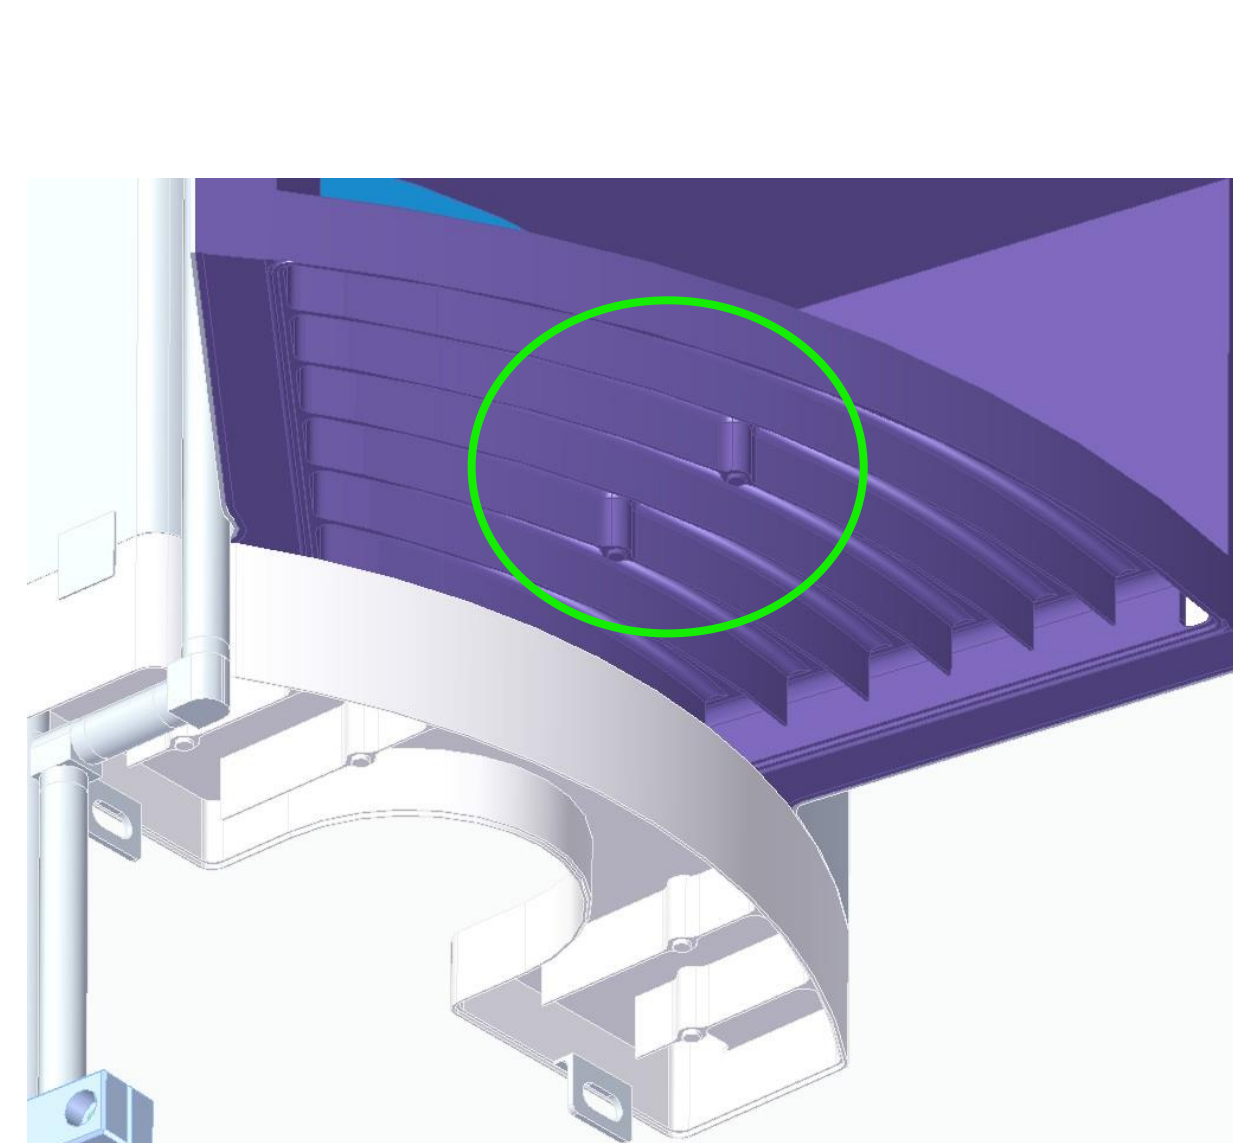
(a) Highlighting where the pip welds are located

Stress concentration around the electron beam welded "pip" joints? Finite Element Analysis was performed to demonstrate where stress concentrations would be. A maximum stress of 190 MPa was seen in these highly stressed areas, much higher than the yield strength of Aluminium 5083-O (125 MPa). Pressure regulations set the limit for Al5083-O at 83 MPa (safety factor of 1.5).

This was to be redesigned using rib stake welds.

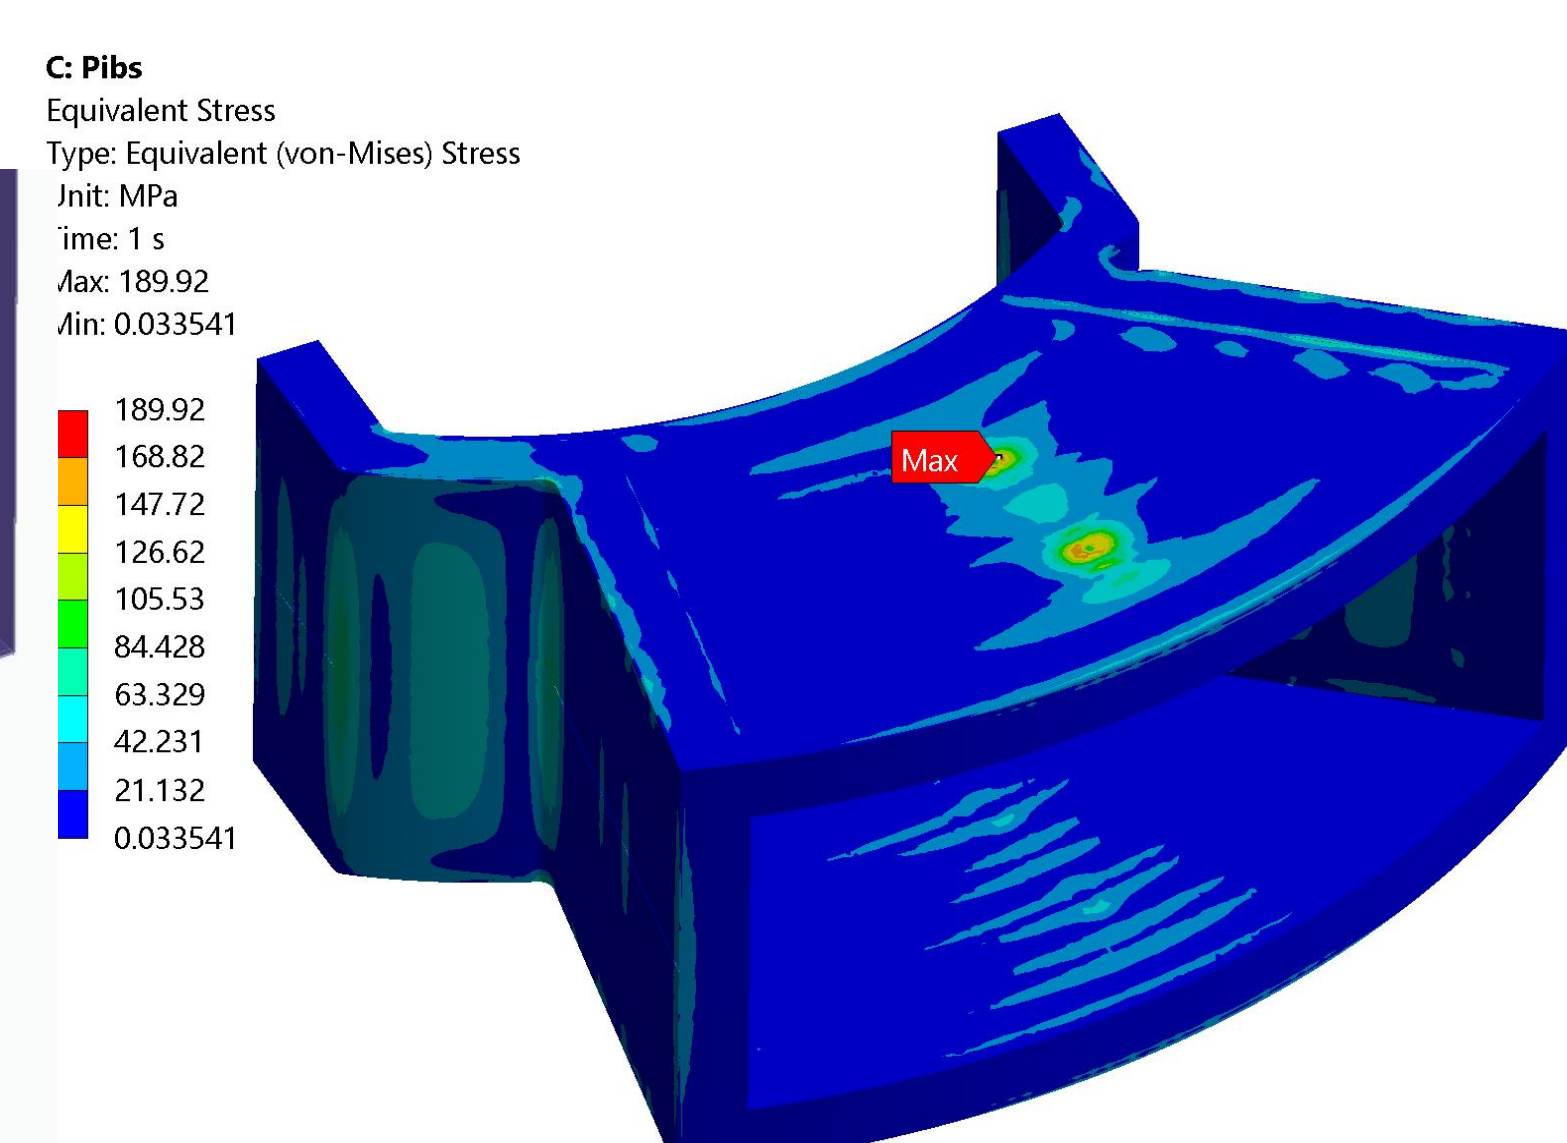
(b) FEA structural analysis highlighting stress concentrations at the pip welds.

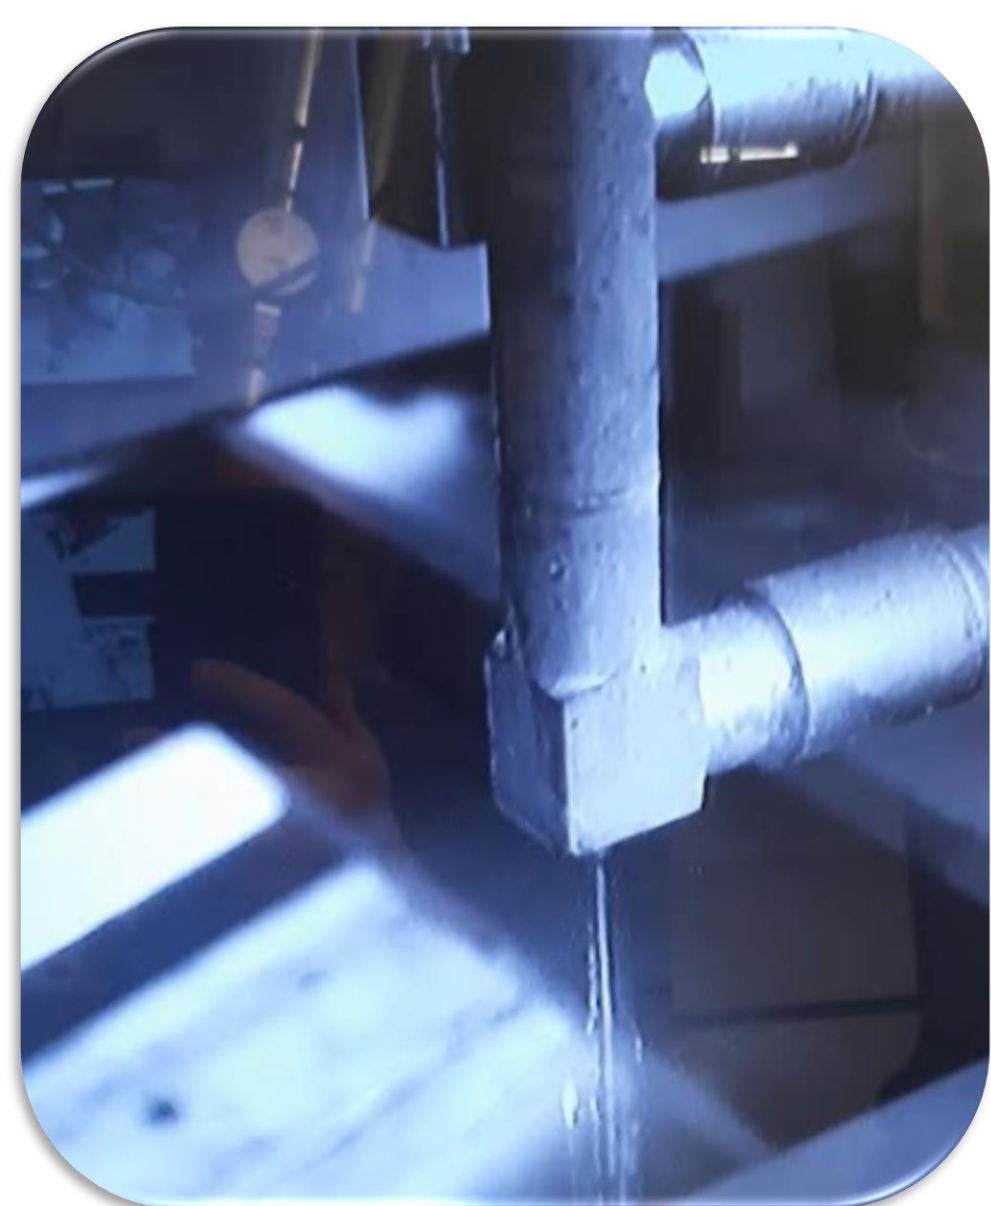
(a) Visual leak spotted on the vertical pipework below the pre-moderator (left). (b) Remote handling visual inspection showing a small amount of corrosion around electron beam welded pip weld (right).

After eight years, a leak was detected in 2021. On visual inspection, water could be seen dripping from the bottom of the pipework elbow (2a). Once the reflector was opened, discolouring of the reflector block from the water block was also seen.

The spare pre-moderator of the same design was installed. Analysis was performed to identify the fault and develop out the problem before manufacturing another spare pre-moderator.

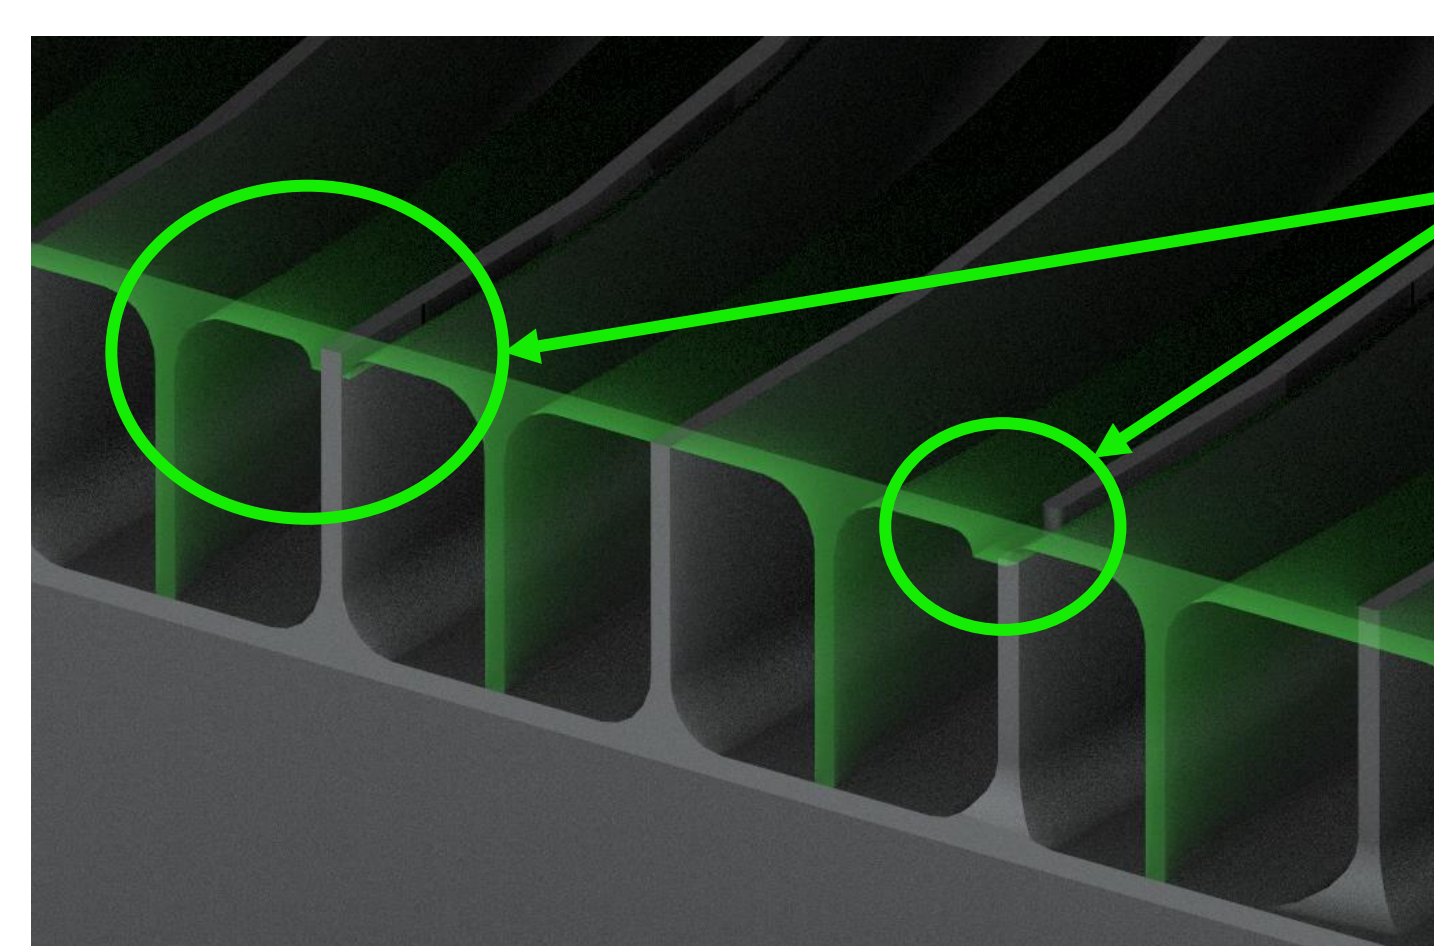
(a) Cut through image of the CAD model showing the rib stake weld

- The pips were replaced with long ribs to distribute the stress along the weld line, thus removing the stress concentrations.
- Thin scribe line to indicate the location of the stake weld through the lid.
- Rib inserts into lid by 1.5 mm to improve the contact for electron beam welding. Less power required and therefore smaller weld profile.

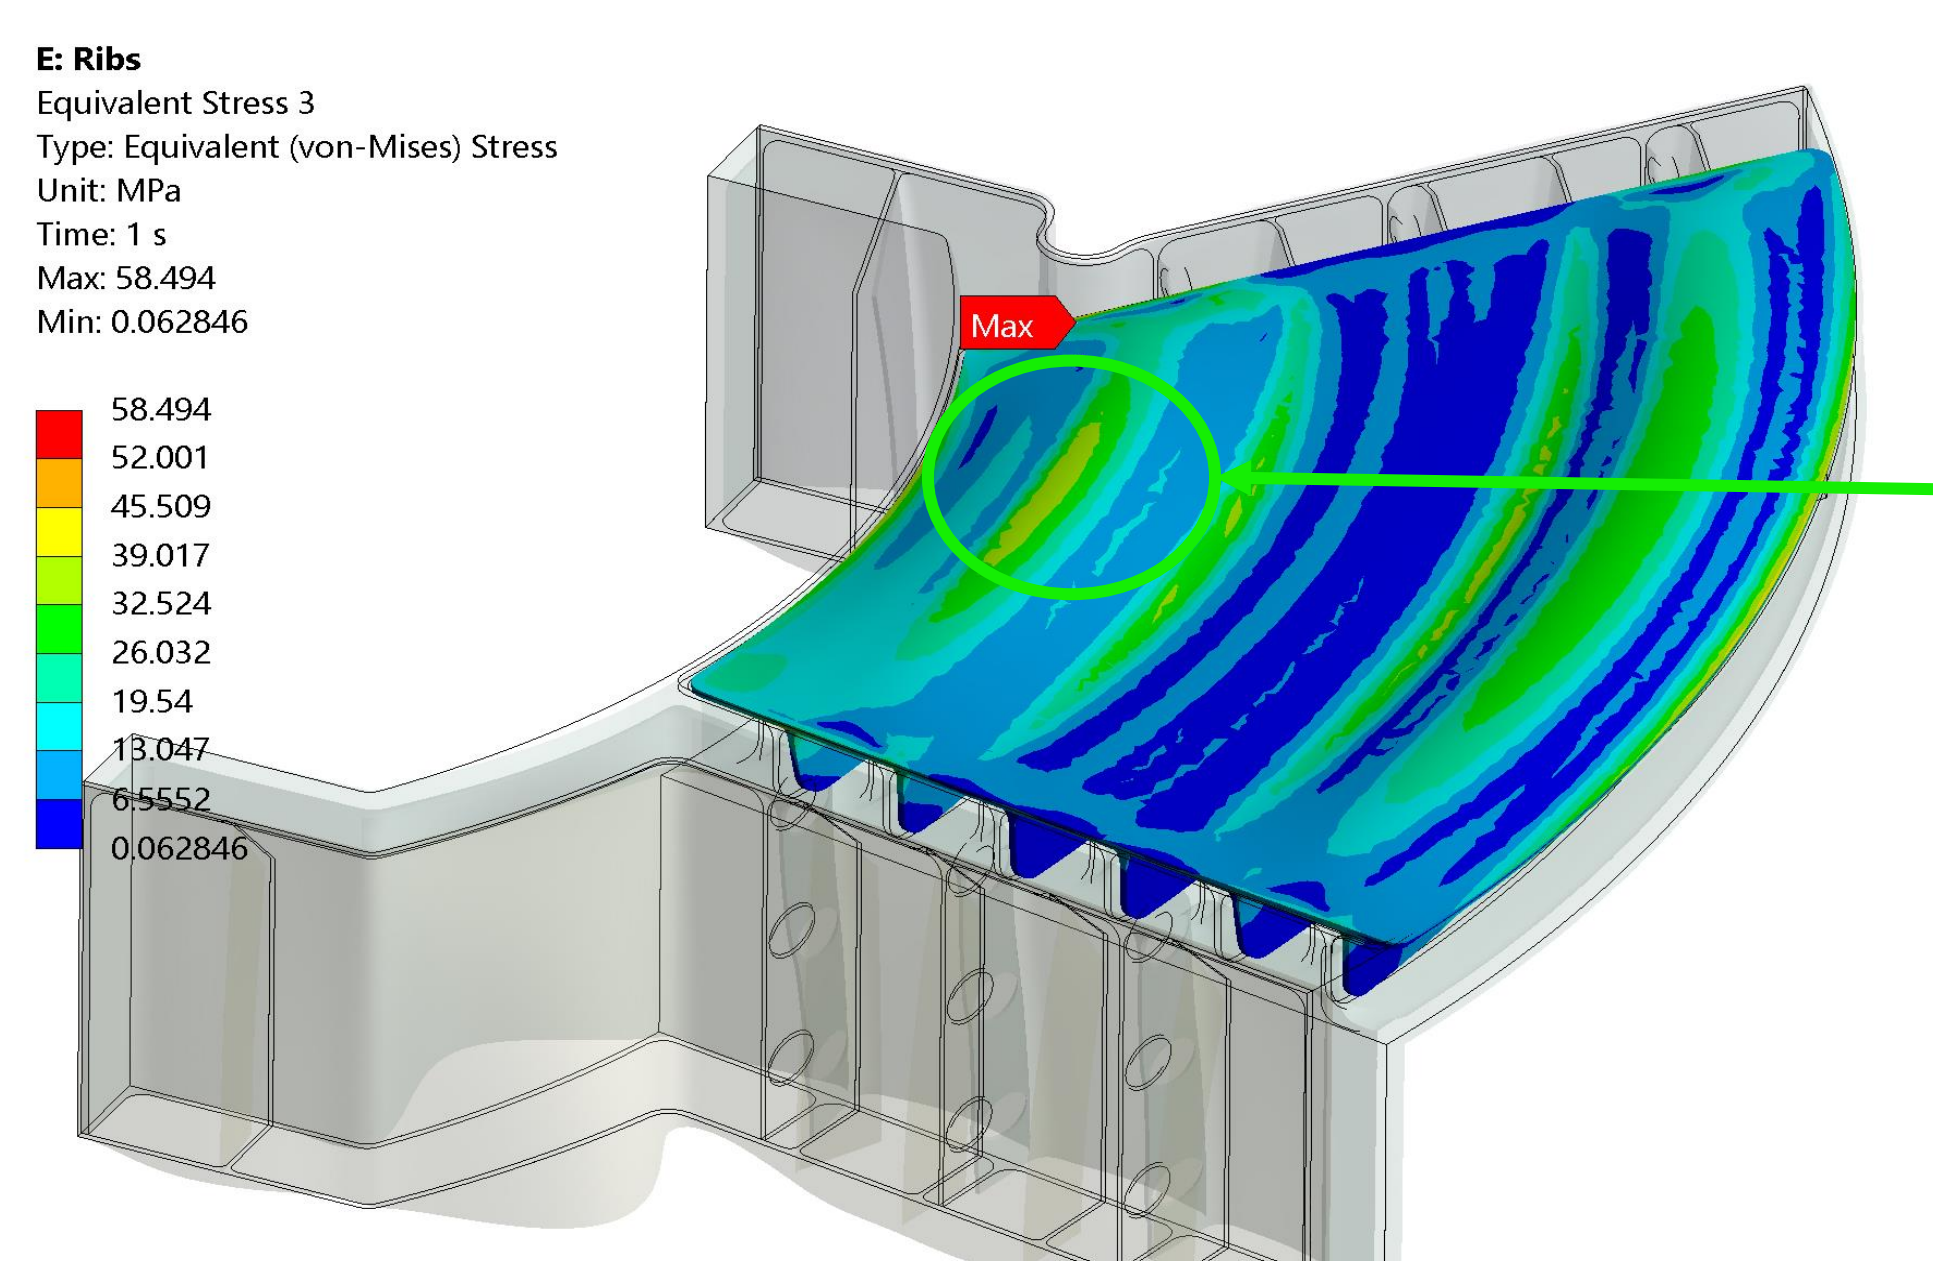
(b) ANSYS Structural analysis showing a lower maximum stress of 58.5 MPa.

Stress at the welds reduced from 189 MPa to approximately 45 MPa. Maximum stress located at perimeter (58.5 MPa).
