# ROCのDATAファイバー Syncエラー問題

RIKEN/RBRC

Itaru Nakagawa

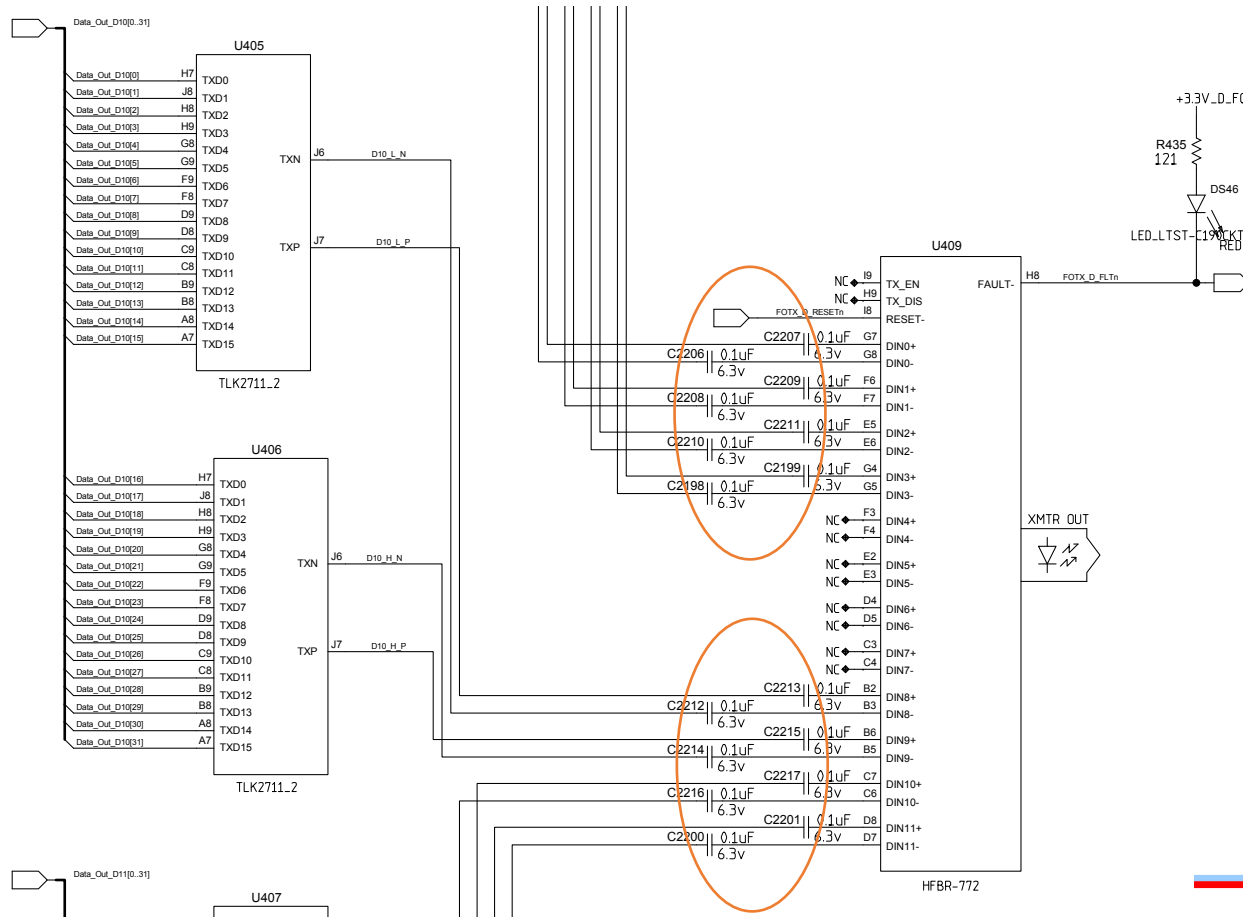
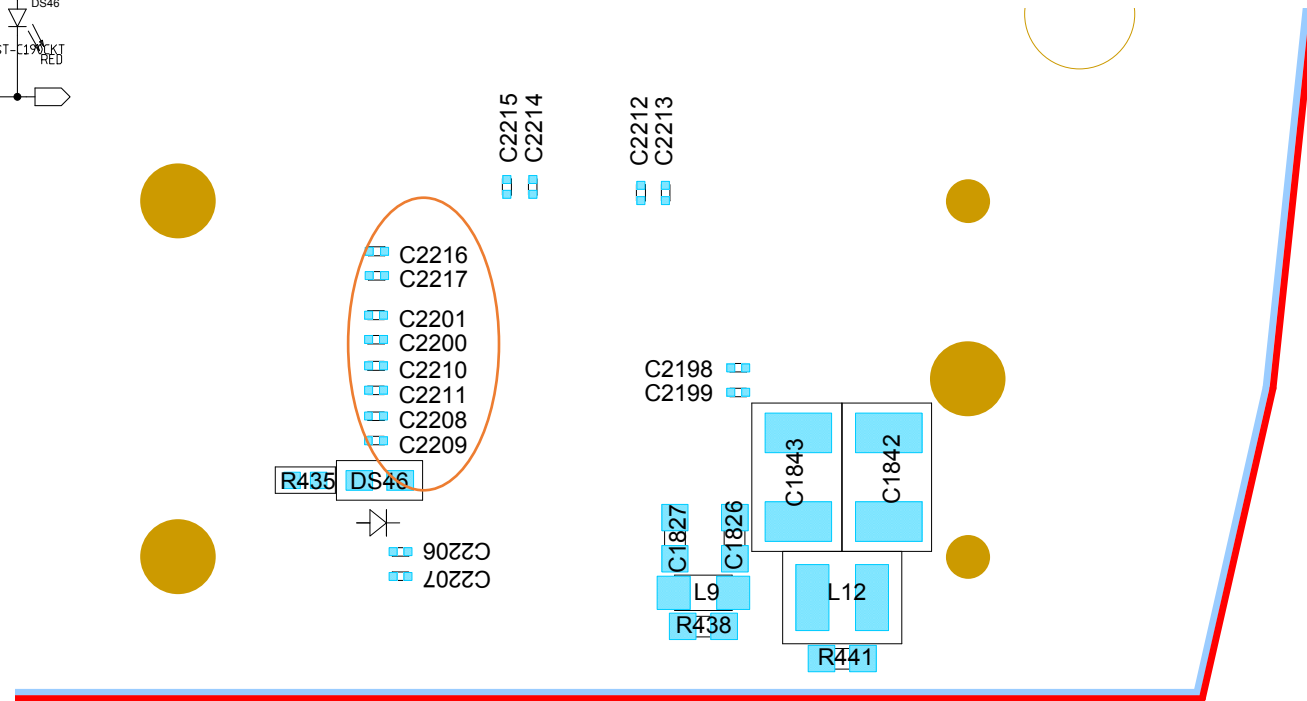
Backside of HFBR-772 area

To be probed AC coupling capacitors which are dedicated to each channels. This way, there is no need to remove the driver for monitoring signals.
