キャリブレーションテスト (20230627)

- ROC14, 21のキャリブレーションテストを行なった。
- 2台のROCはBNLに送る前の状態と比べてだいぶ悪くなっていた。

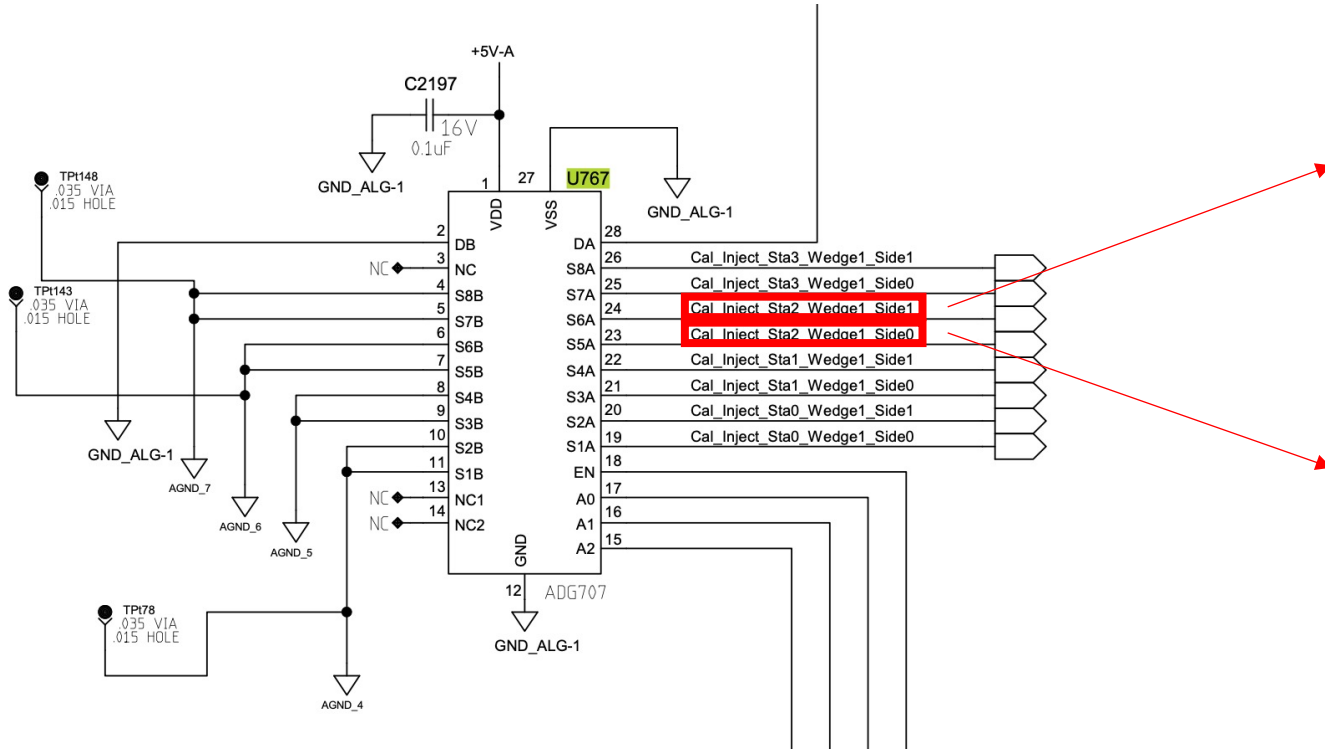
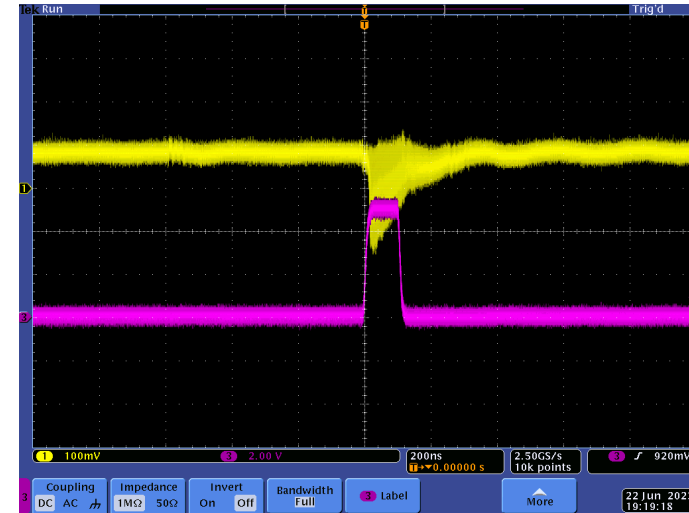
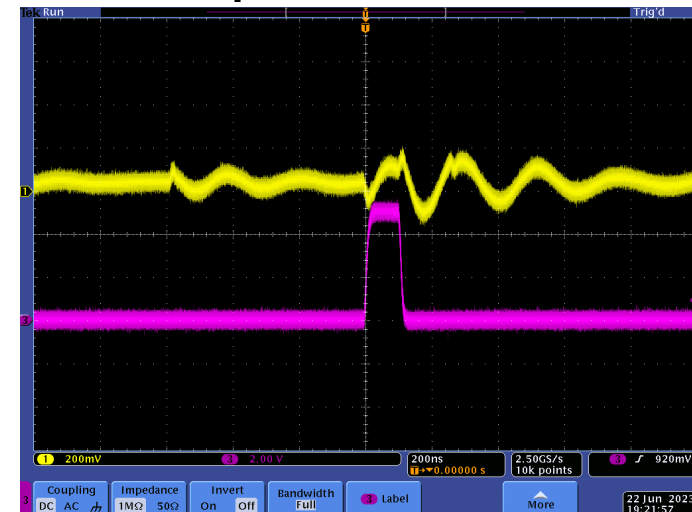
Measurement of pulse (Check multiplexer)

Multiplexer is **bad!!**

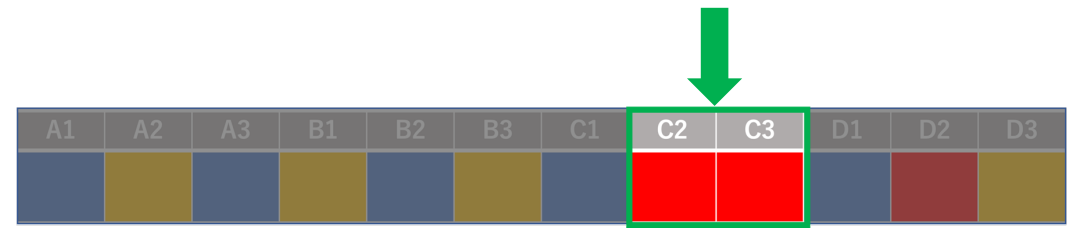
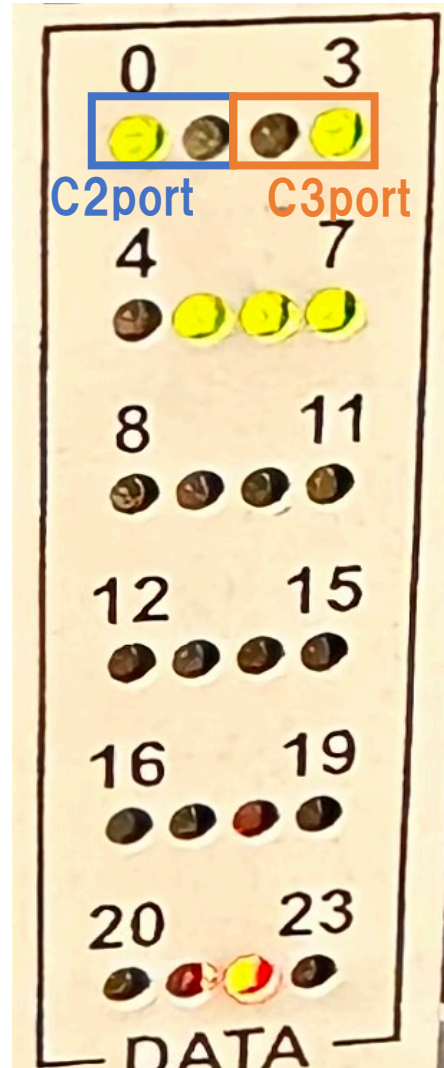
ROC21 (C2, C3port)

Fiber latch problem

Exchange serializer!

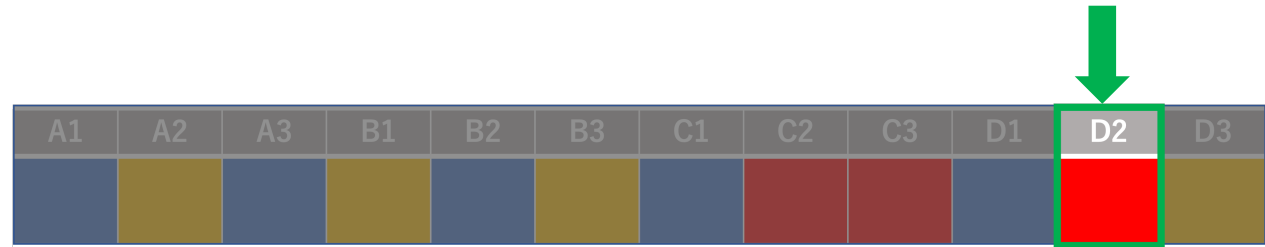
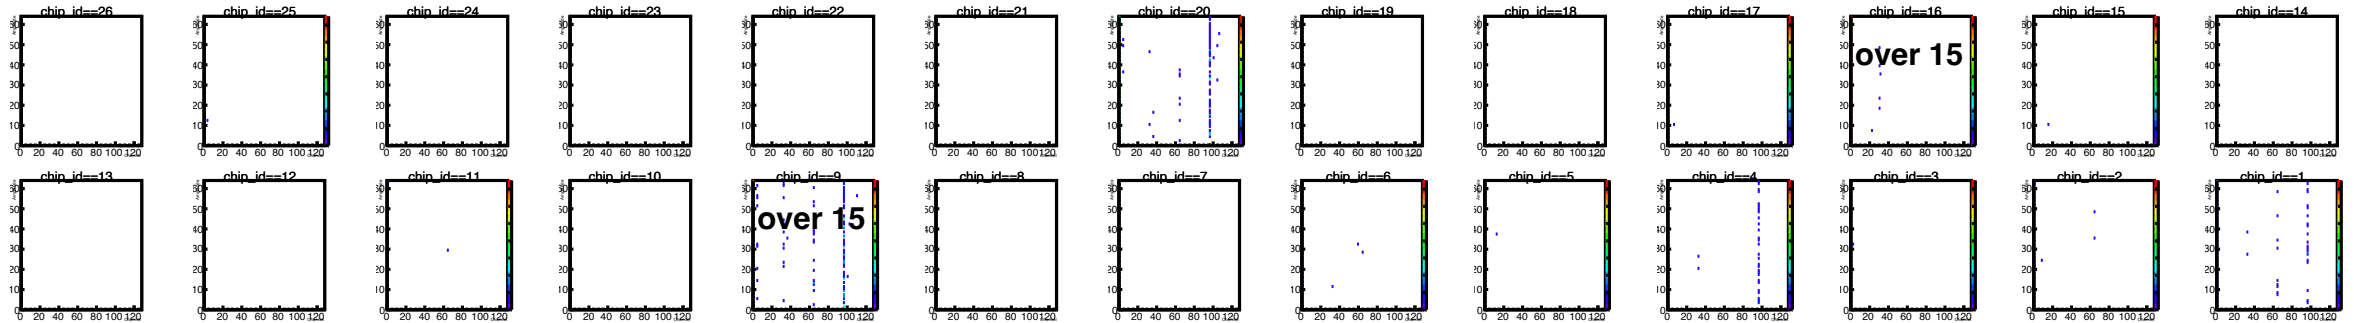
ROC21 (D2port)

Check input and output of regulator!!

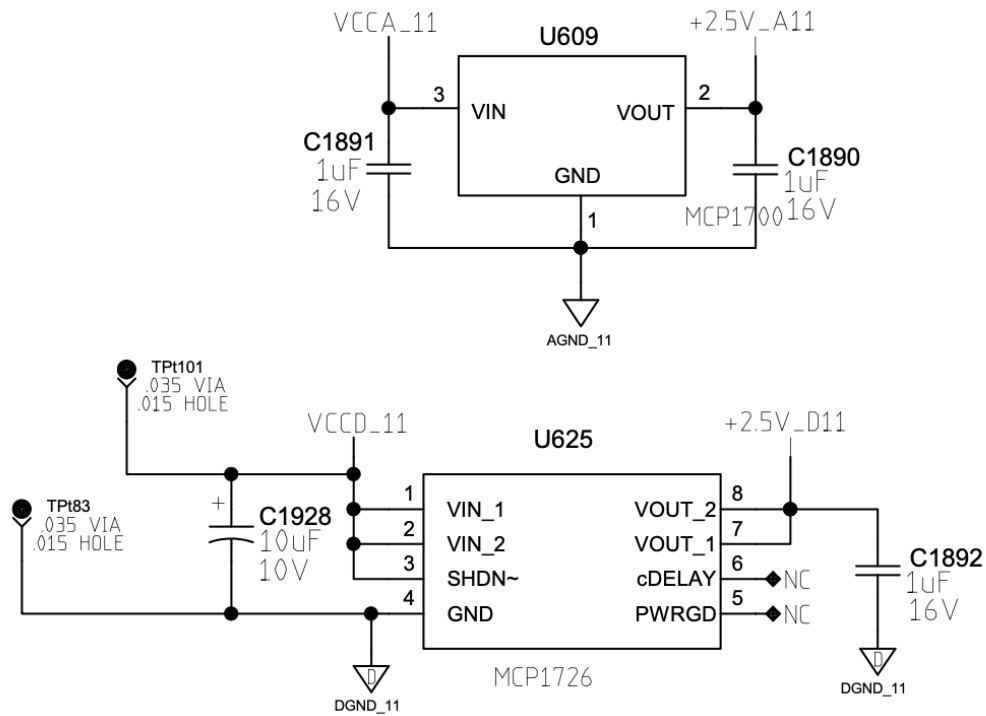
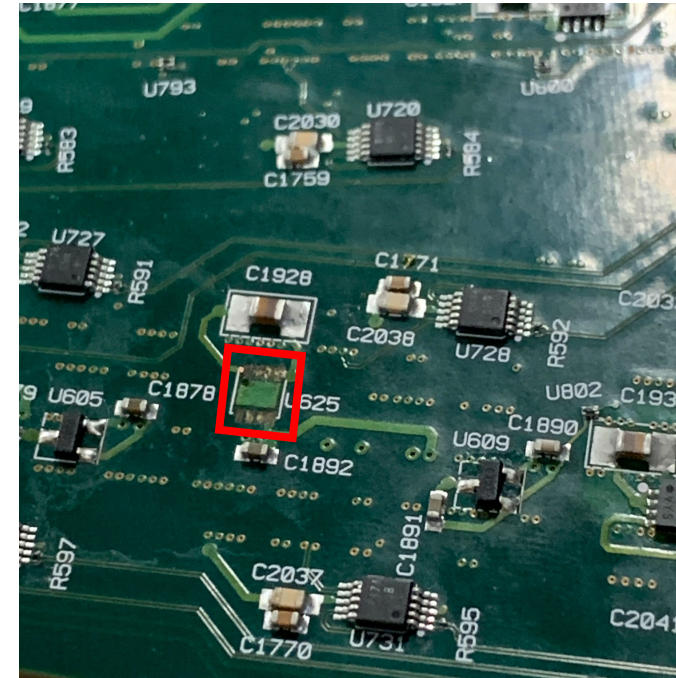
ROC21 (D2port) (Regulator Test)

Output C1892 → 0.601V (usually 3.00V)
Input C1928 → 4.914V (usually 3.50V)

U625 is lost

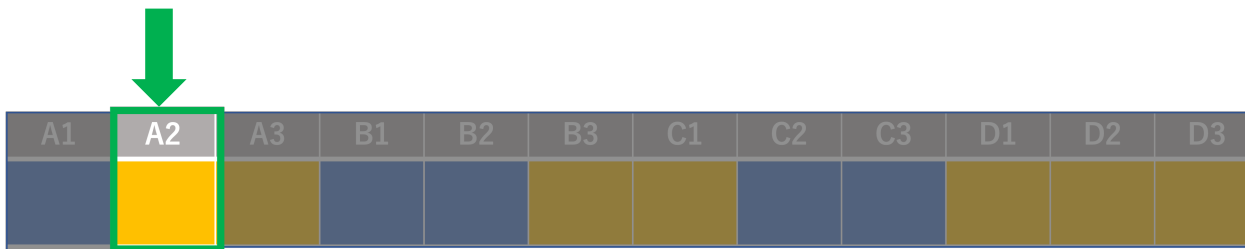
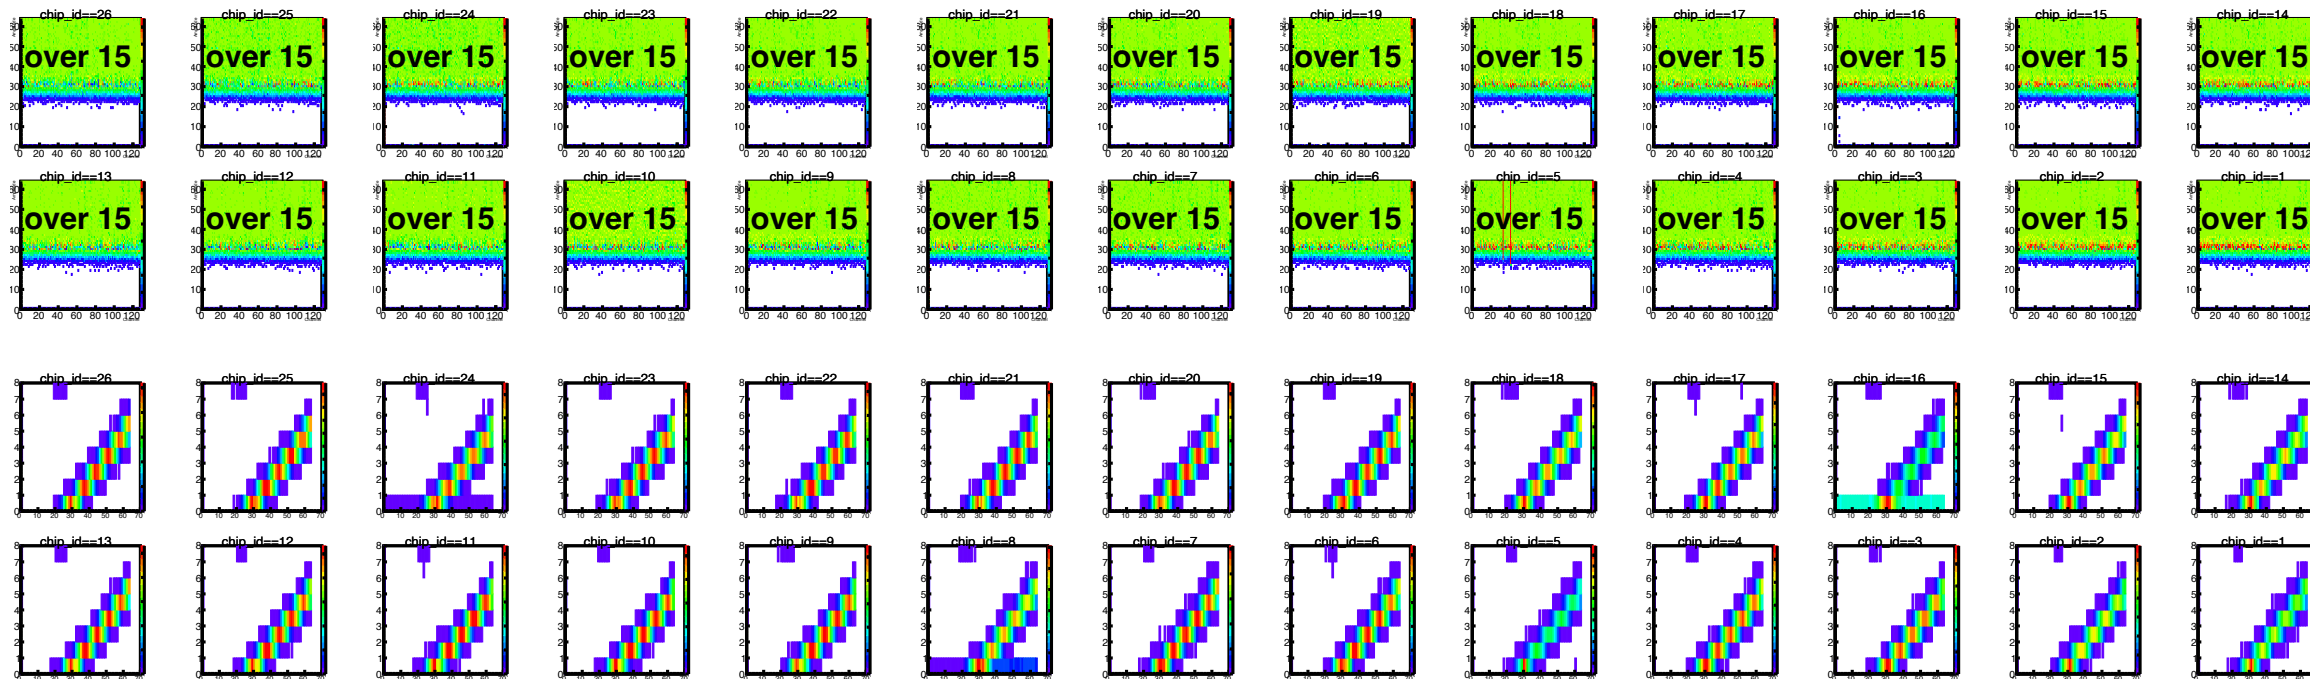
ROC14 (A2port)

全データがover15

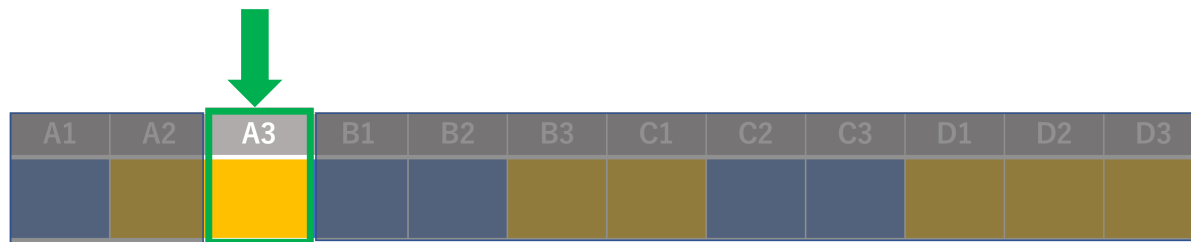
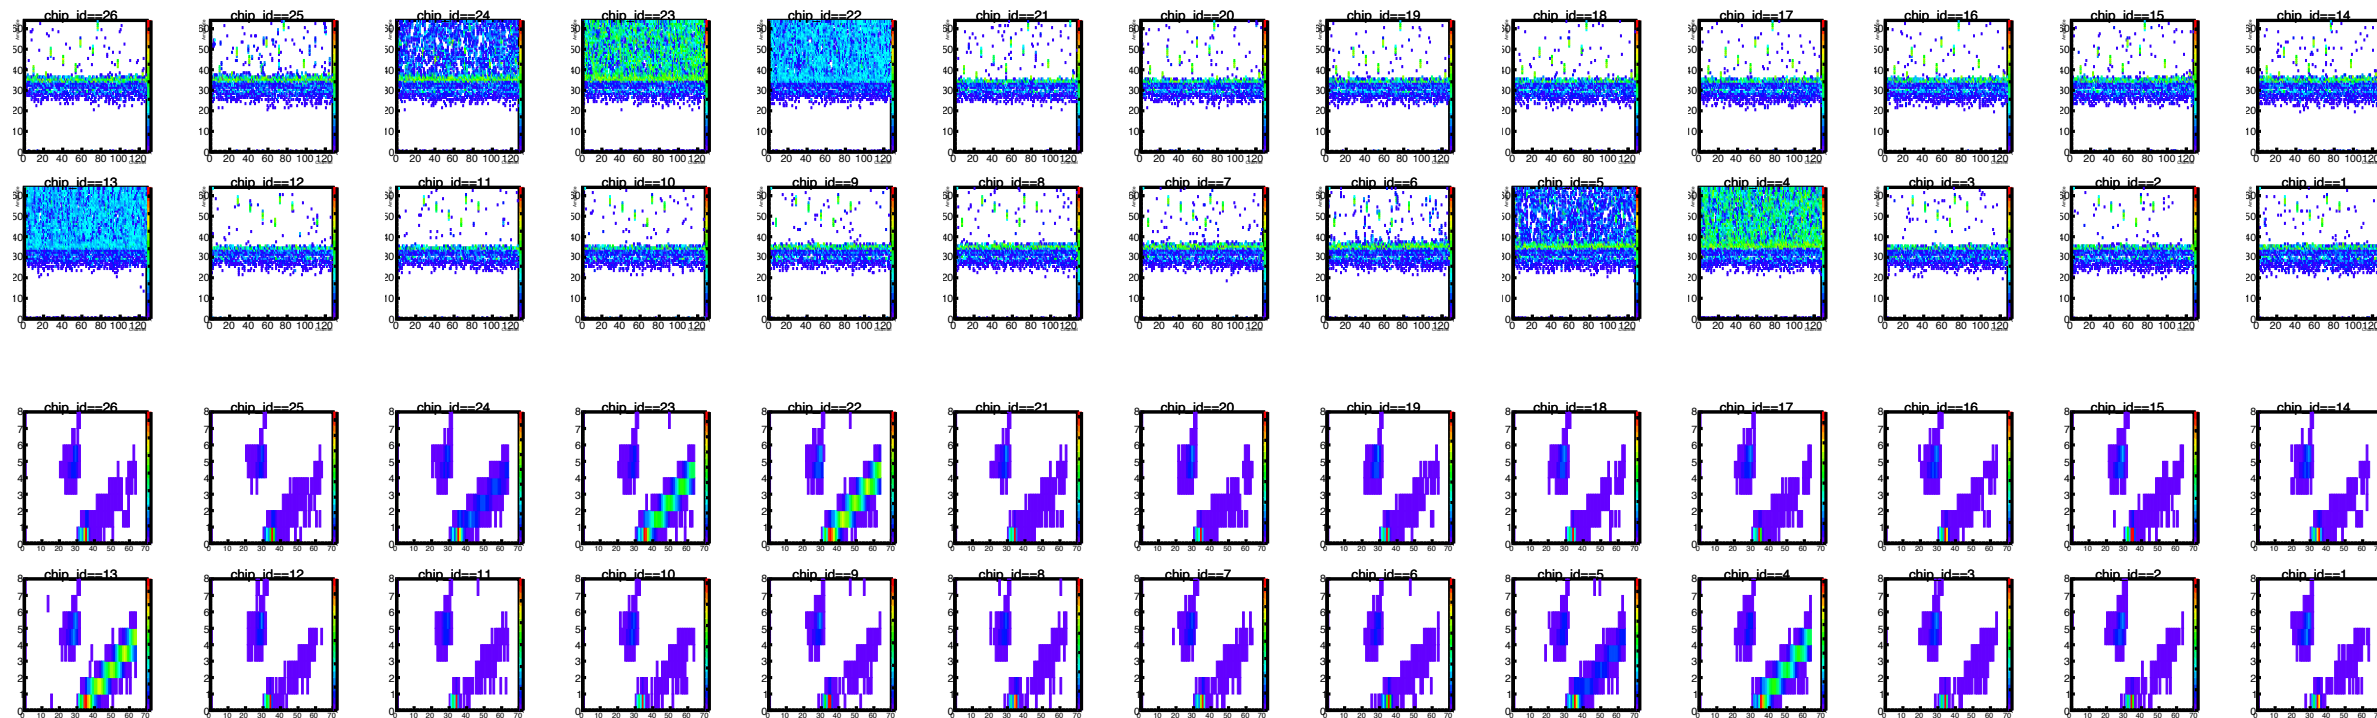
ROC14 (A3port)

全体的にデータ数が少ない。奈良女で見たニワトリデータ？

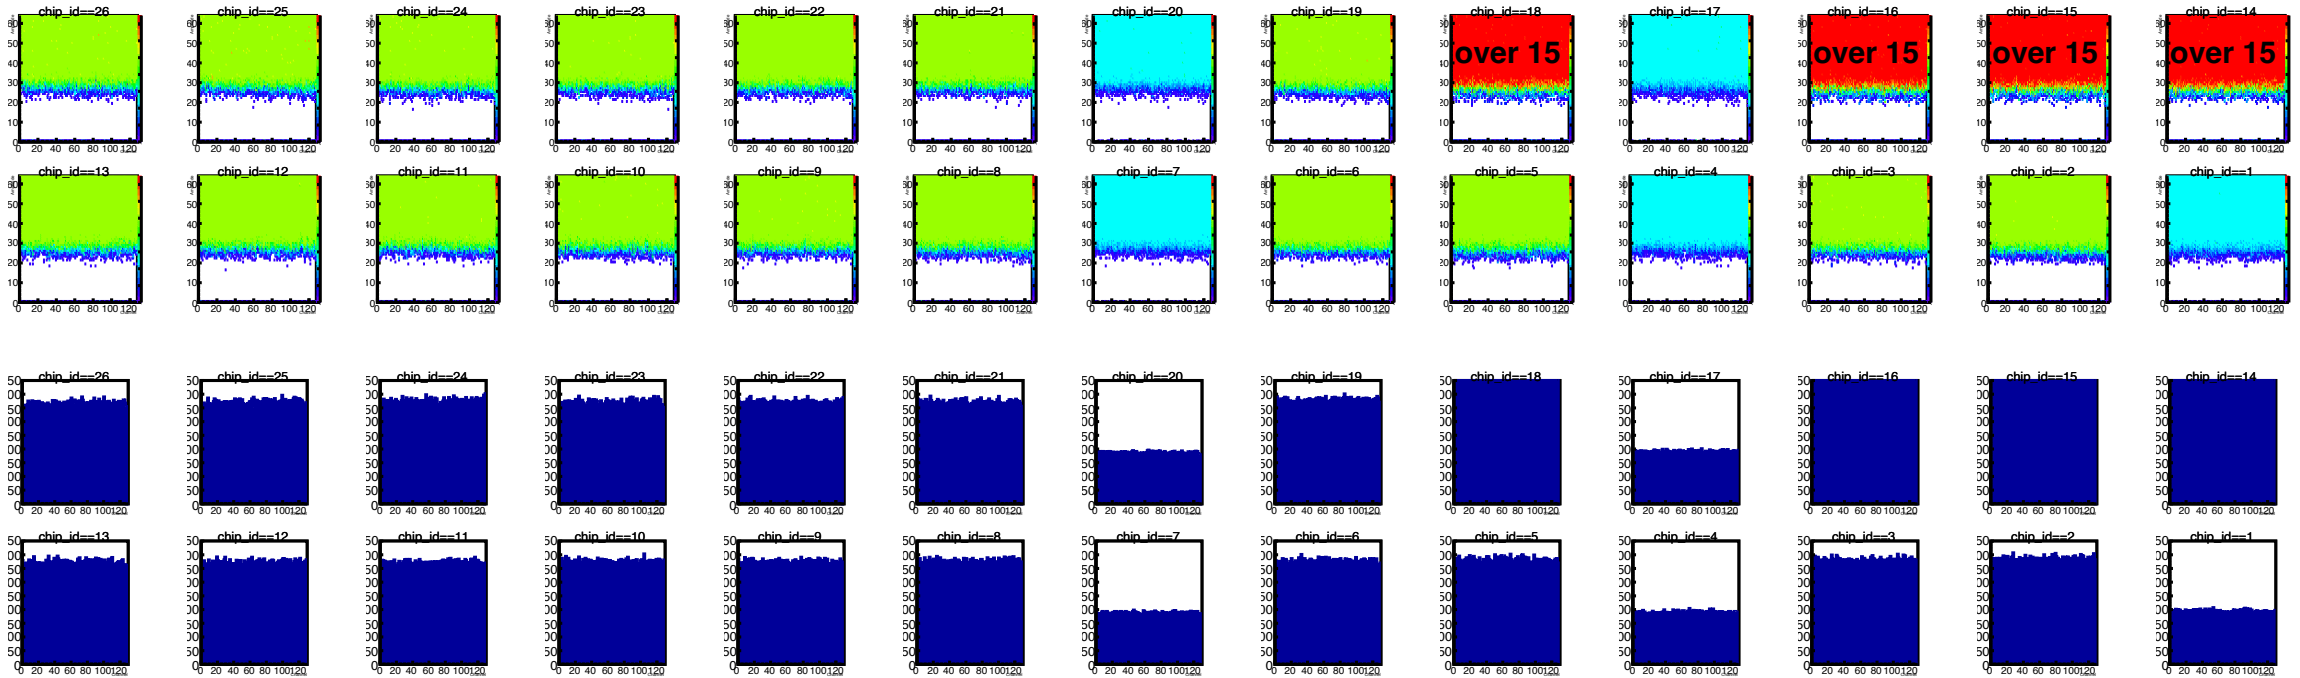
ROC14 (C1port)

Chip1,4,7,17,20→half entry
Chip10,12,14,15,18→over15

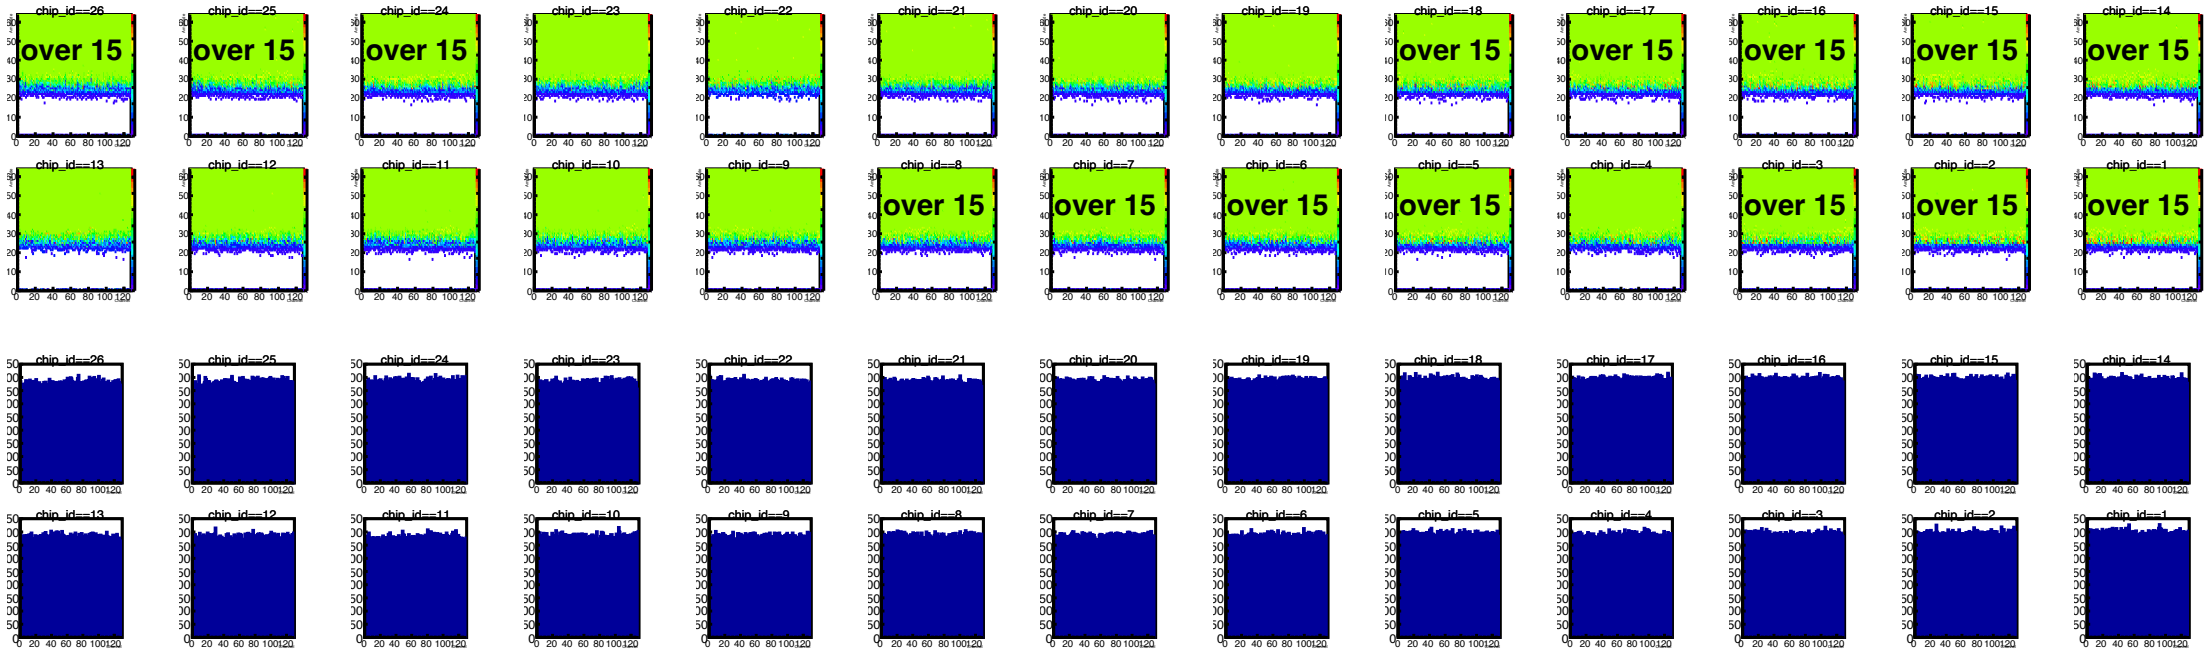
ROC14 (D1port)

Chip1~3, 5~8, 14~18, 24~26→over15

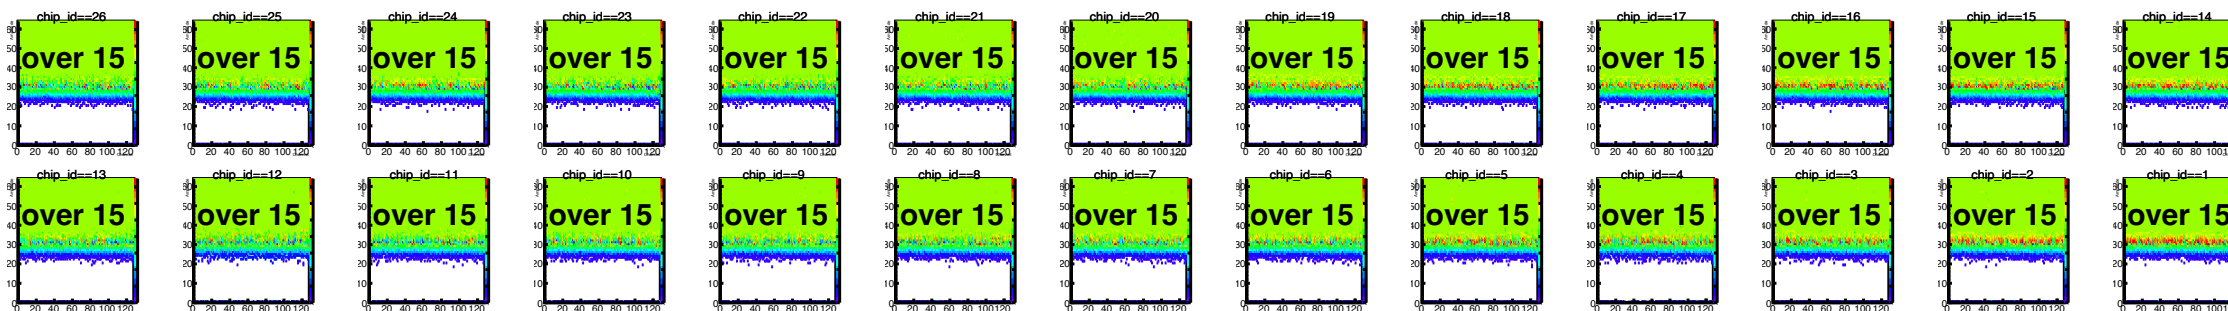
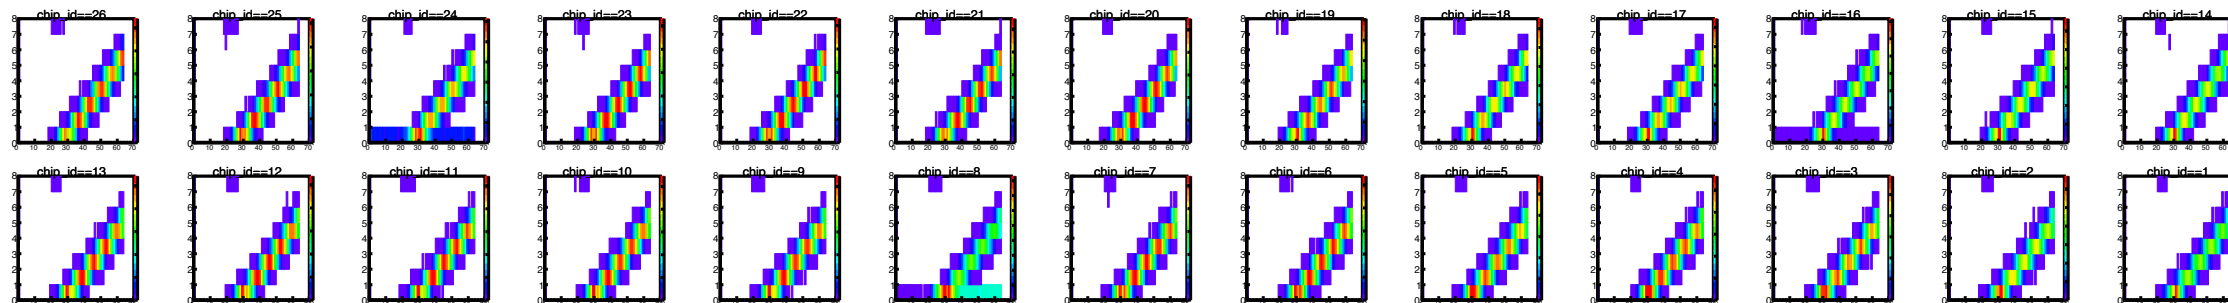
ROC14 (D2port)

全chipがover15

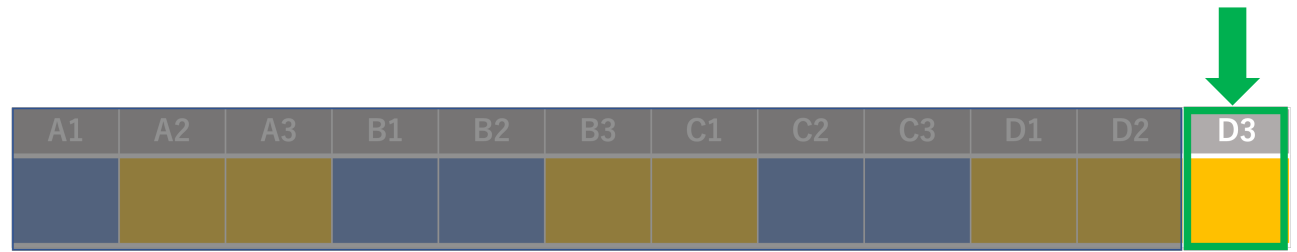
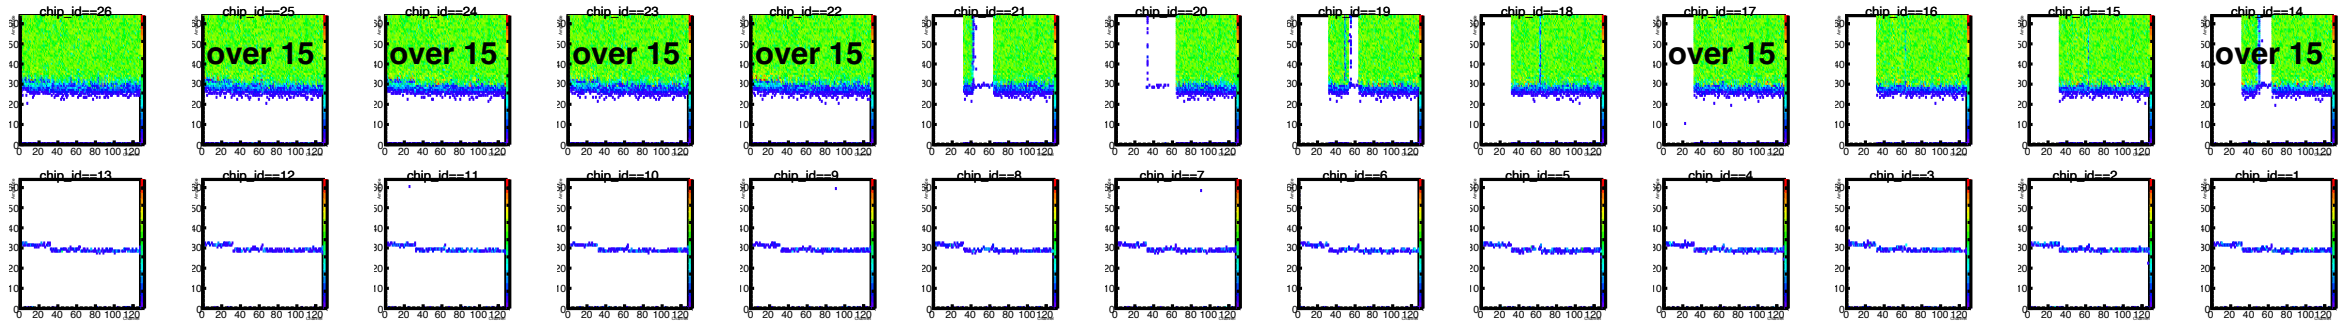
ROC14 (D3port)

Chip1~13→ほぼ空データ
Chip14~21→データかけ

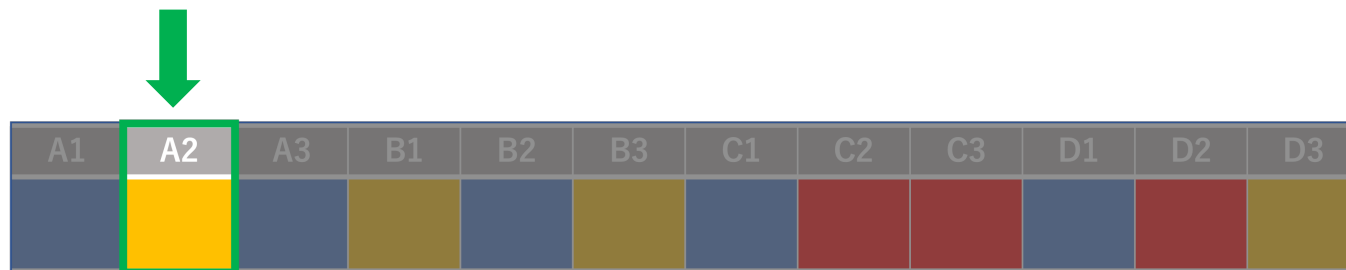
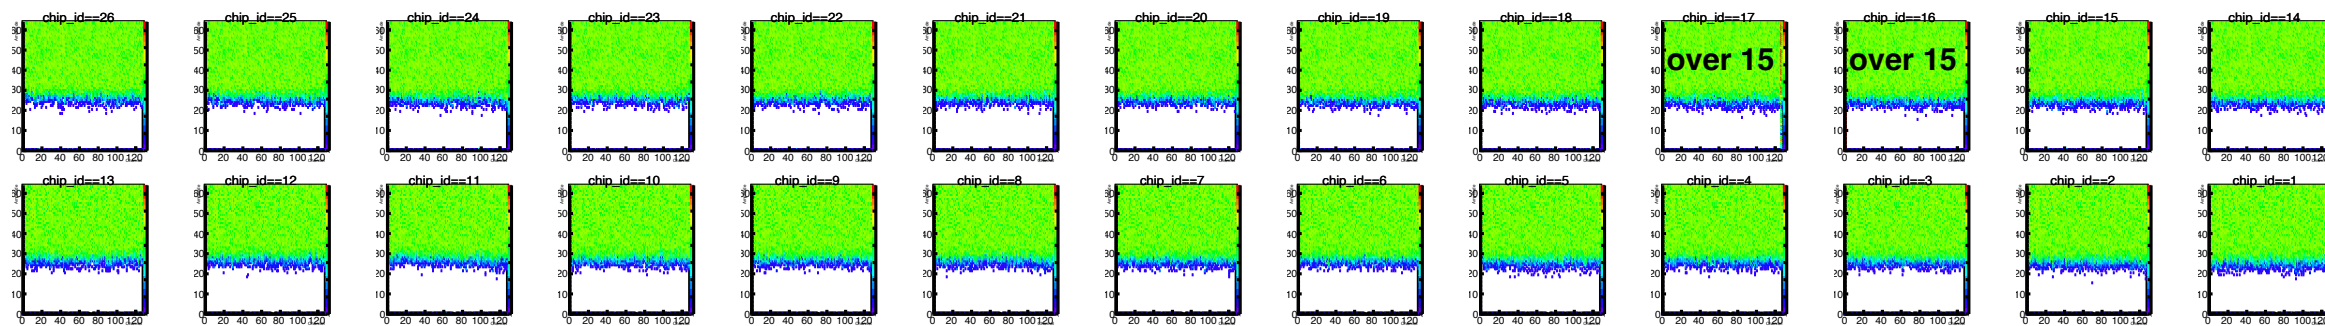
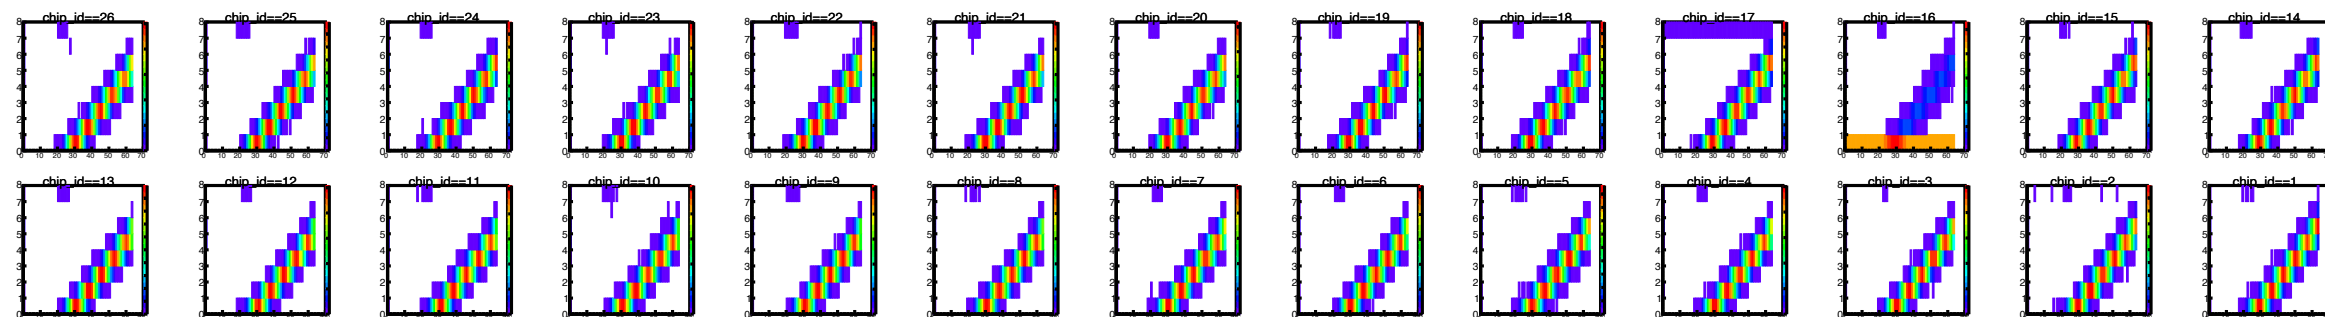
ROC21 (A2port)

ノイズが大量に来た。Chip15,17がover15

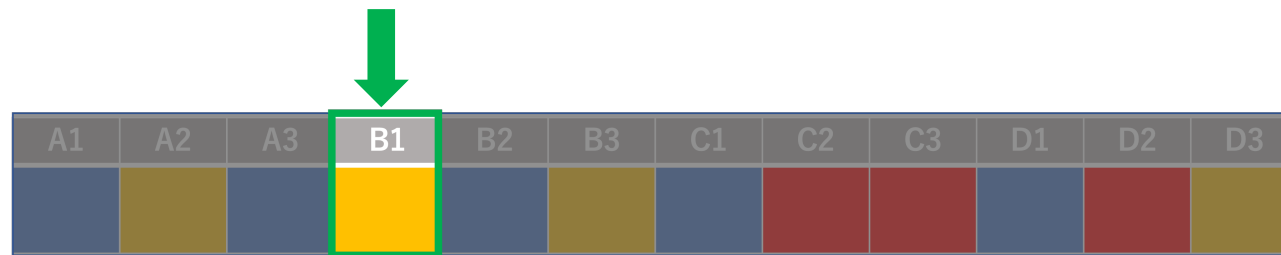
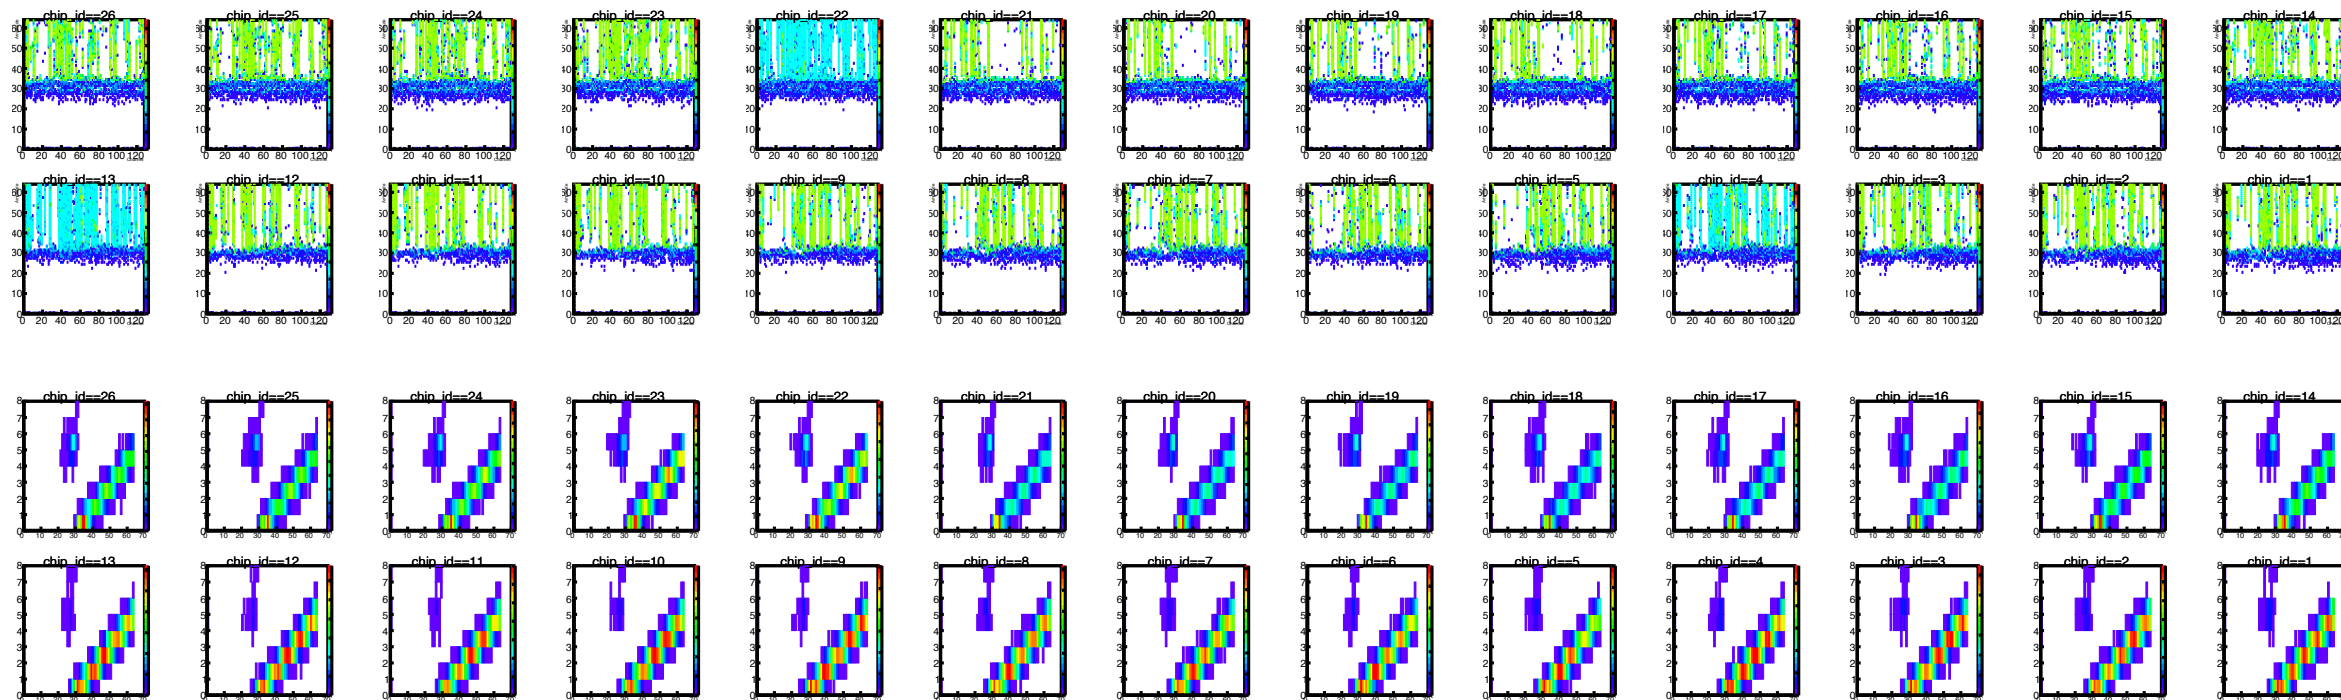
ROC21 (B1port)

全chipでエントリーが足りていない。

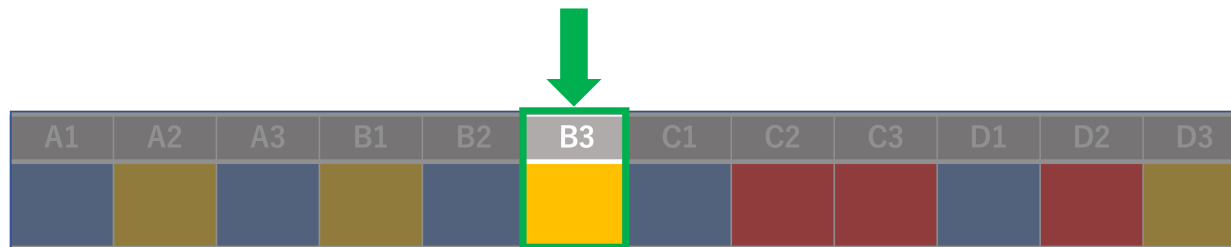
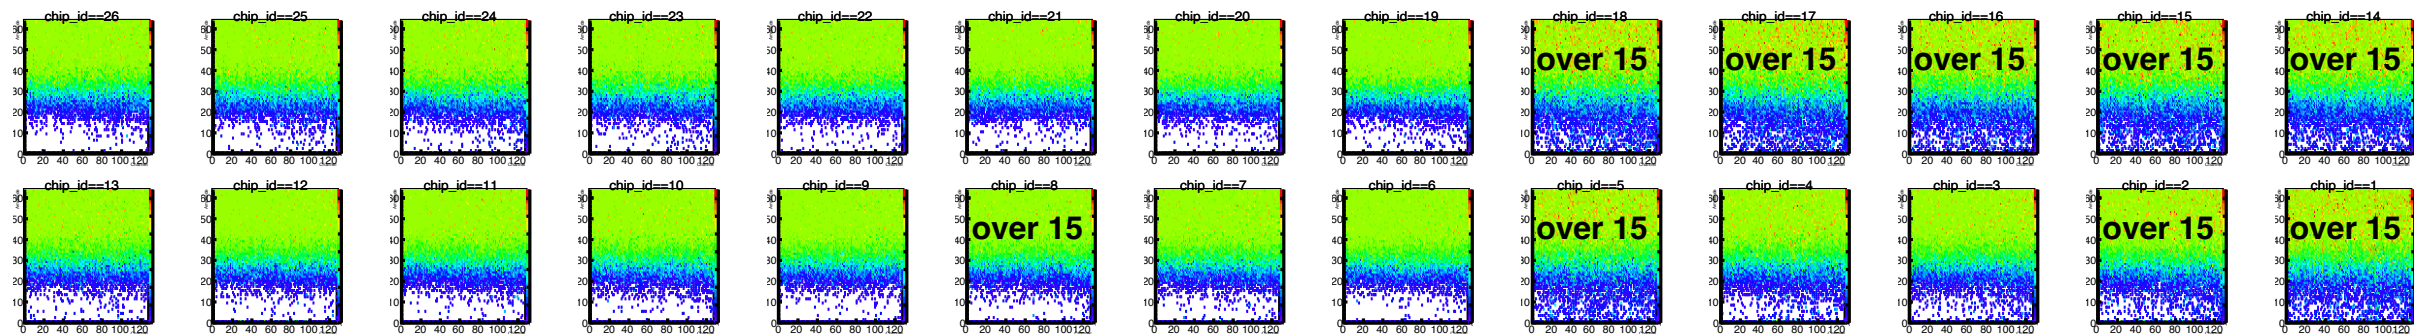
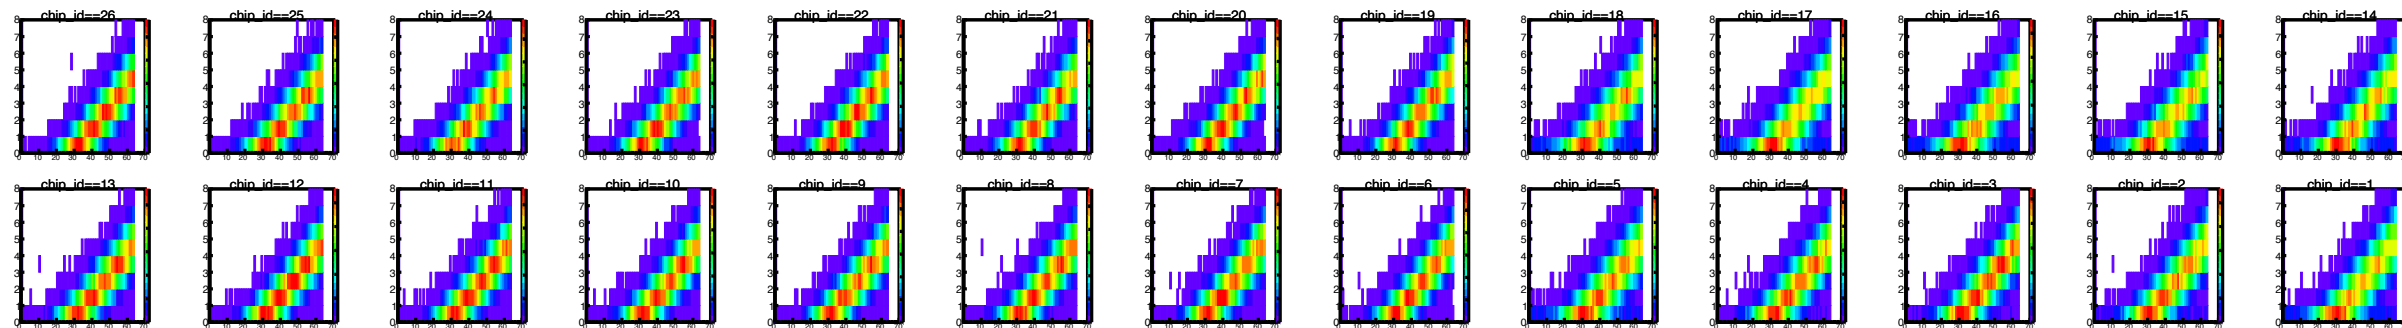
ROC21 (B3port)

Chip1, 2, 5, 8, 14, 15, 16, 17, 18 → over15

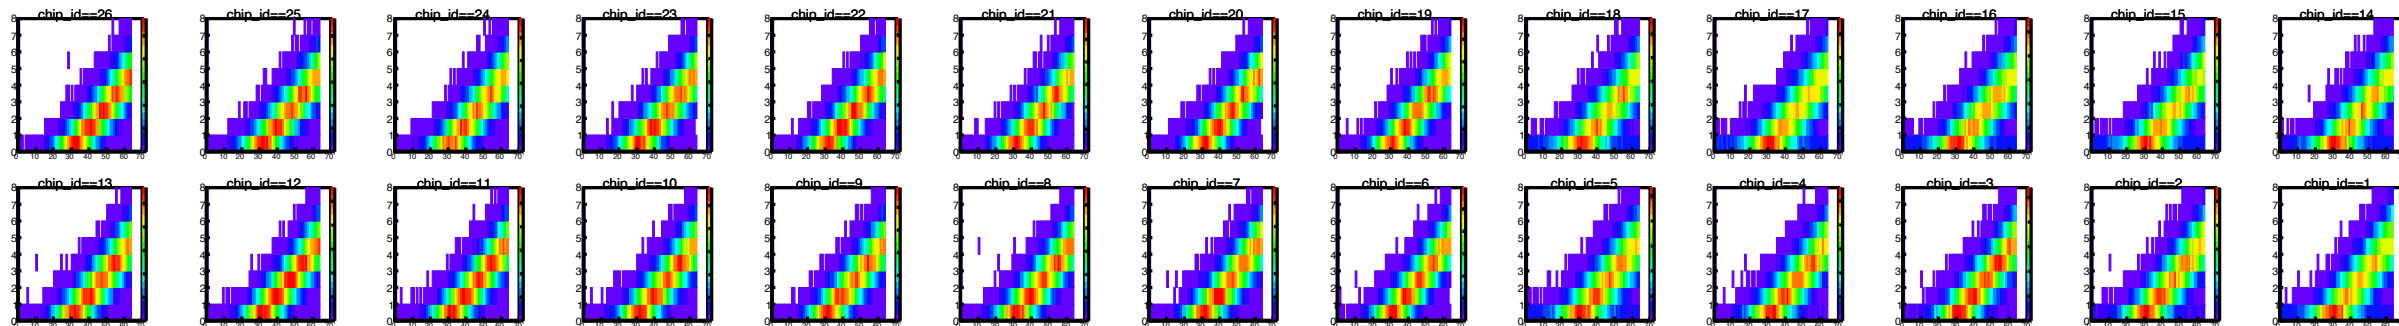
今回のデータ

Chip1, 2, 5, 8, 14, 15, 16, 17, 18→over15

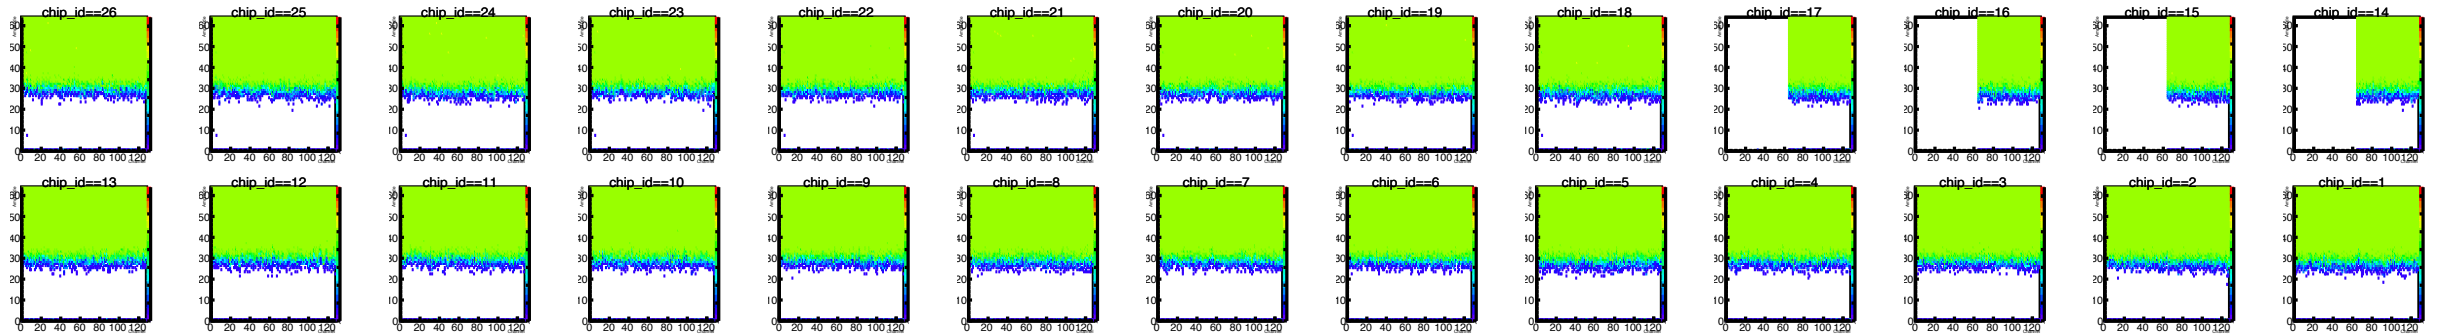
ROC21 (D3port)

D3ポート欠け。
