MPC-EX MINIPAD SENSOR FABRICATION STATUS

Ewha womans university

Seyoung Han

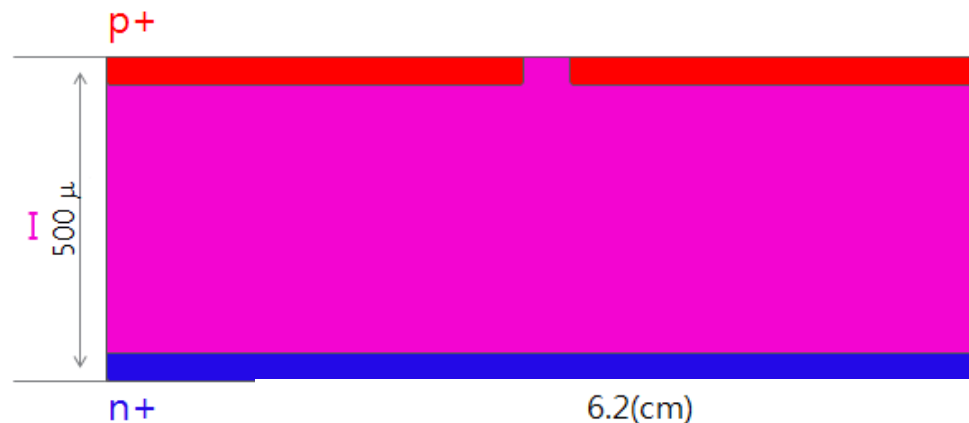
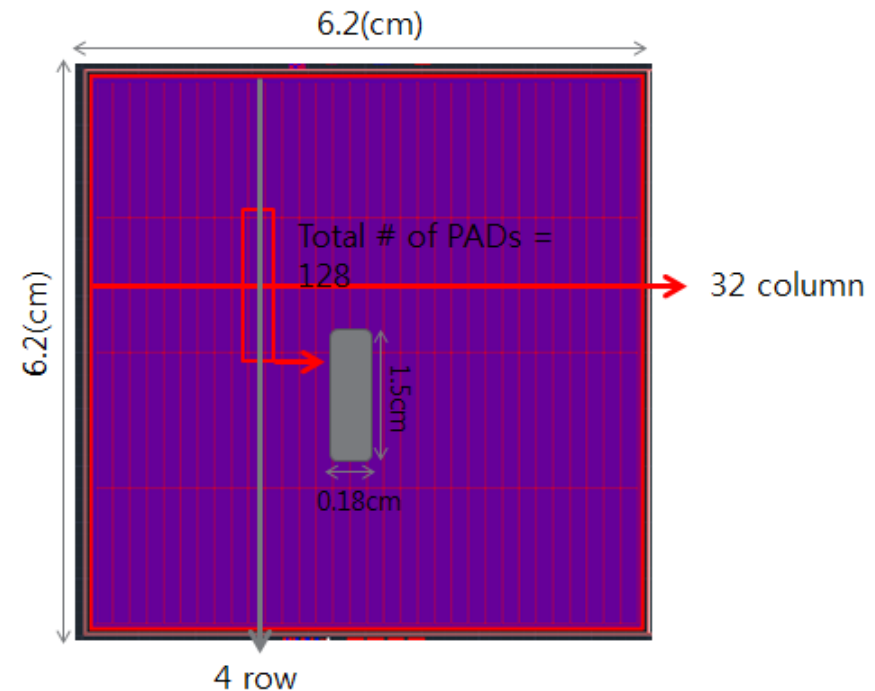
Structure of minipad sensor

Vertically, PIN-structured ('p+'-intrinsic-'n+') silicon sensor

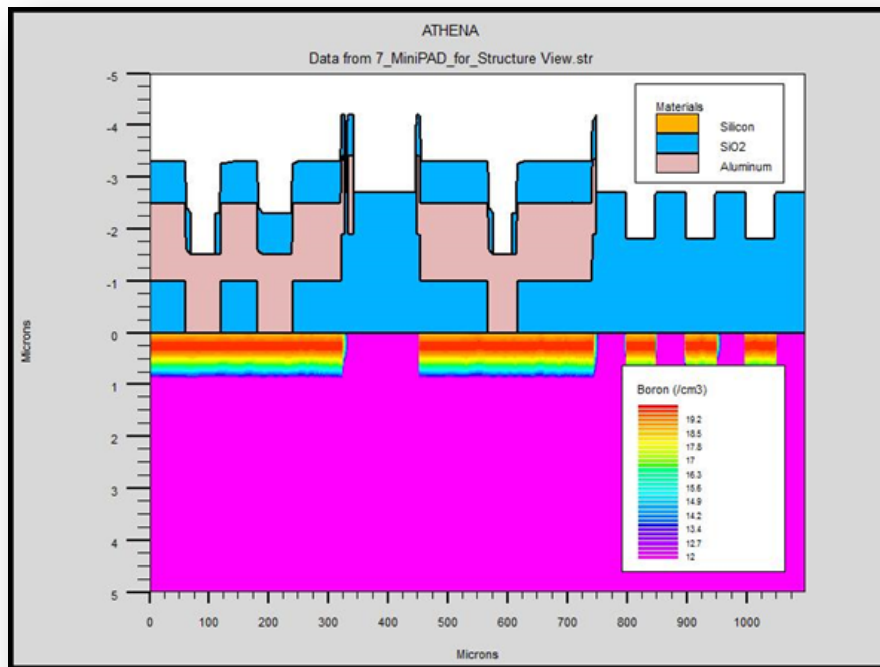
Sensor Fabrication Steps

Thermal oxidation

Backside : POCl₃ defusion

Front pattern etching

Front p⁺ implant + Guardring

Metalization and Etching

Passivation : Oxidation

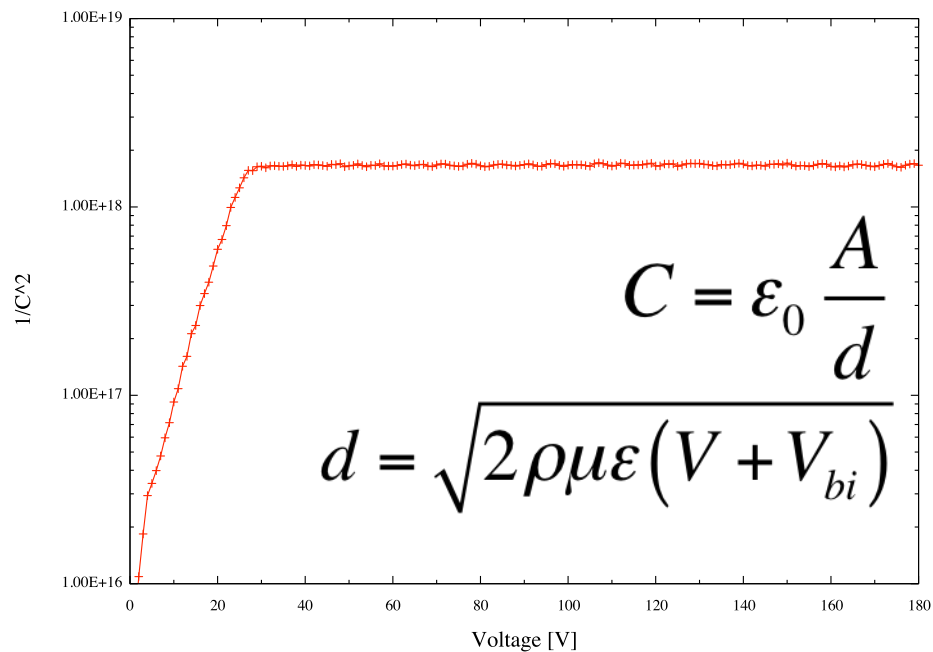
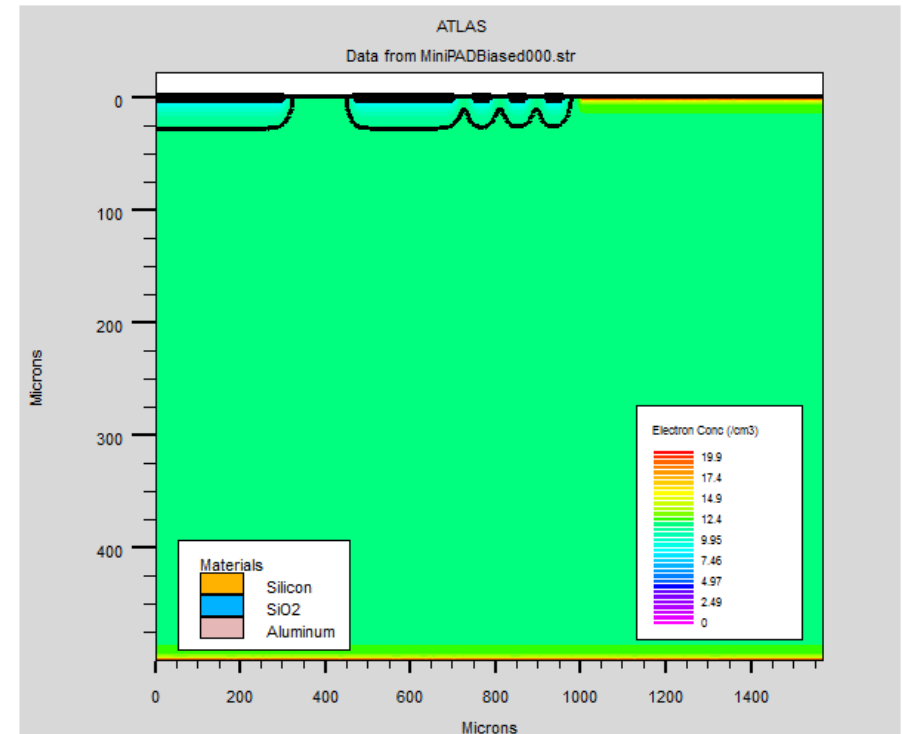
0 V

Depletion volume

- CV test

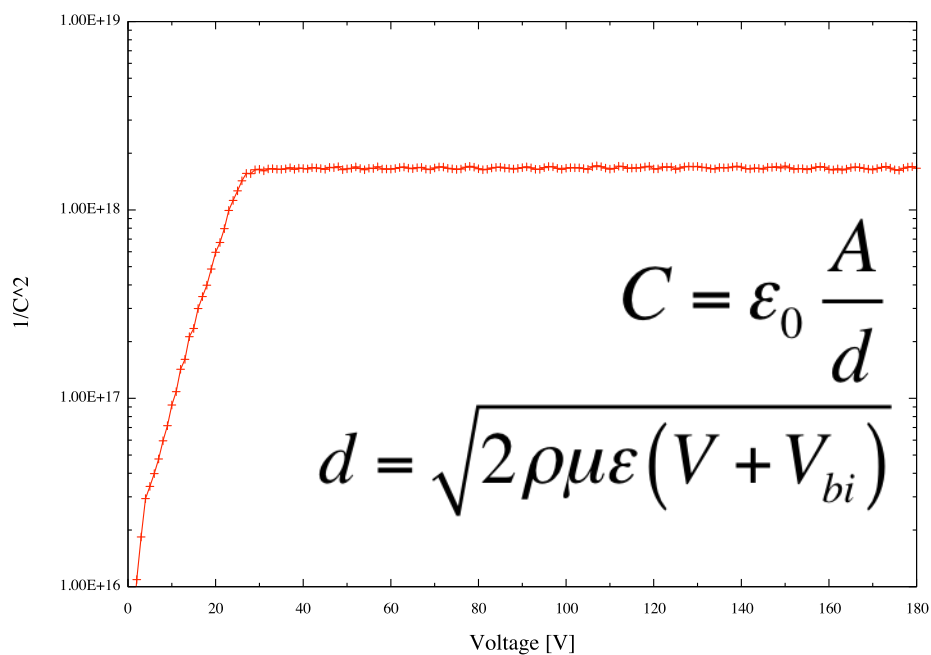
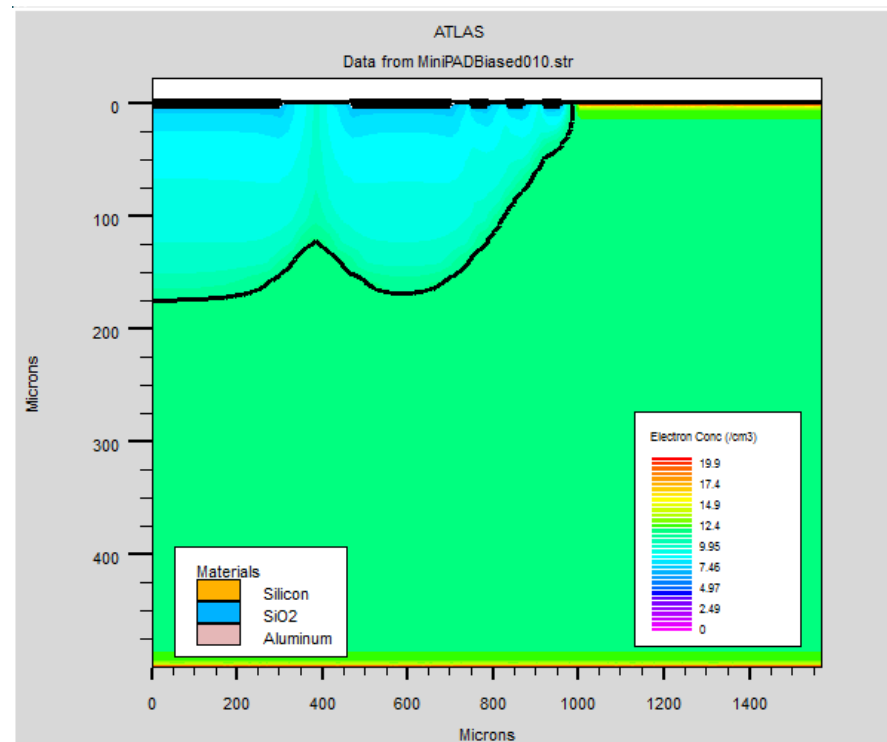
10 V

Depletion volume

- CV test

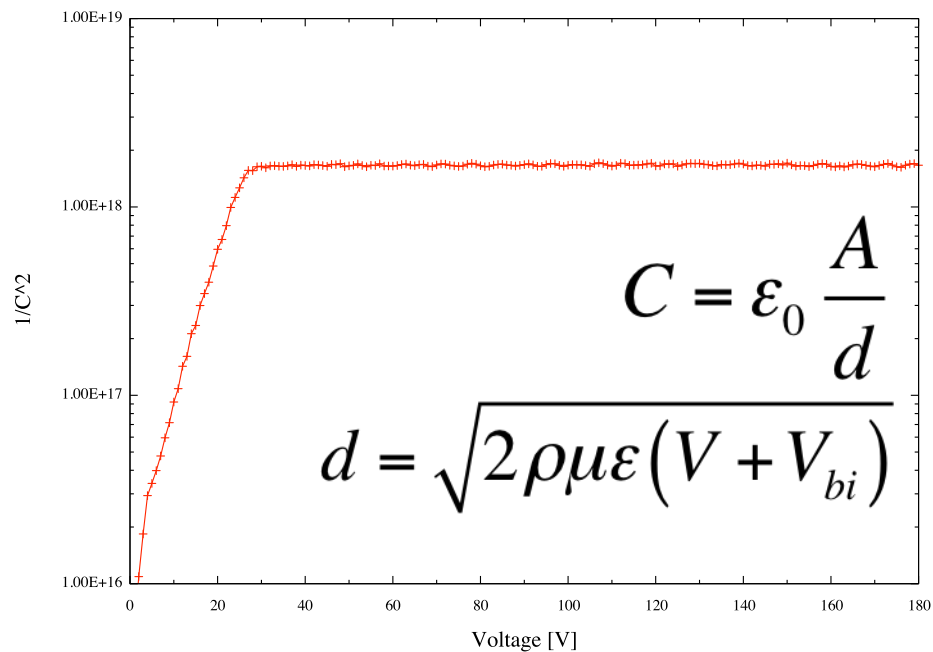
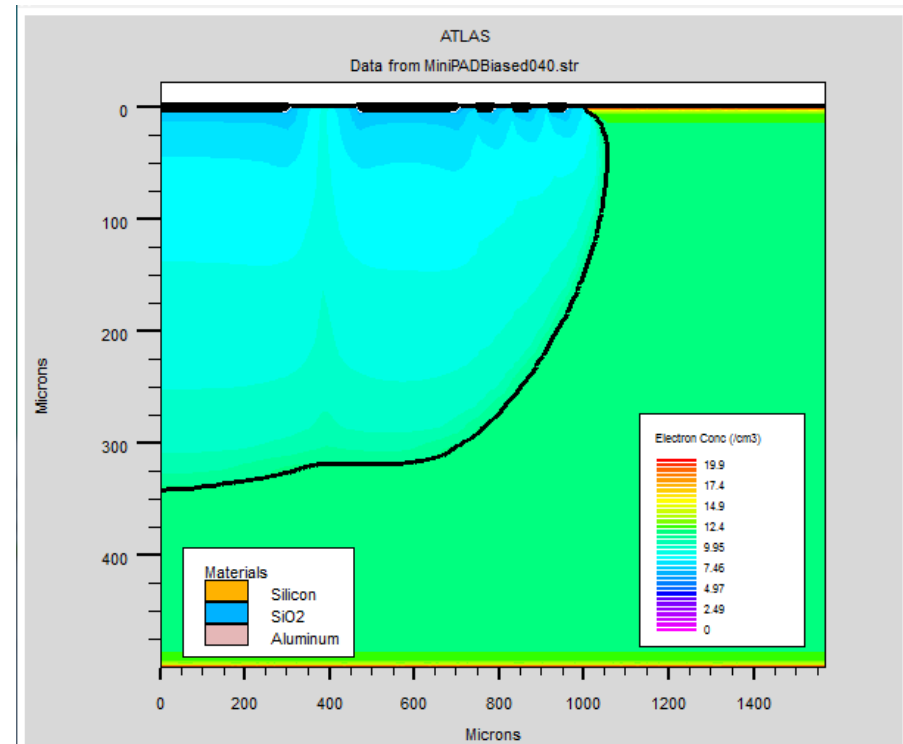
40 V

Depletion volume

- CV test

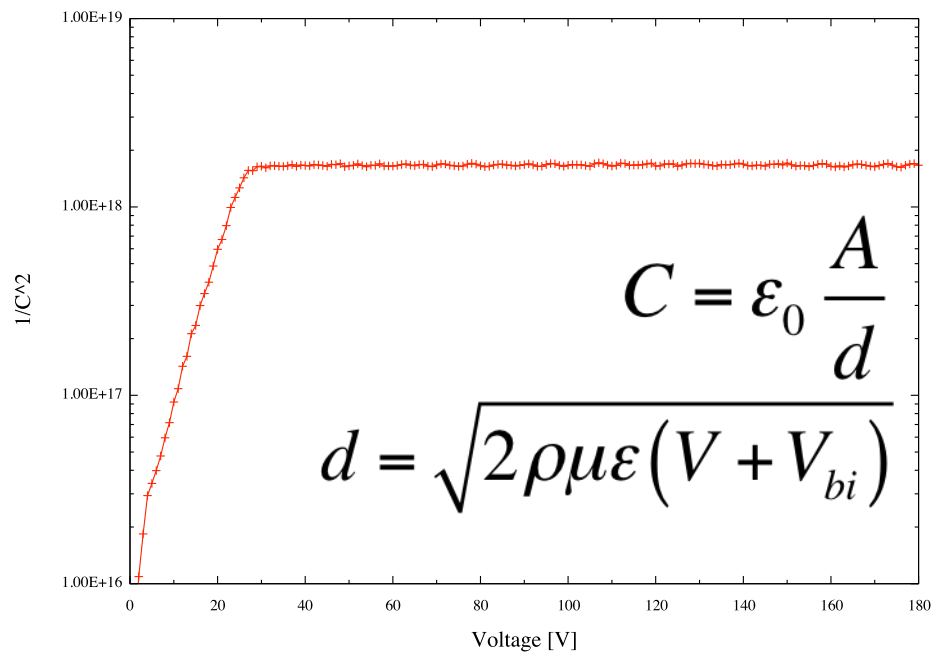
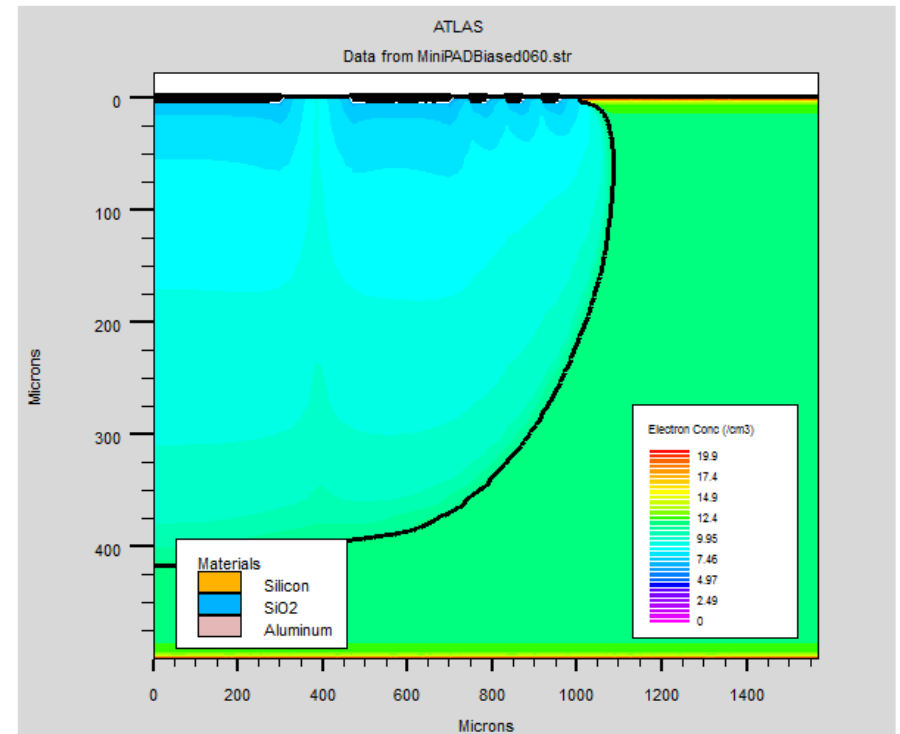
60 V

Depletion volume

- CV test

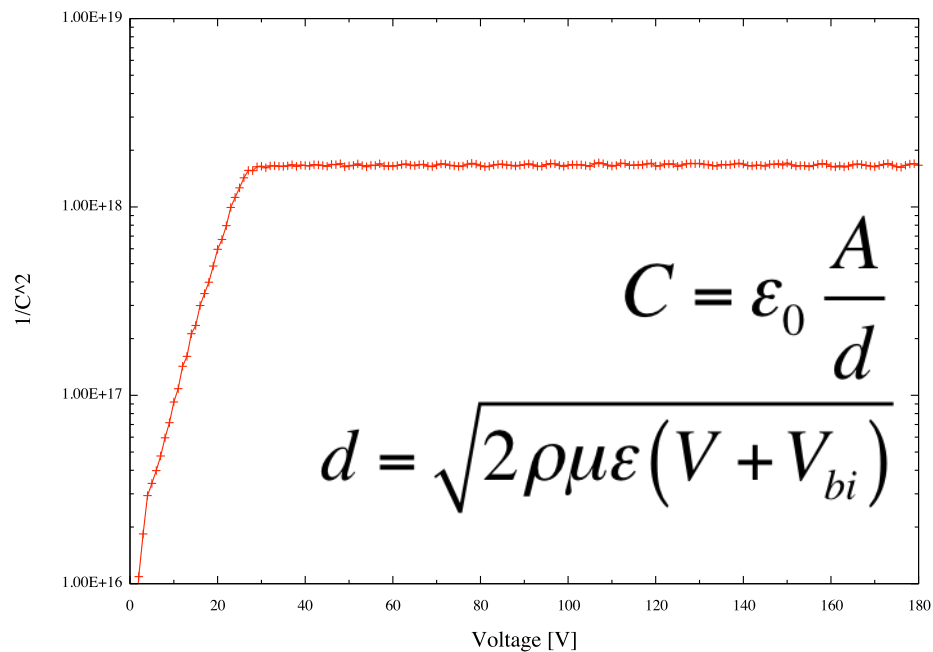
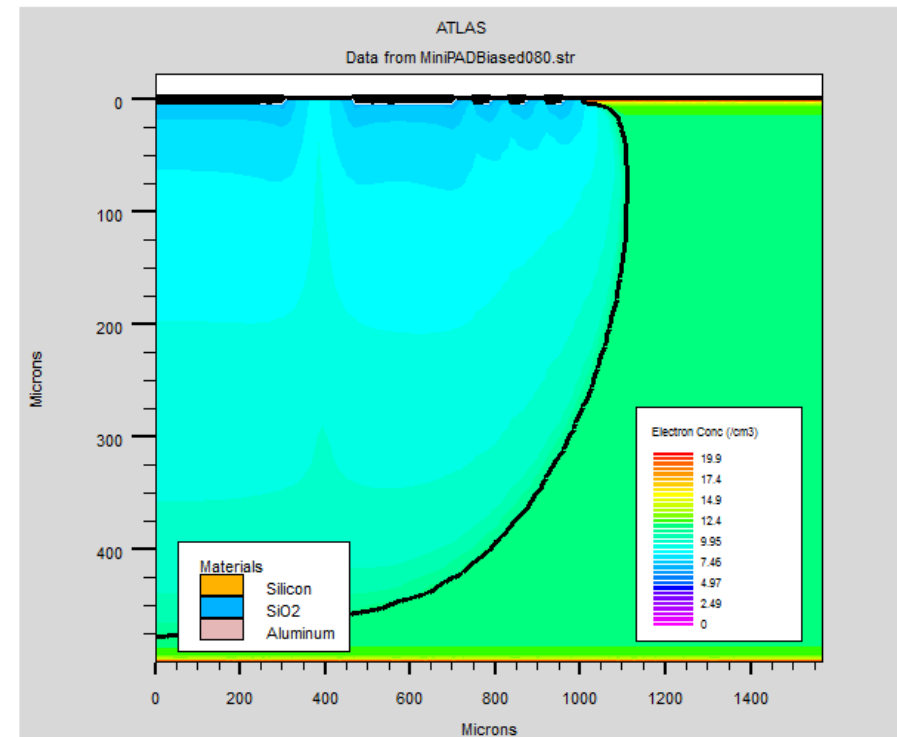
80 V

Depletion volume

- CV test

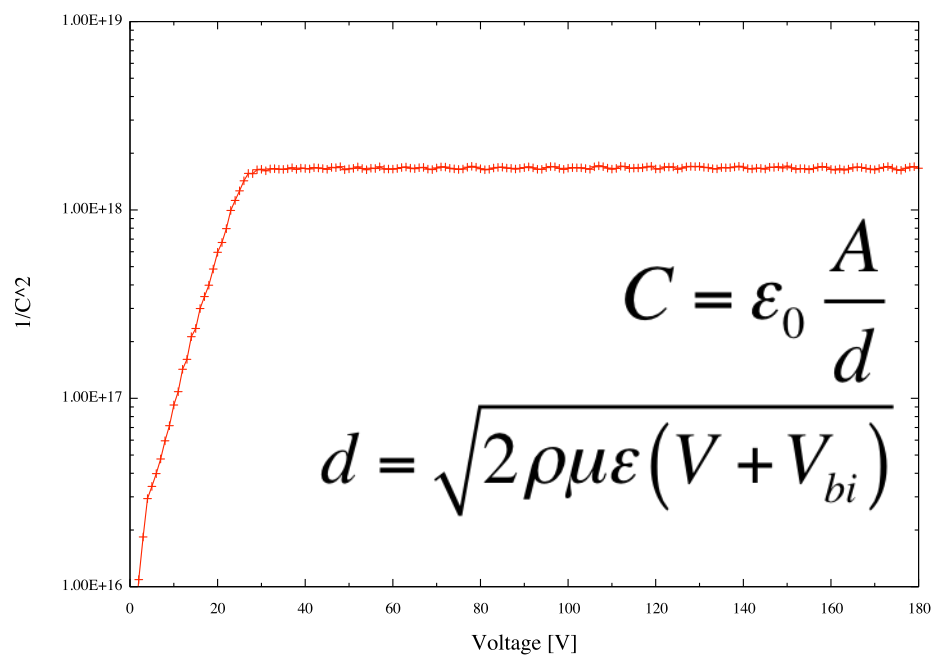
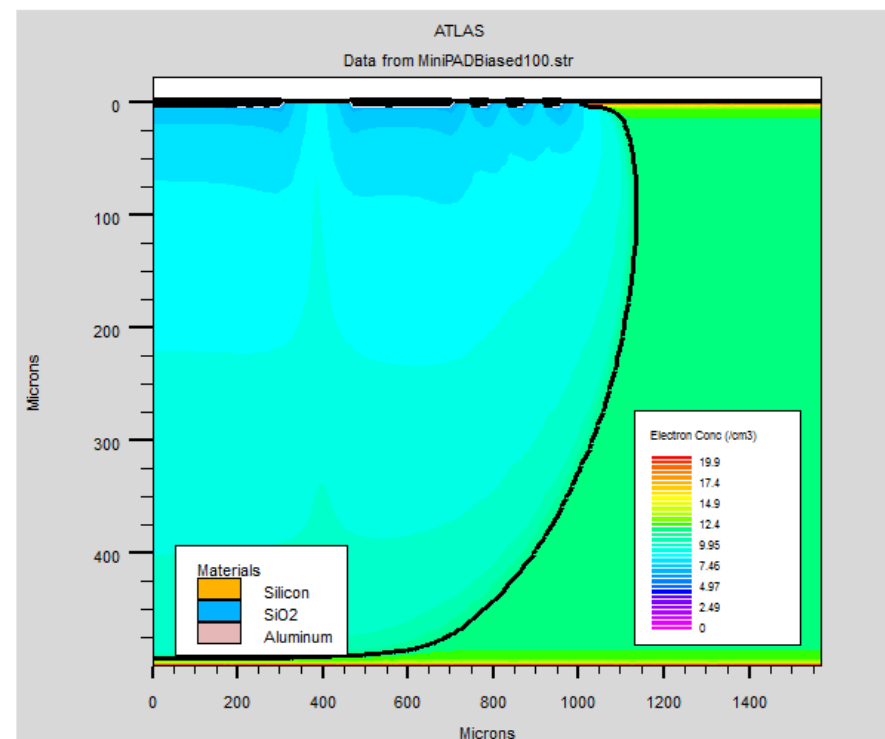
100 V

Depletion volume

- CV test

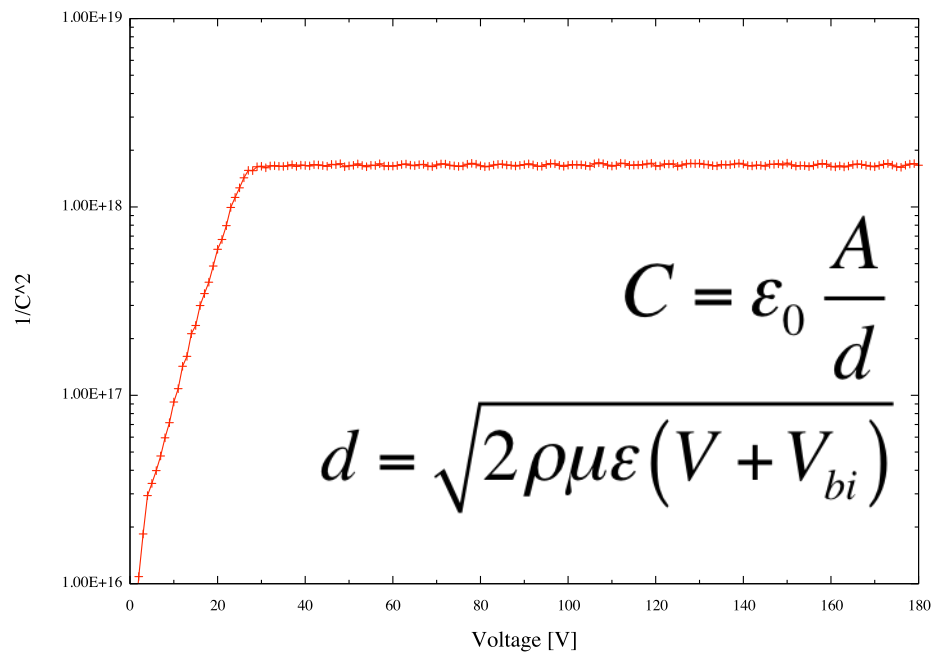
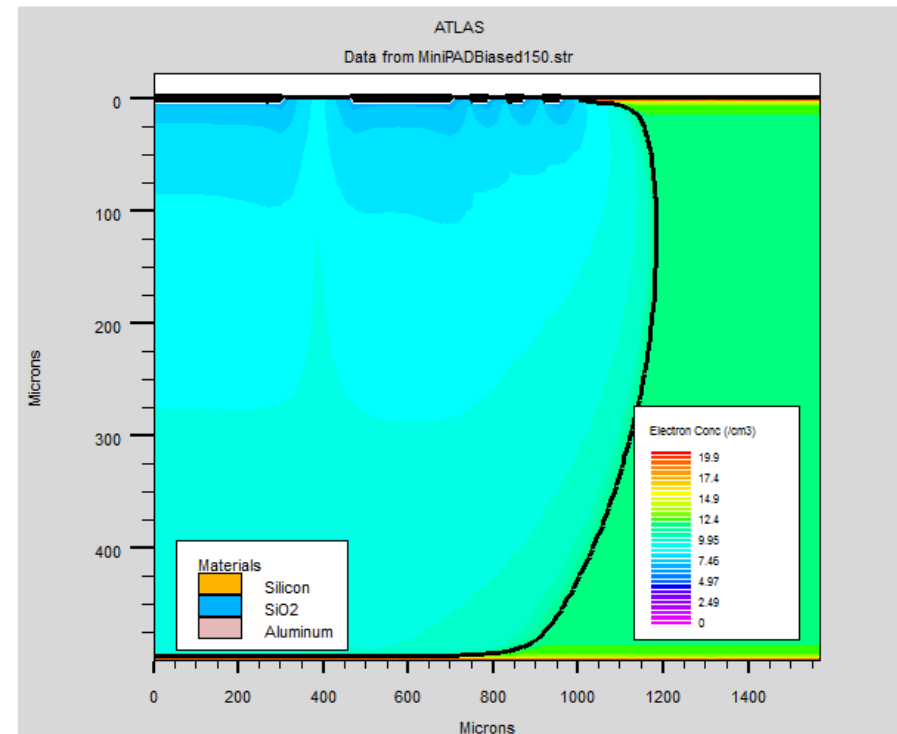
150 V

Depletion volume

- CV test

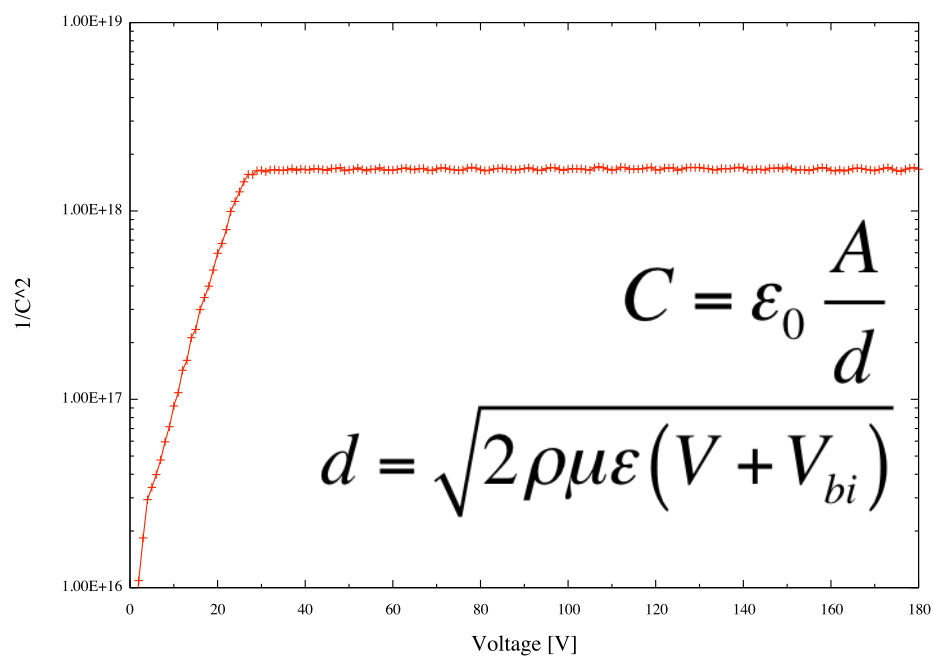
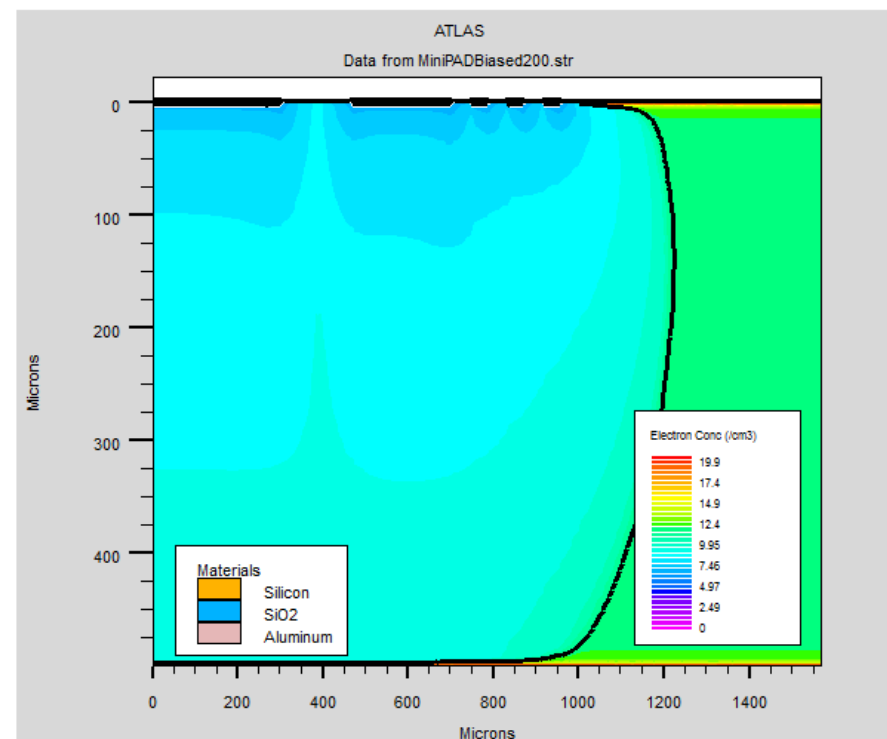
200 V

Depletion volume

- CV test

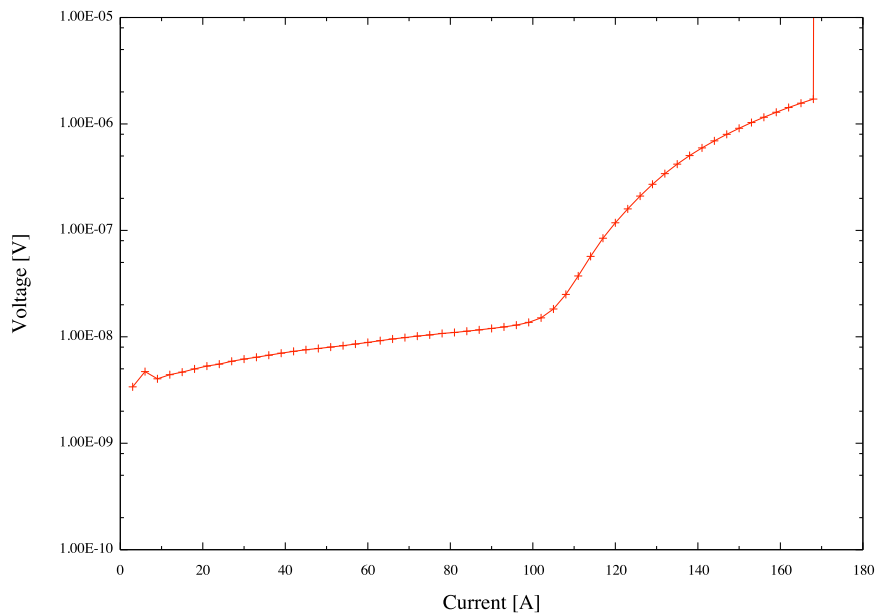
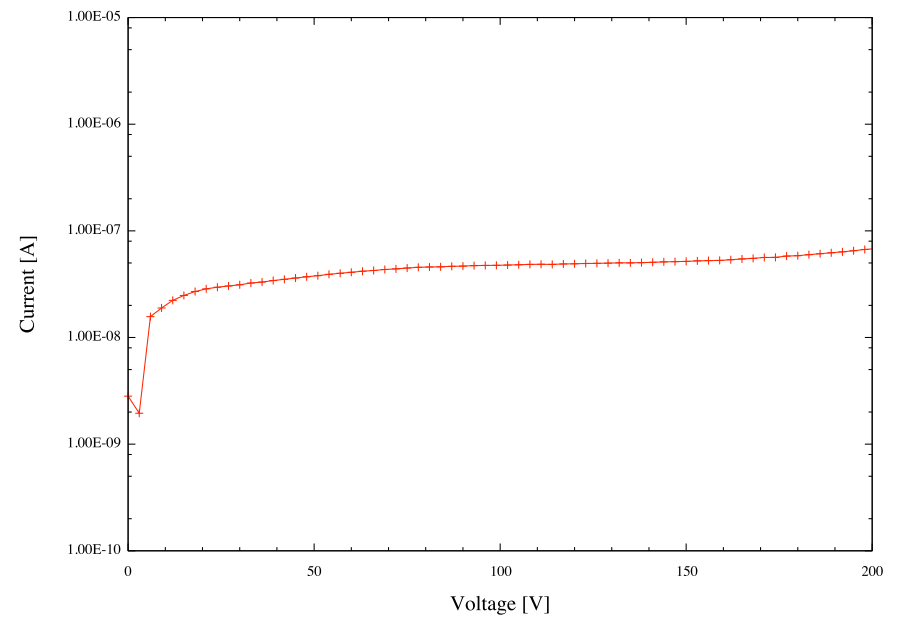
Process

- Overall quality

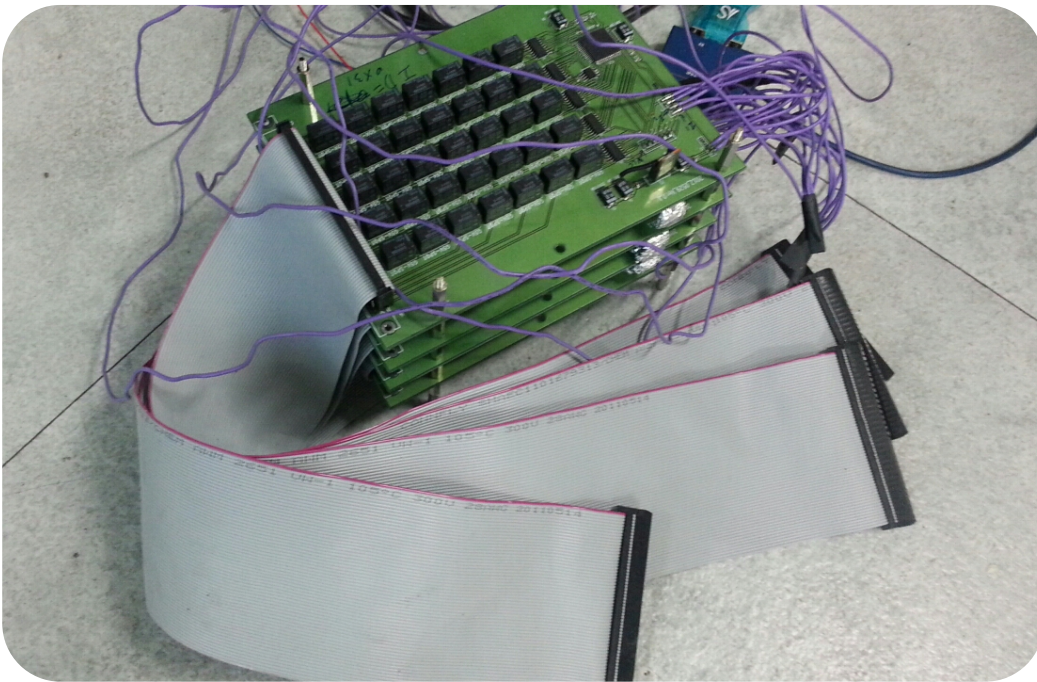
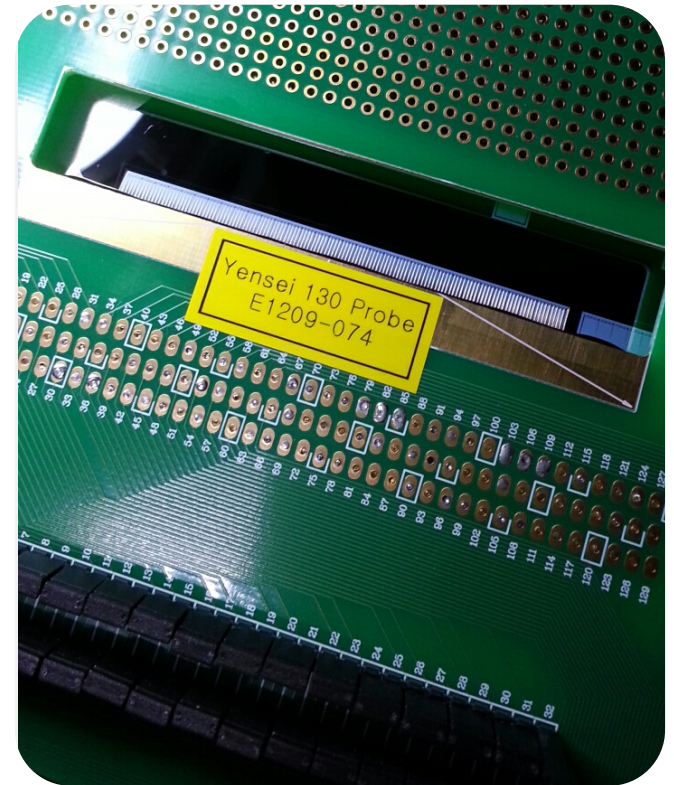
Metallization

- Short test

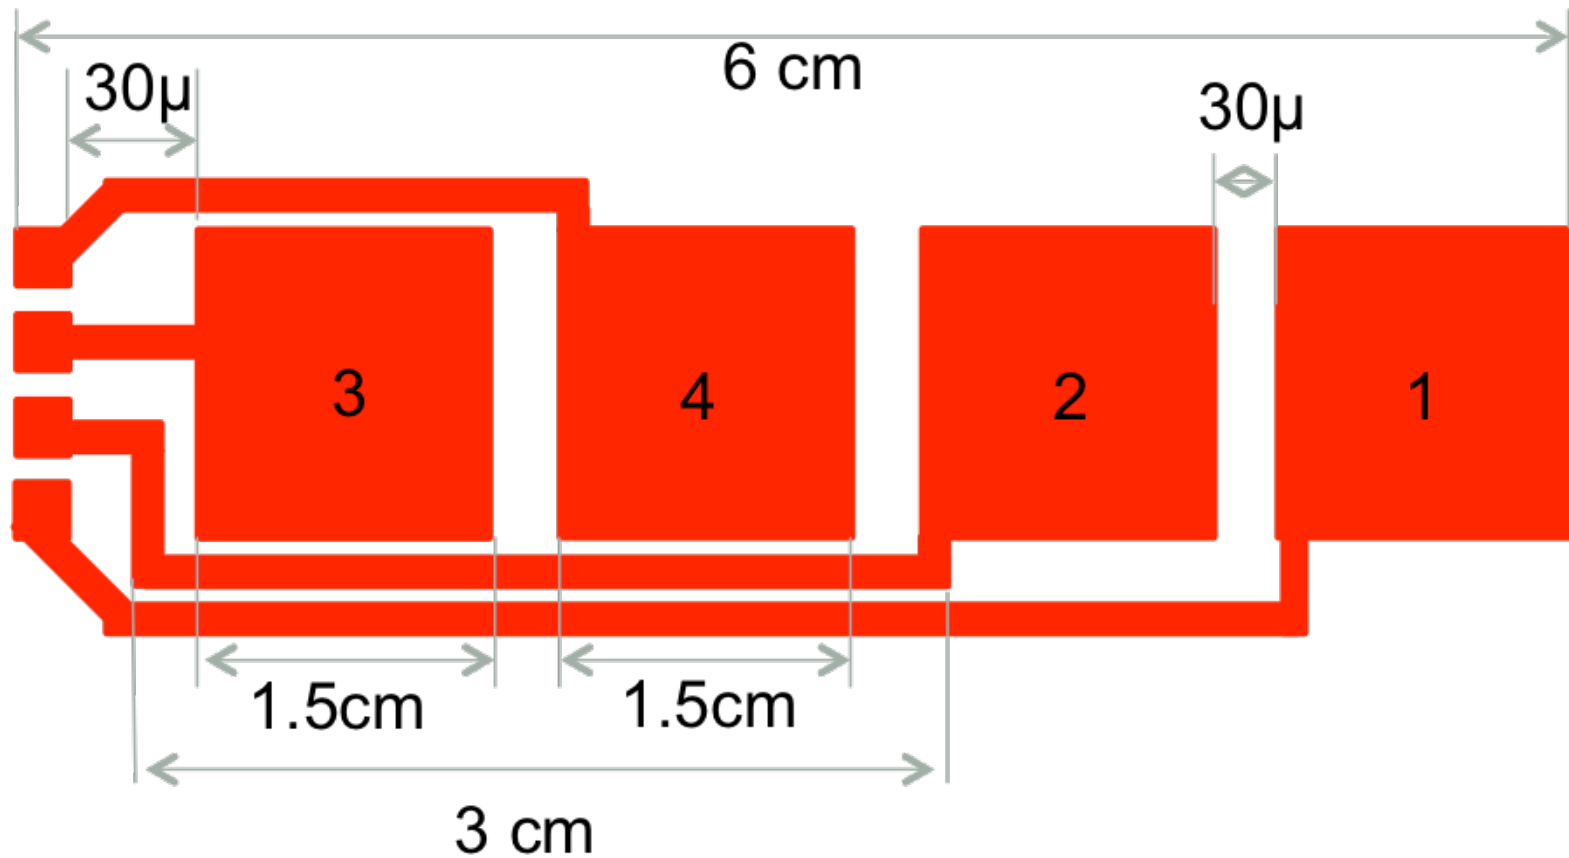
Wafer

Metallization

- Short test

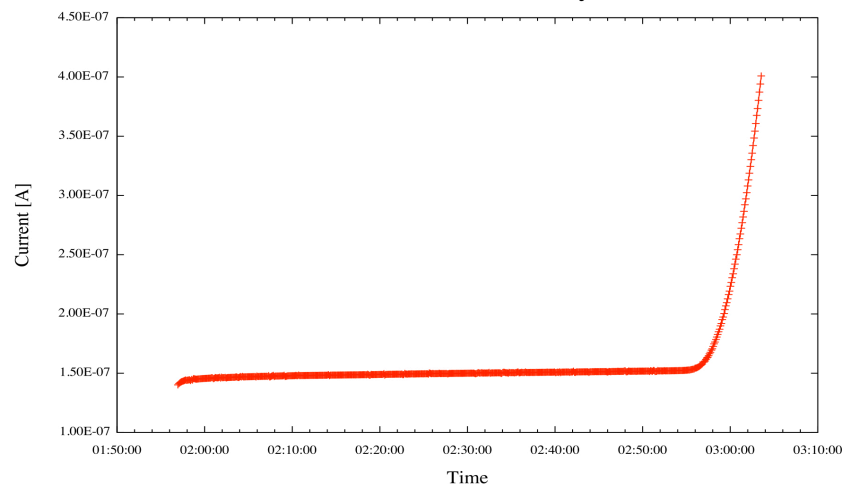
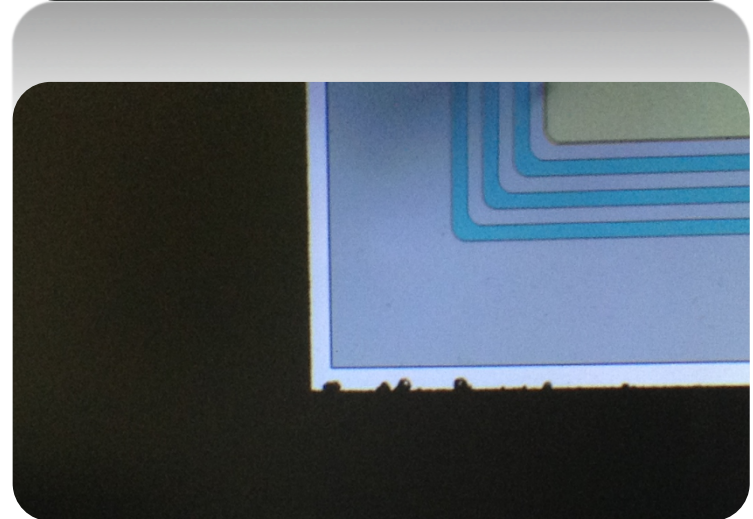
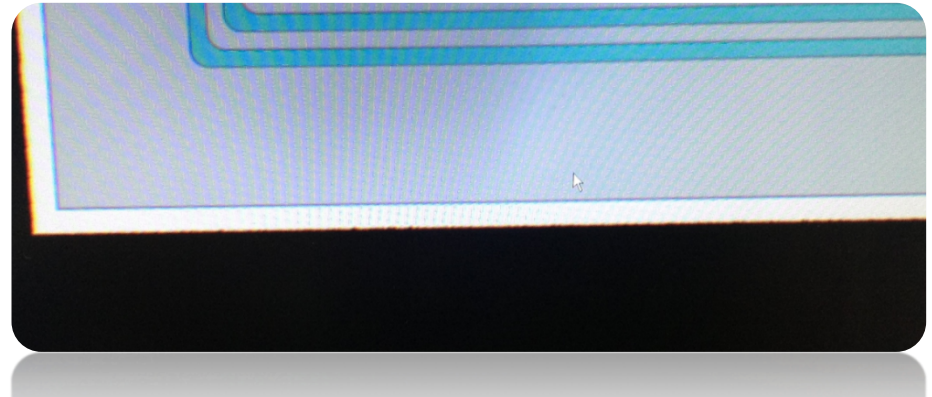
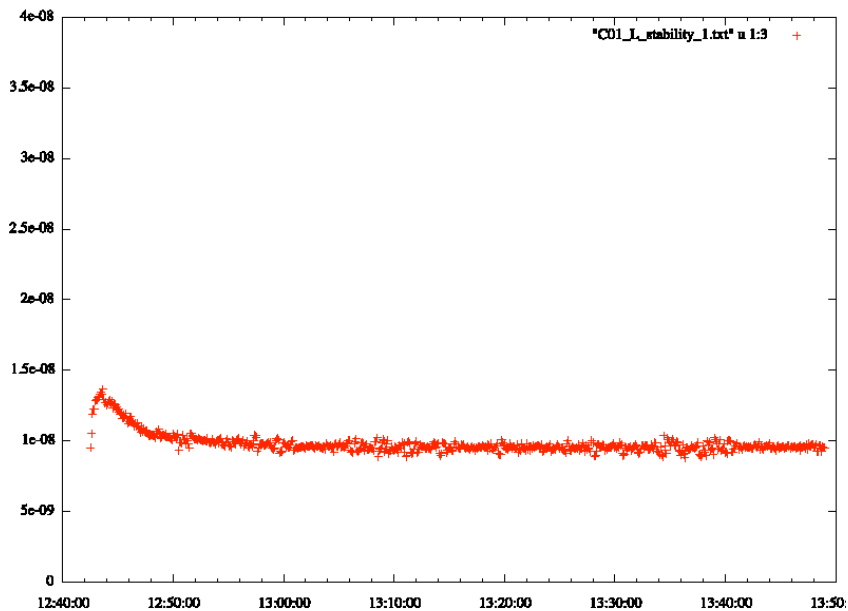
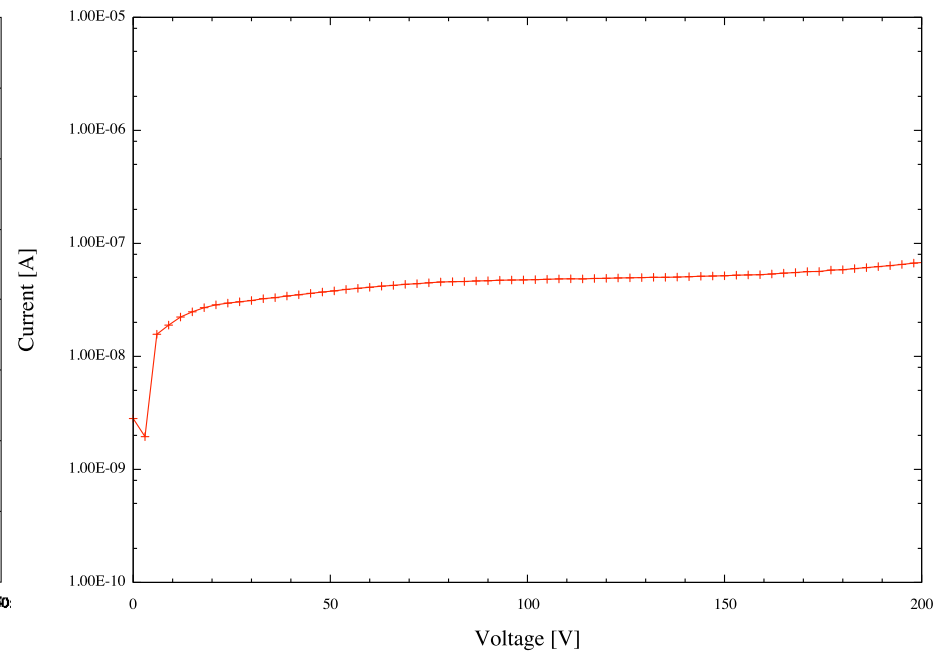
Problem Solving

- Reduce leakage current
- Good stability

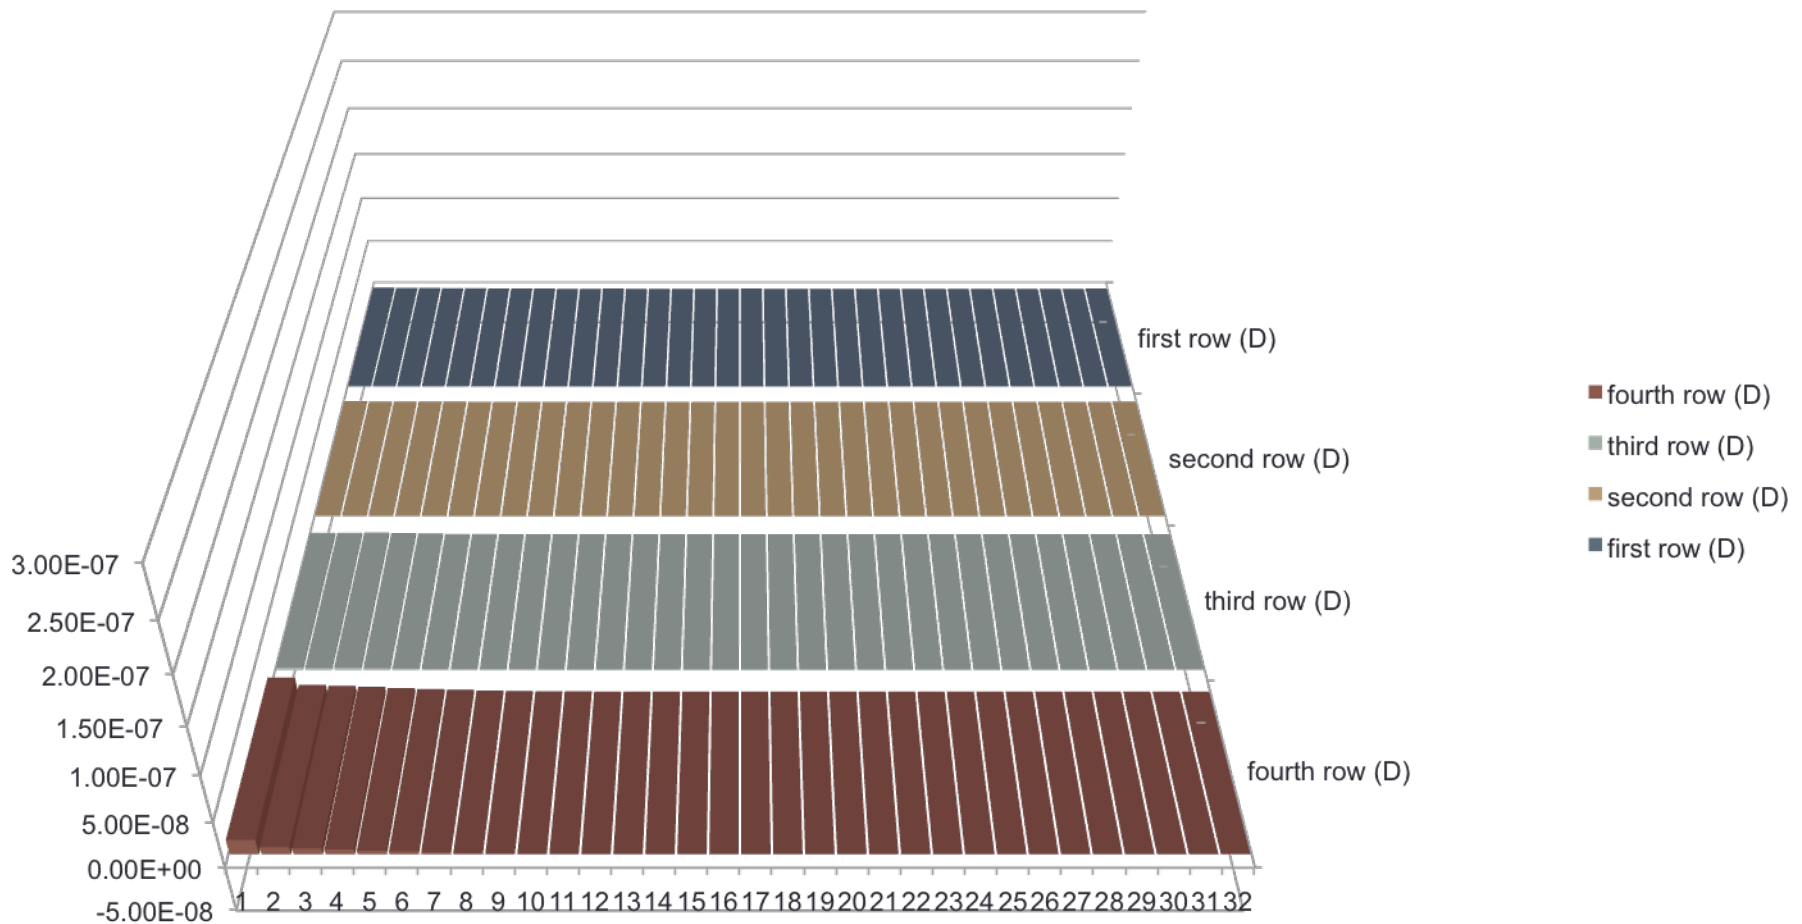
Photo response

- Response to ionizing radiation
