HPTW2023, 9 Nov. 2023

Muon Production Target at J-PARC

Shiro Matoba
KEK J-PARC

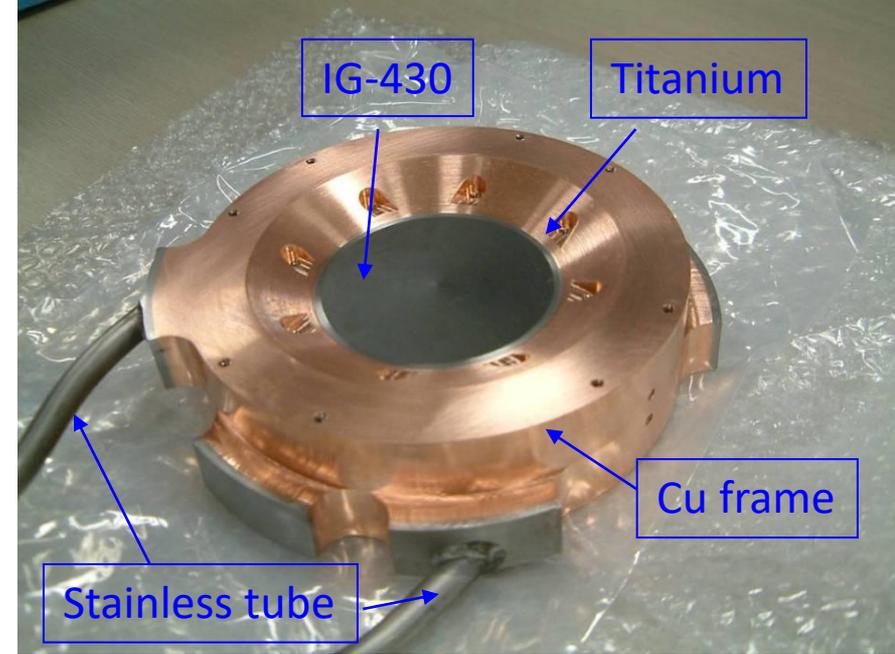
Muon Fixed Target (2008-2013)

Isotropic Graphite

Thickness; 20 mm, Diameter 70 mm

4-kW heat, beam diameter 14 mm

Fixed edge-cooling method

Irradiation by proton beam to graphite,
Lifetime; 6 months (@1MW)

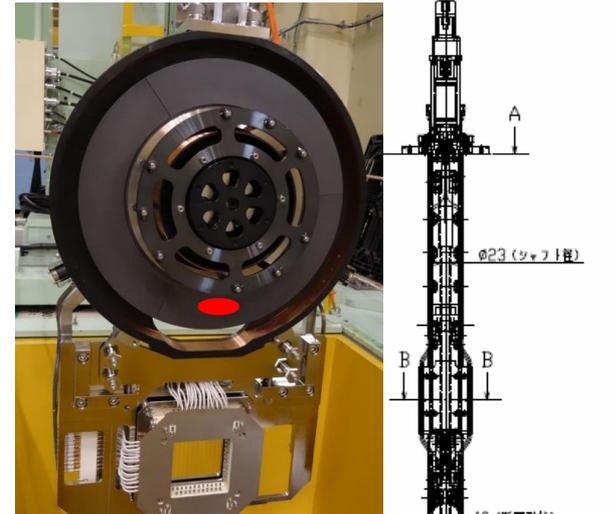
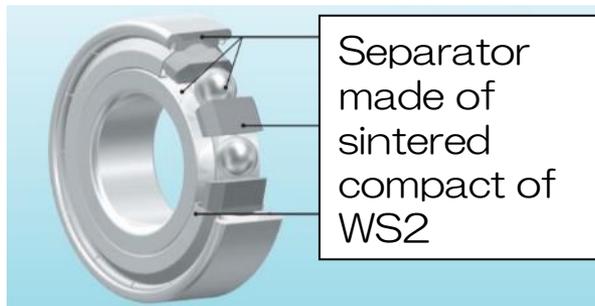
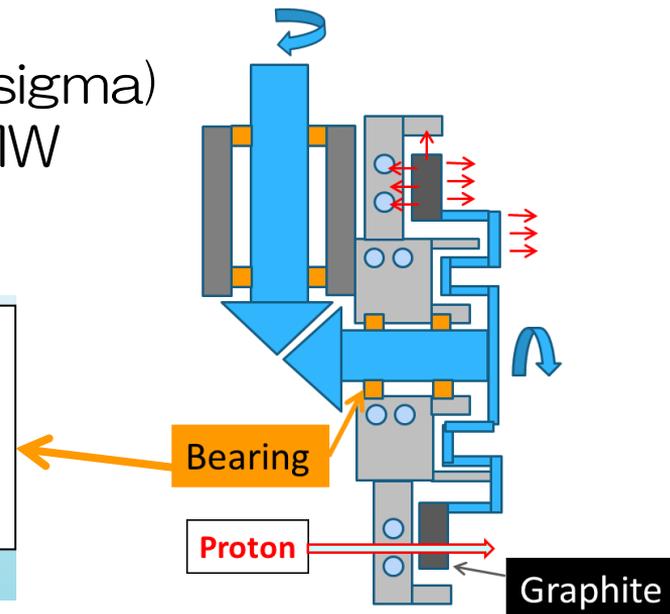
Rotating Target for muon production

The No.1 target was installed in Sep. 2014, and was replaced with the No.2 in Sep. 2019.

- Diameter: 33 cm, thickness : 2 cm
- 15 rpm operation
- Radiation cooling
- Lubricant of bearing: tungsten disulfide
- Life time : aiming ≥ 10 years
- Beam diameter: 14 mm (2sigma)
- 4kW heat on target at 1 MW

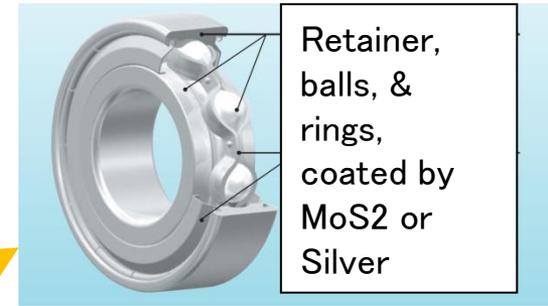
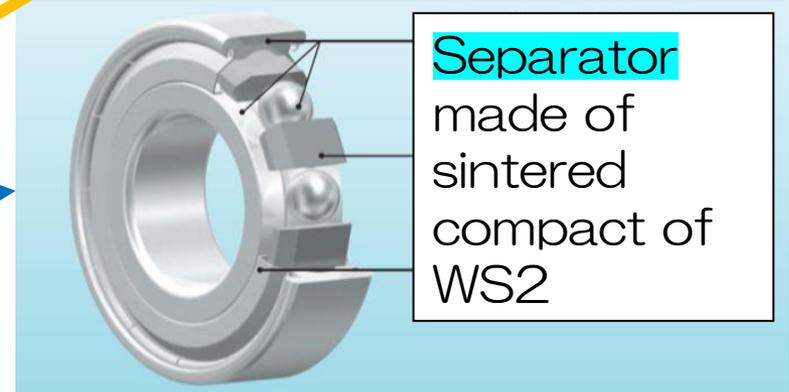
Bearings

The lifetime of bearings is critical.

Solid lubricant;

- ❑ Silver coating at PSI (-2020)
- ❑ Disulfide tungsten at MUSE

Dose; **100MGy/year**、 Vacuum; **10⁻⁵Pa**、 Tmp.; **150°C**、 Radial load; **33N**, thrust load; **20N**

I.D. =17mm, O.D.= 40mm, w=12mm, Internal clearance C4 (ISO 5753)

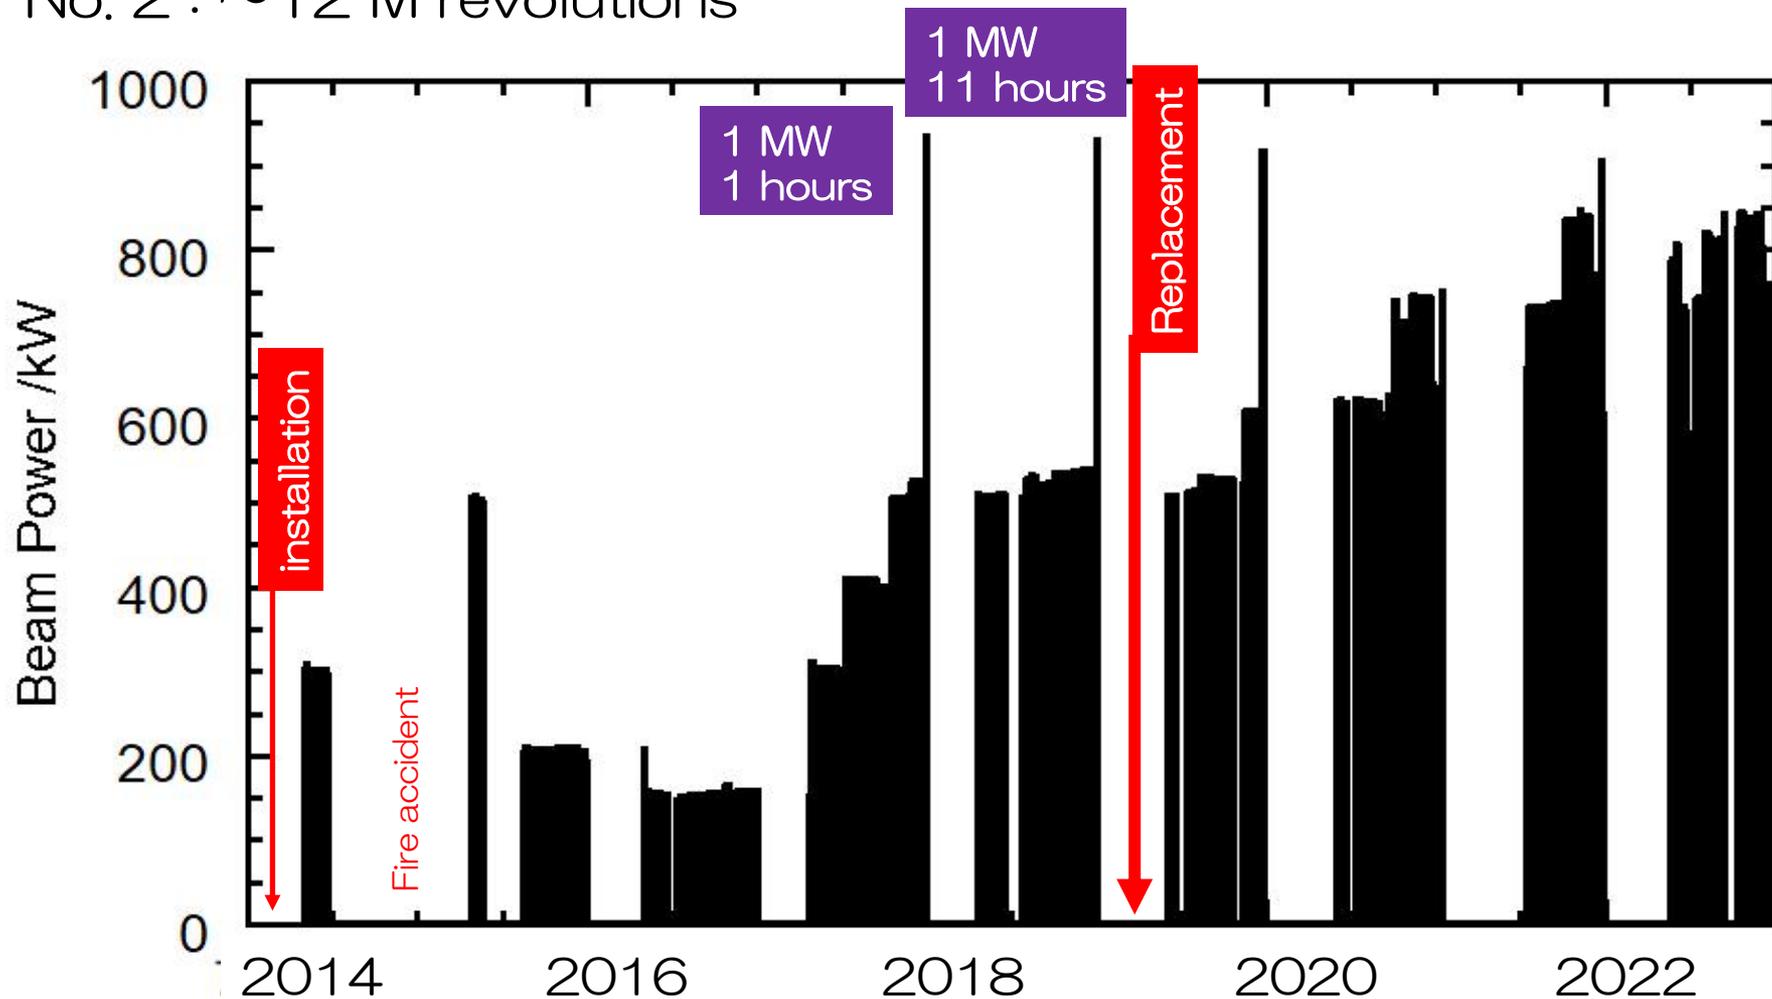
Operation history of the rotating targets

- No.1: Operation for 5 years.
- History of beam operation (~ June 2019) : ~15000 h
Rotation : ~15 M revolutions (Service life of WS₂ bearings ~50 M)
- No. 2 : ~12 M revolutions

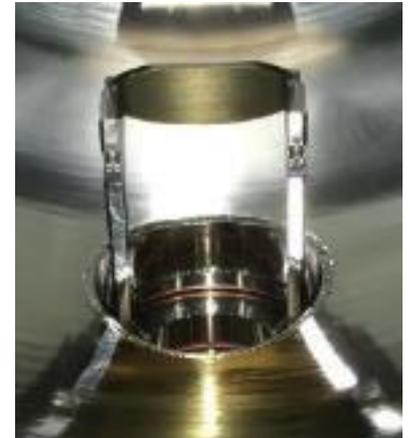
Infrared mirror in beam duct

- The beam duct was replaced with a duct with a camera port. The reflected light from the mirror in the duct is measured. We performed a trial measurement for several months.

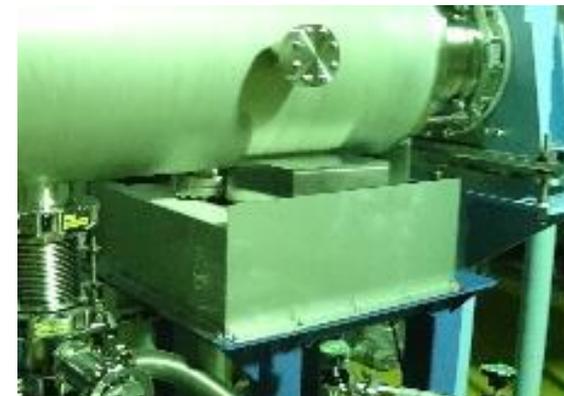
Shielding for the camera

- The infrared camera has irradiation test (QST Takasaki and NIRS). The camera is expected to have radiation resistance of more than one year (5 Gy or more) at 1 MW operation.

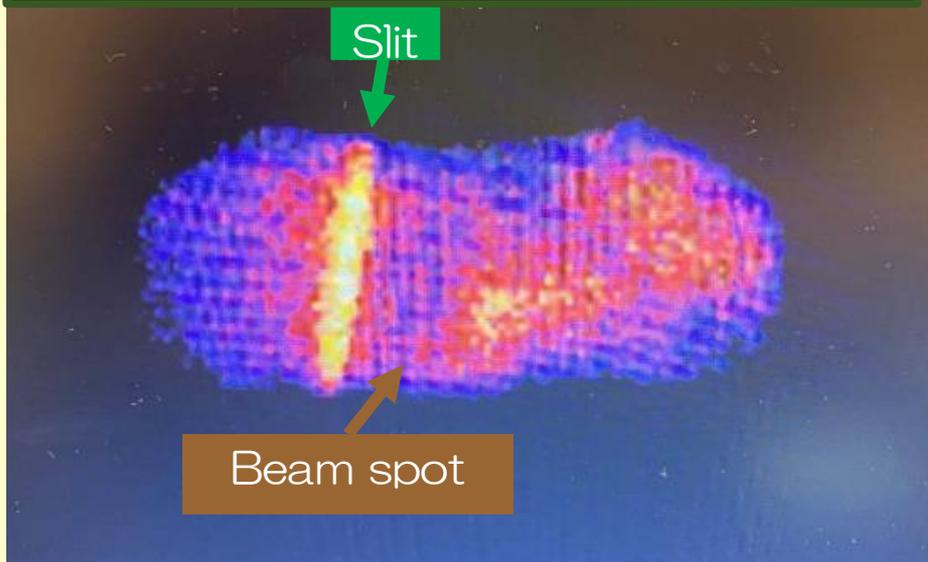
Fig. 1 Infrared camera image at 1 MW

- Direct observation with the infrared camera was successful. (Figure 1, Figure 2)
- At the center, a high-temperature part, which is likely to be a beam spot with a diameter of about 1.5 cm, was observed.

- At the center, a high-temperature part, which is likely to be a beam spot with a diameter of about 1.5 cm, was observed.
- According to a simple analysis, the temperature in the high temperature area was 650 degree C, which was different from calculated value of 510 degree C at 500 kW.
 - Detailed analysis will be performed.

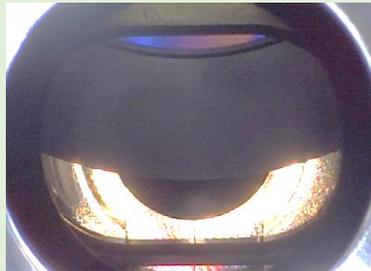
Photo of the target taken with a digital camera during the beam stop.

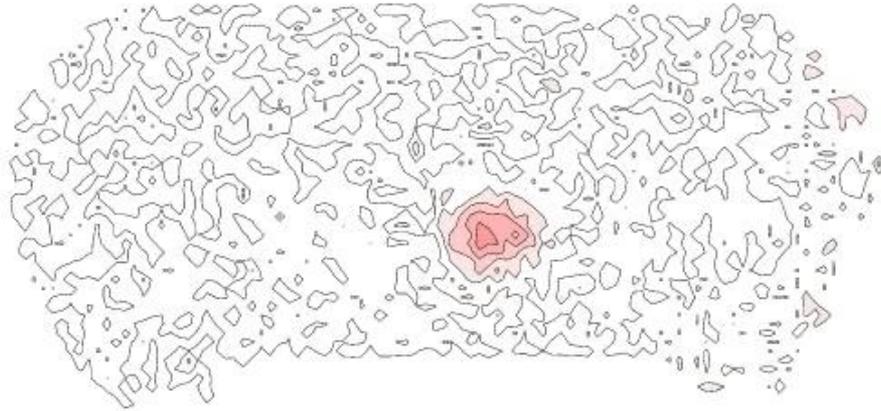
Analysis of images

- Diffusion of local heating by the proton beam can be seen in the direction perpendicular to the rotation.

- Fast eXtraction(FX) : Missing 4 pulses every 2480 ms at MLF
-> Heat is more diffuse during FX.
- The infrared camera takes a picture every 99.4 milliseconds on average.
After 25 shootings, $99.4 \times 25 = 2485$ ms
- **The 5 msec gap allows for stroboscopic analysis.**

Heat conduction analysis was estimated from thermal diffusion images taken every 5 milliseconds.

$$\text{Thermal conductivity } k = D \rho C_p = 144.18 \text{ W/K/m}$$

is good agreement with IG430 of the target material : $k \sim 140 \text{ W/K/m}$

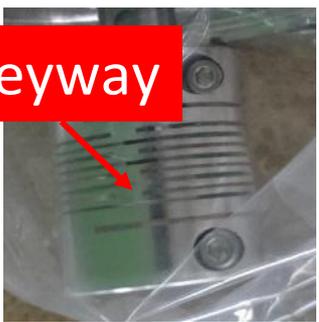
Keyway

- The rotating coupling to transmit rotational motion was broken (found in Sept. 2018 during maintenance work).
- The rotating coupling has a keyway process to prevent slippage at the joint with the rotating shaft. There was a mistake in the processing of the keyway, and the strength of the coupling was reduced.

The damaged coupling was replaced with a stronger one in the summer of 2018. Another weak coupling is used in vacuum. Beam operation was continued until 2019 under strict monitoring.

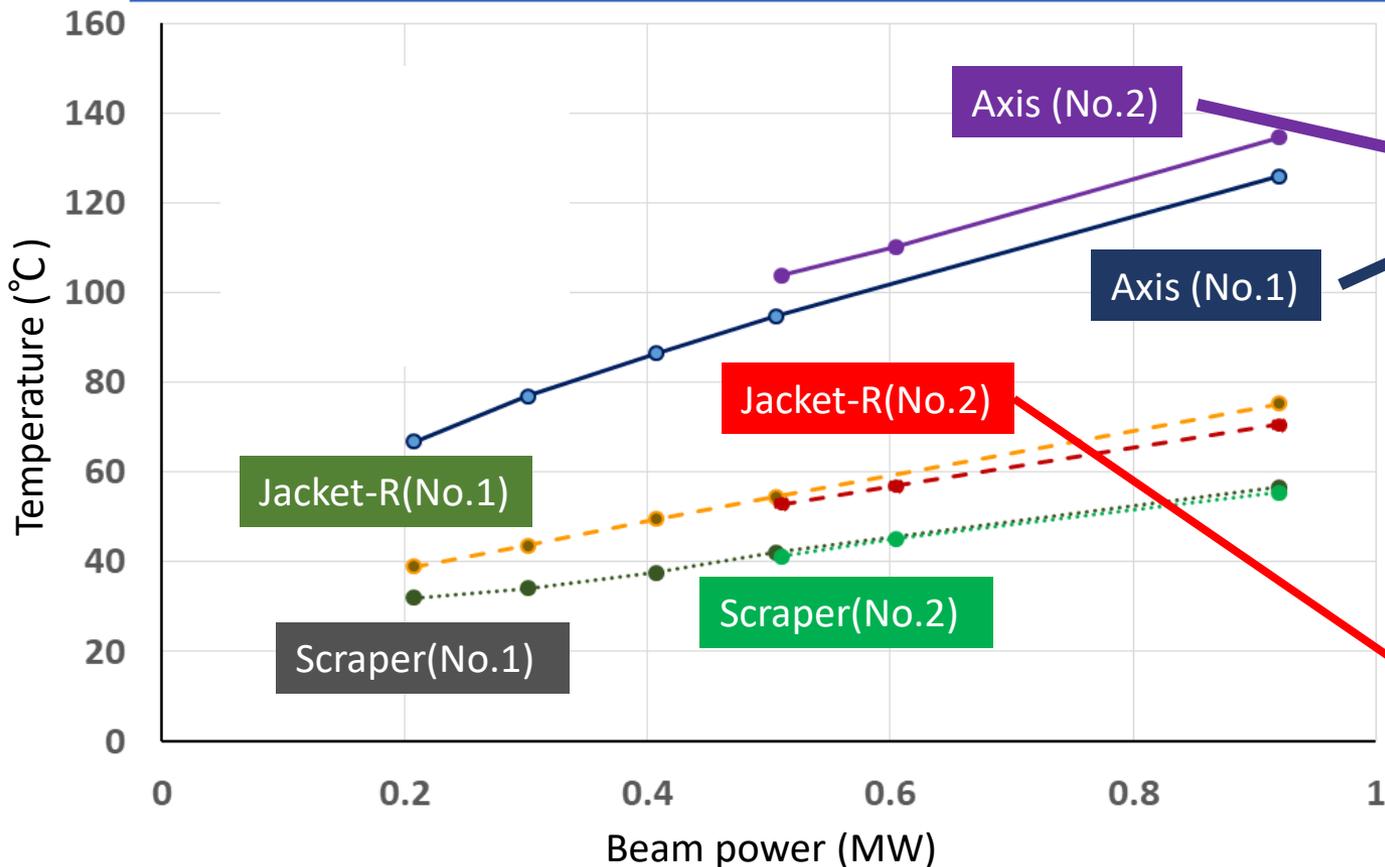
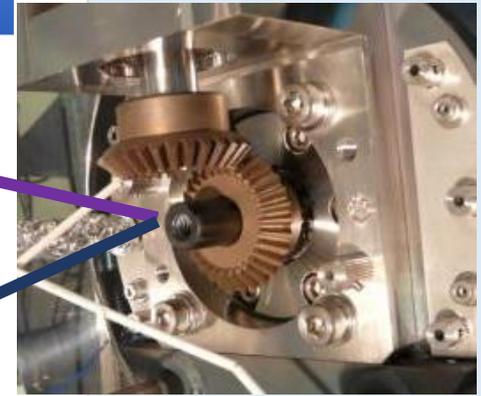
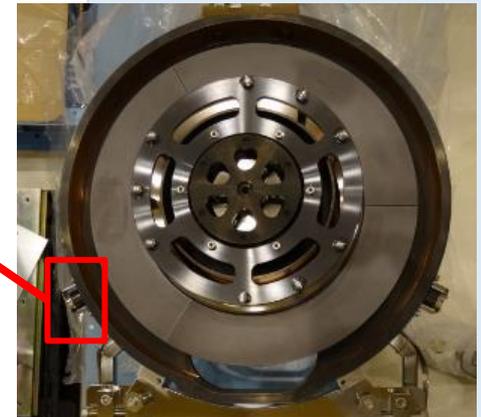
Beam-power dependence of target system temperature

1 MW operation for 32 hours (June, 2020)

- Thermal response of targets and scrapers was found to be consistent with the prediction.
No difference was observed between the previous (No.1) and current (No.2) target systems.
- Motor torque showed no anomaly during 1 MW operation.

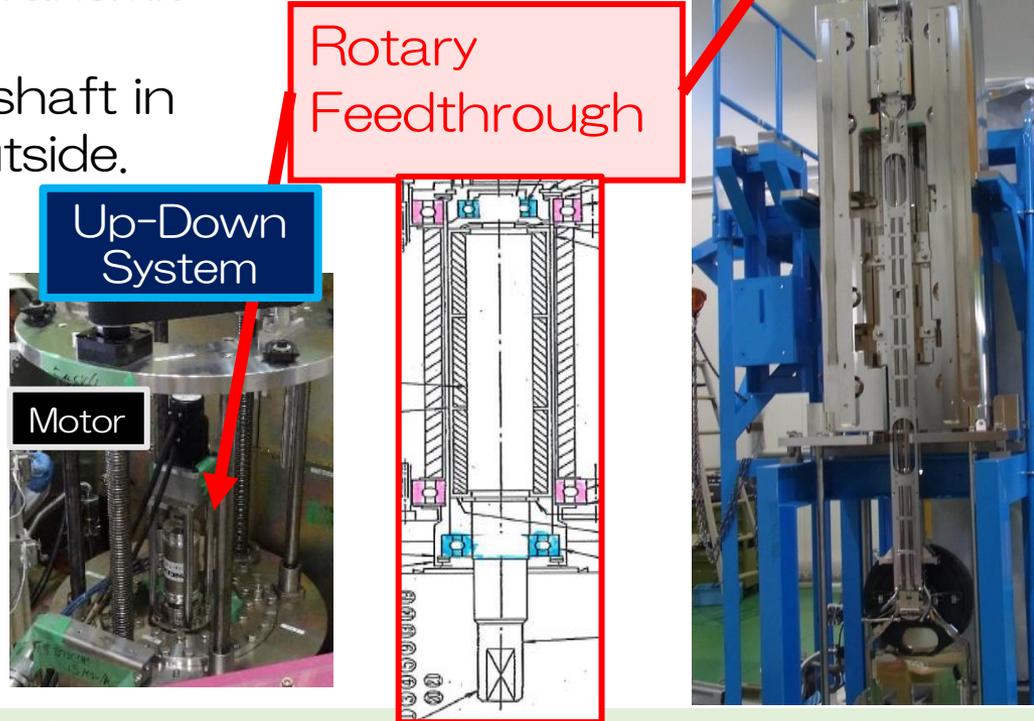
■ A rotary feedthrough is used to transmit rotary torque into the vacuum. The rotation is transmitted to the shaft in vacuum by magnets inside and outside.

Since the summer maintenance in 2021, the motor torque has increased.

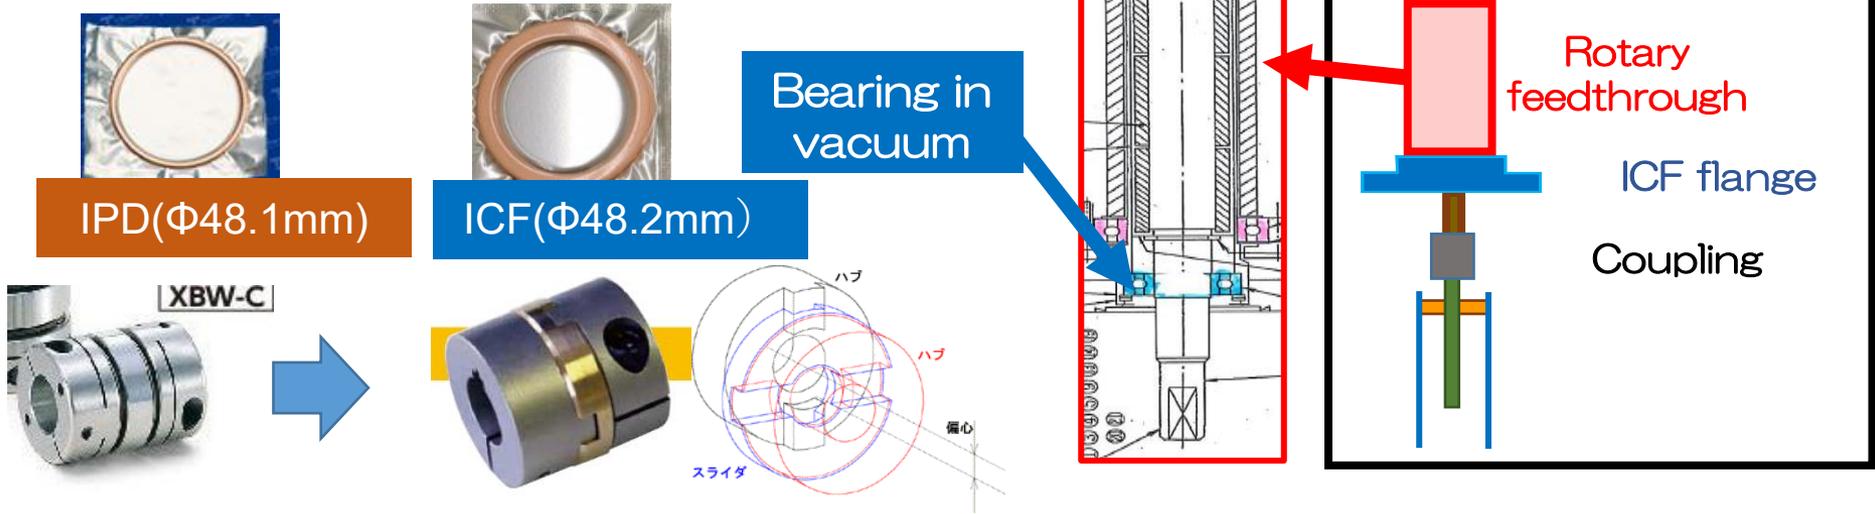
- The rotary feedthrough was examined and found to have a damaged bearing (molybdenum disulfide coating). The cause of the bearing damage was due to misalignment of the rotating shaft.
 - The misalignment was caused by the use of a vacuum sealing gasket with an inner diameter 0.1 mm smaller than standard.
 - The gasket was replaced with one of the correct specification in the 2022 maintenance.
- In addition, an Oldham type coupling was installed to tolerate the misalignment. The target itself was not replaced.

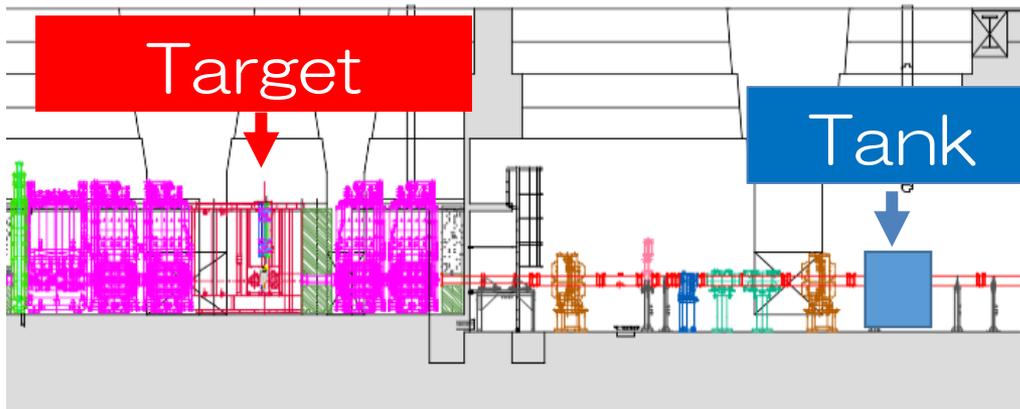
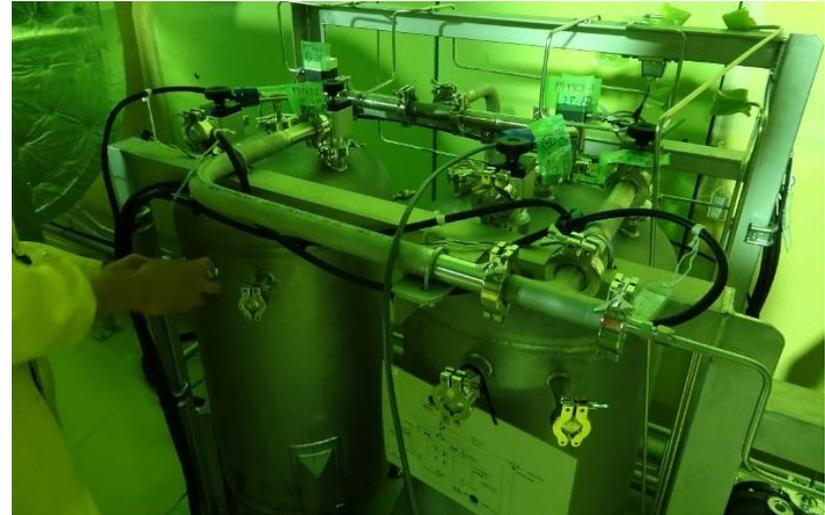
Buffer tank

- The exhaust of vacuum pump is temporarily stored in a buffer tank and is vented after measurement of concentration of RI.
To temporarily accumulate RI in ducts in case of trouble
To measure the amount of RI generated

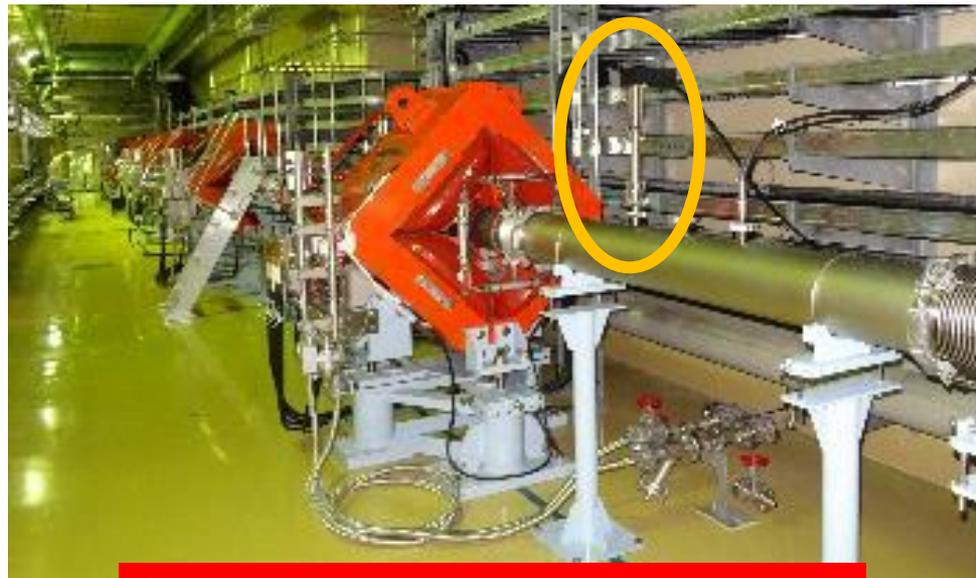
Q-Mass at the proton beam line

■ Tritium produced at the target contaminates the beam duct, making maintenance difficult.

→ Tritium measurement with Q-Mass

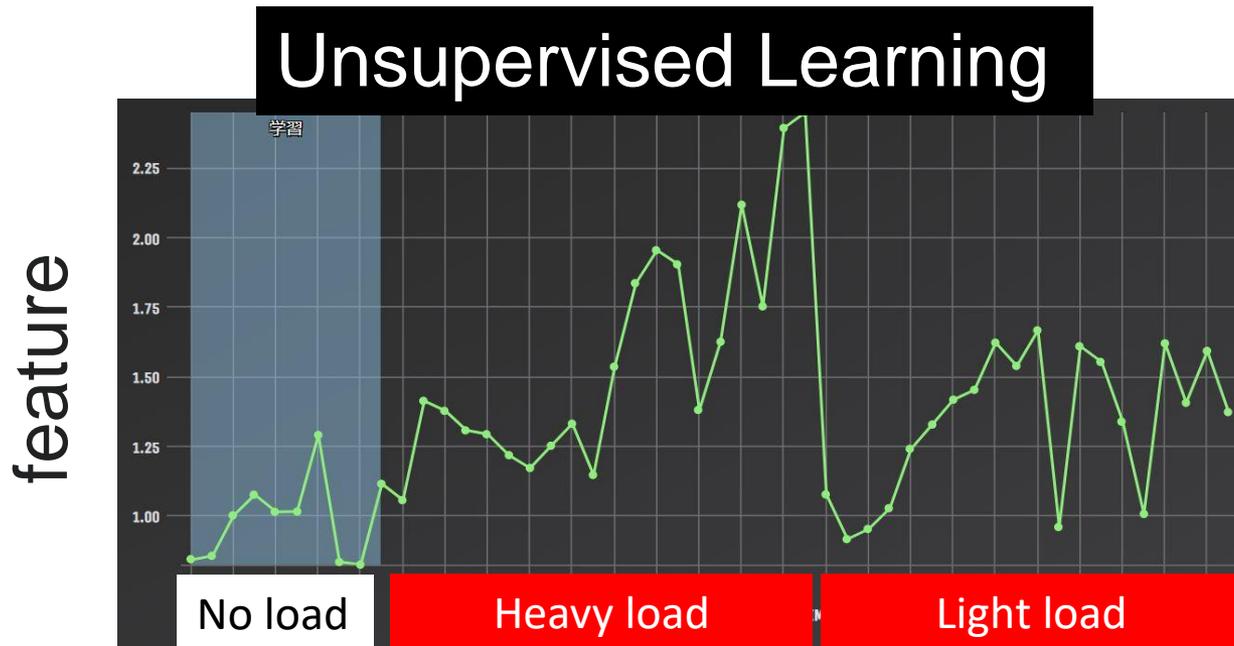
Machine learning of torque and servo current

- If the rotating target stops, the target will be damaged. By detecting abnormalities in the rotating system at an early stage, it will be possible to consider countermeasures before damage occurs.
- By sensing the "torque" and "current" of the rotating servomotor, it was verified whether the attributes at the time of abnormality could be captured.

- There is a possibility that machine learning can predict danger. It is necessary to improve the prediction accuracy by performing supervised learning at offline site.
