Bus Extender Status

Takashi Hachiya

Nara Women's University & RIKEN BNL

Bus-Extender = Very long data cable

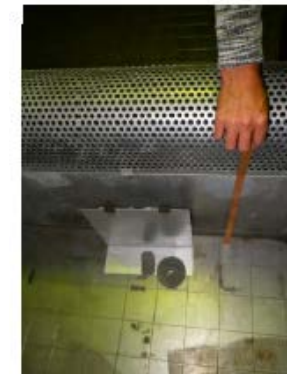
Cherenkov lights in water

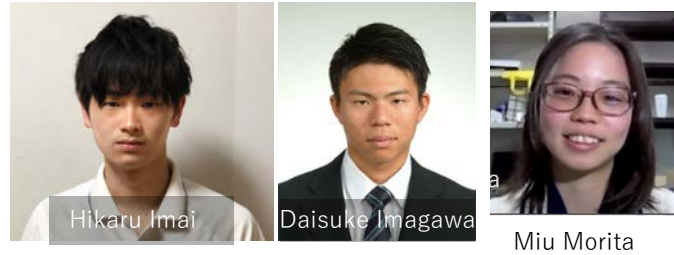
- We tested the radiation hardness by measuring:
 - Peel strength
 - Bending elastic modulus
 - Itaru, H. Imai, D. Imagawa, M. Morita measured them
- Peel strength by tensile test
 - Snapshot of the analysis
- Peel strength look no change with 5kGy and get reduced with higher dose.
 - ~15N(/2cm) at 1000kGy
 - Could be OK
 - Polyimide shows ~20N(/2cm) without dose

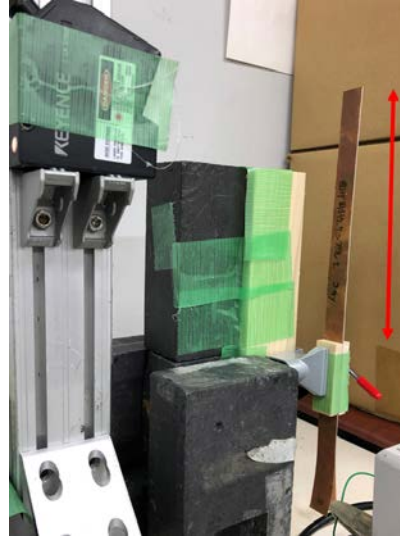
- Bending elastic modulus
 - the natural (proper) frequency is measured
 - FPC sample is flicked by finger to vibrate

$$f_n = \frac{\lambda_n^2}{2\pi l^2} \sqrt{\frac{EI}{\rho A}}$$

$f \rightarrow$ frequency
 $l \rightarrow$ length
 $\rho \rightarrow$ density
 $A \rightarrow$ cross-section
 $\lambda \approx 1.875$

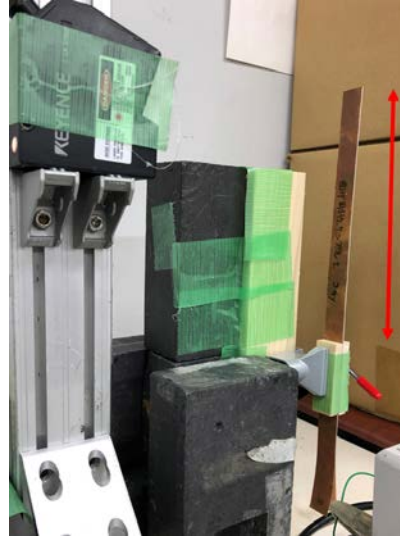
$$K = fl^2 = \frac{\lambda^2}{2\pi} \sqrt{\frac{EI}{\rho A}}$$

- To check if the measurement is OK, we measured the sample several times with the different arm lengths (15, 20, 25cm)
- Result shows the bending elastic modulus seems to be flat
 - No effect by radiation

- Bending elastic modulus
 - the natural (proper) frequency is measured
 - FPC sample is flicked by finger to vibrate

$$f_n = \frac{\lambda_n^2}{2\pi l^2} \sqrt{\frac{EI}{\rho A}}$$

$f \rightarrow$ frequency
 $l \rightarrow$ length
 $\rho \rightarrow$ density
 $A \rightarrow$ cross-section
 $\lambda \approx 1.875$

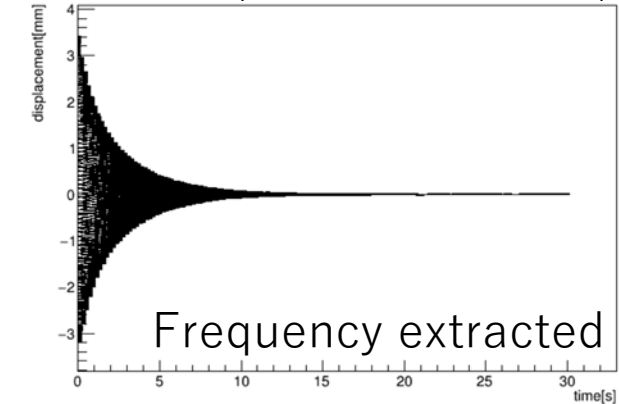
Raw data (Dumped vibration of the sample)

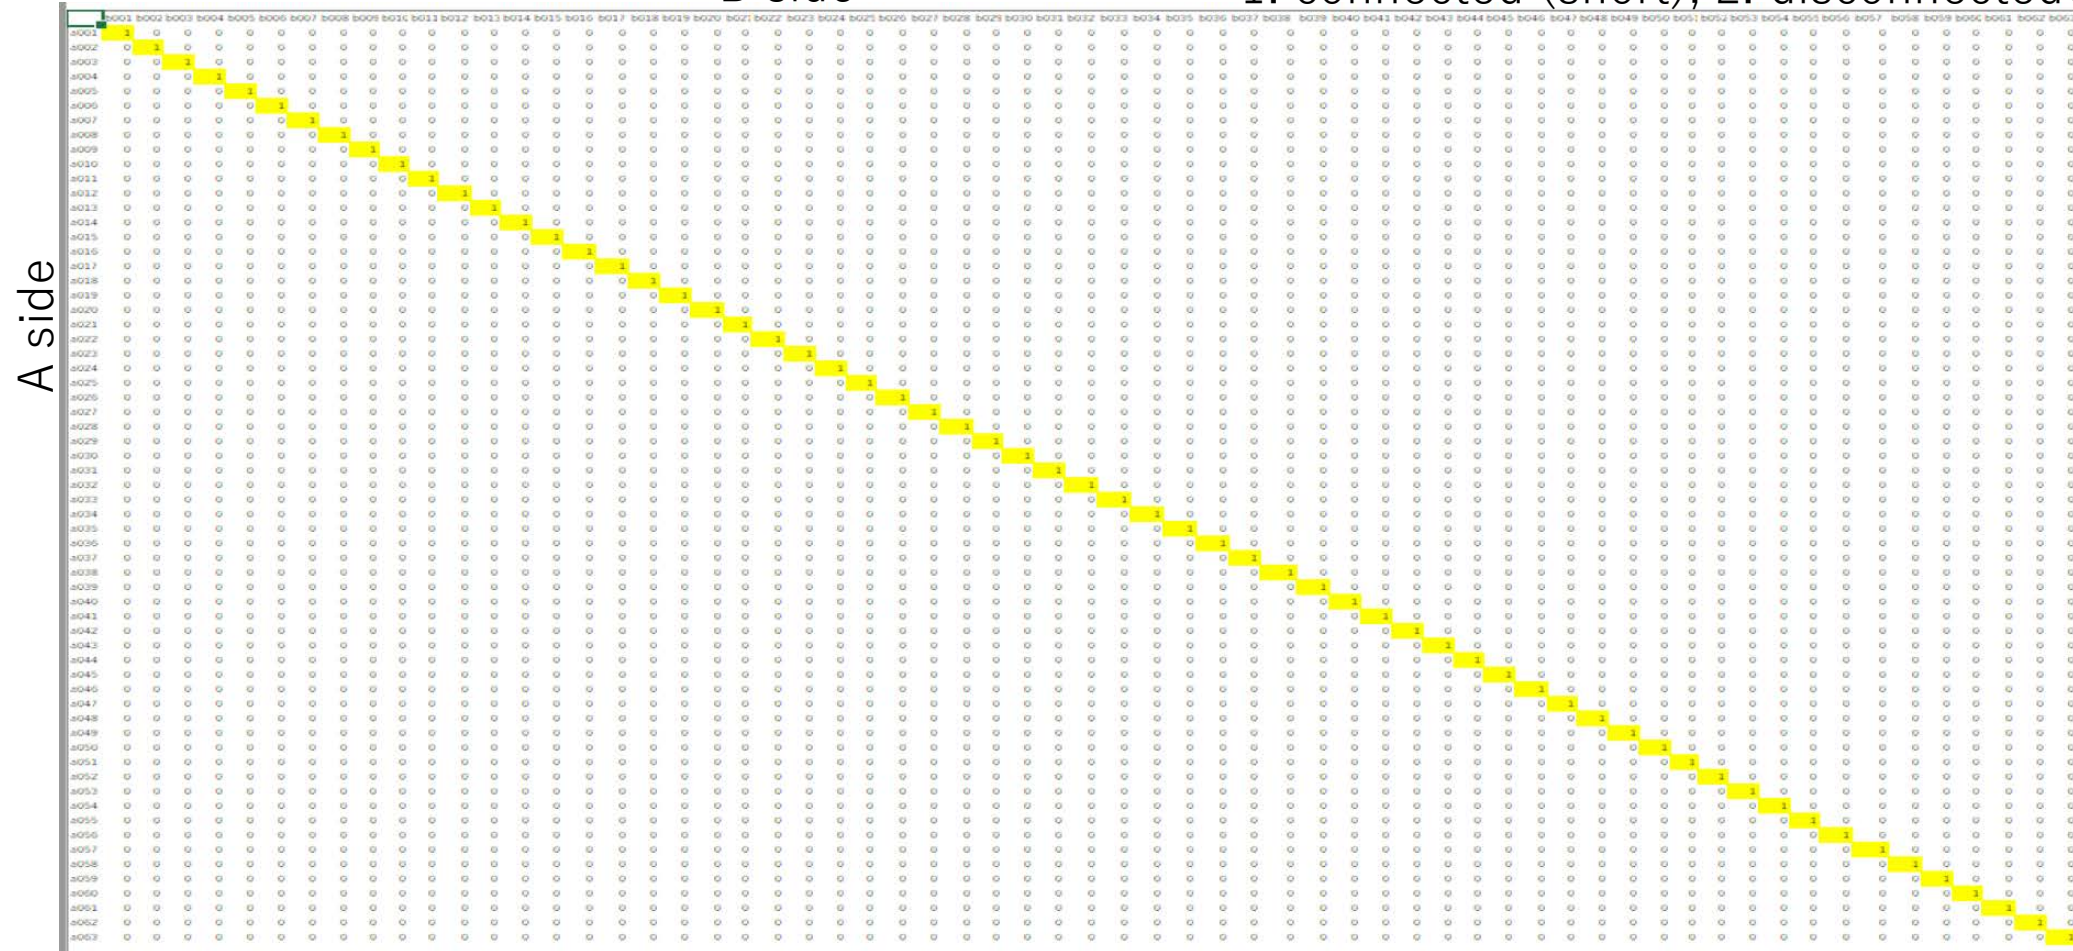
1: connected (short), 2: disconnected(open)

- Diagonal part =1 means “connected”, others =0
- This test equipment works nicely.

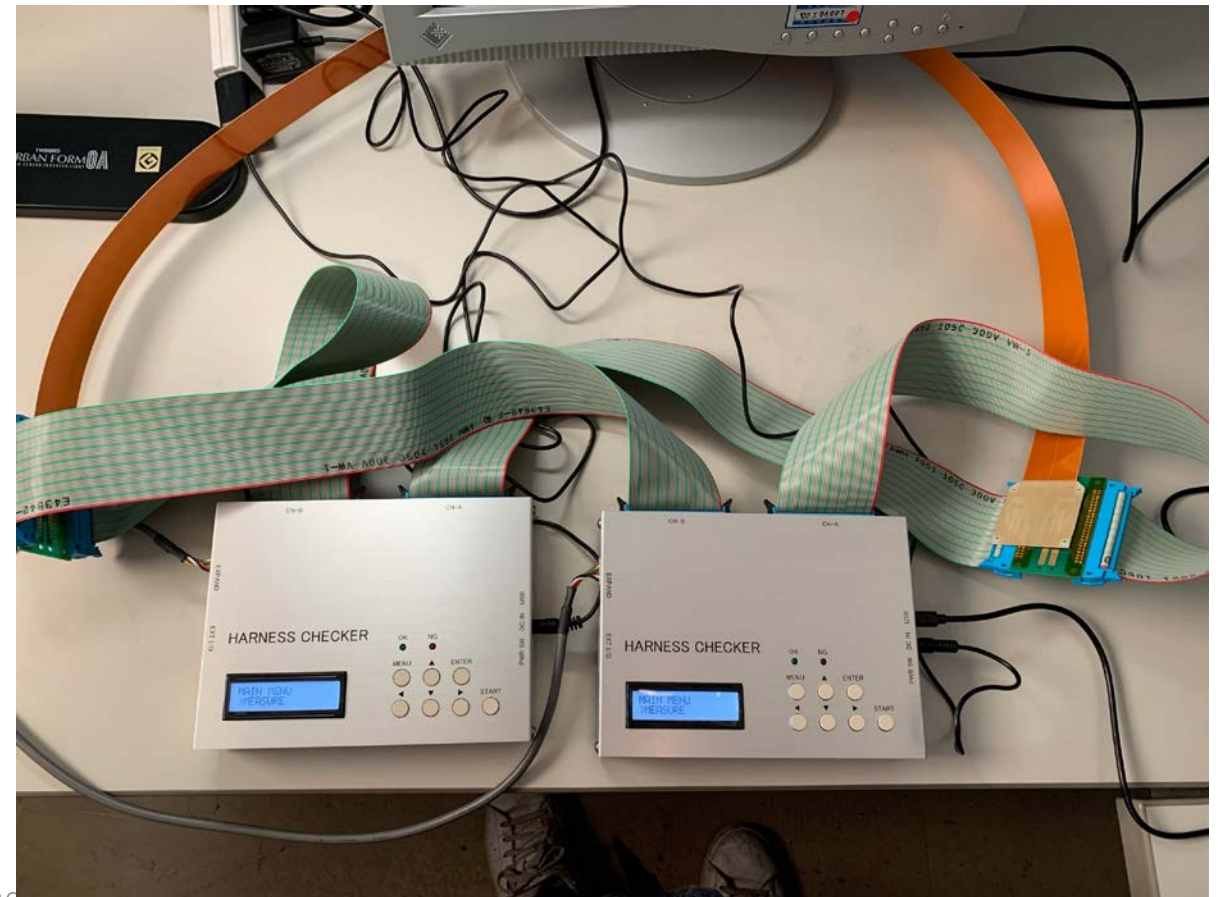
Test equipment for the final BE

- Plan to use the same equipment to check the continuity of the final BE products
 - Just connect with DF18 connector instead of the contact probes
