6th Korea-Japan PHENIX/sPHENIX/RHICf/EIC Collaboration Meeting

Development of Long and High Density Flexible Cable (Bus Extender) for INTT

Long and High Density Flexible Cable

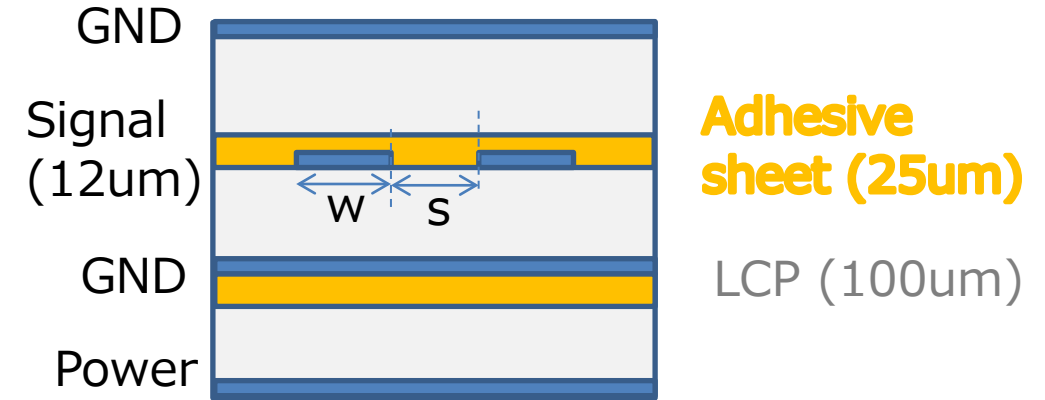
- Cable design
 - Dimension (L x W): 120 x 5 cm²
 - Line and space : 130 & 130 μm
 - Z_{diff} : 100Ω by strip line structure
 - Signal layer is sandwiched by GND layers
 - Liquid Crystal Polymer (LCP) as substrate
 - Relatively new material for FPC
 - Less signal loss due to low di-electric constant & $\tan(\delta)$
 - Thick LCP available for Z_{diff} : 100μm

4 layers laminated by the adhesive sheet

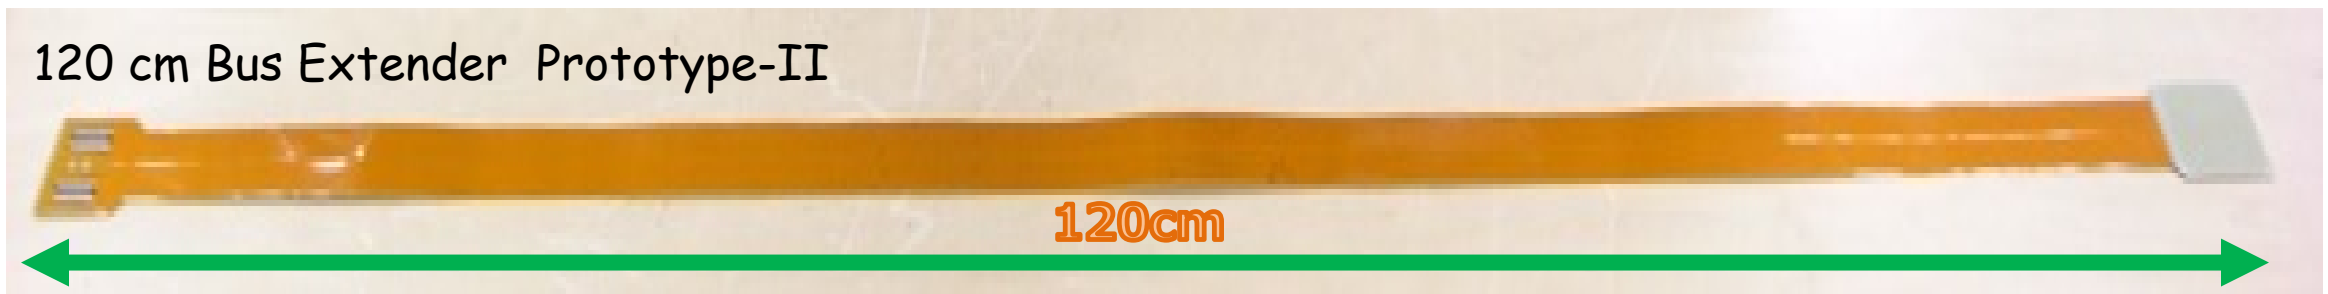
- Prototype The design is decided based on EM-field simulation

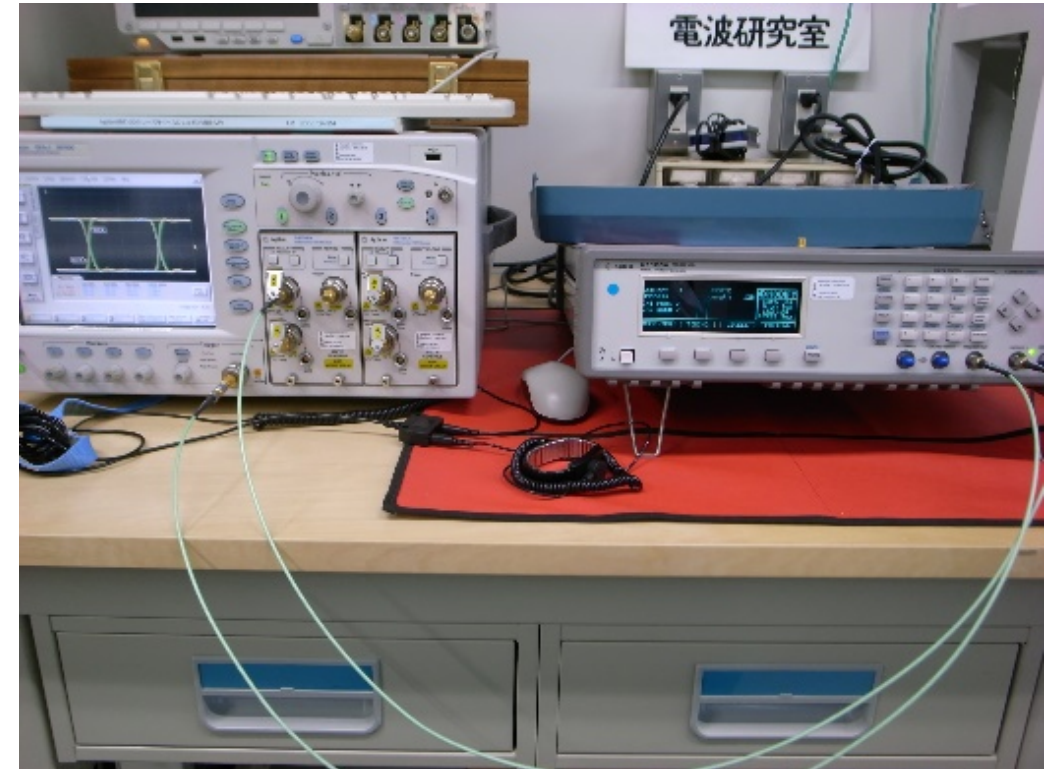
Test bench to study properties of the single Bus-Extender

- Electrical properties
 - Signal loss vs freq. ,
 - Z_{diff} by TDR
 - Eye diagram
- Mechanical property
 - Accuracy of line & space
- Aging test
- Radiation hardness

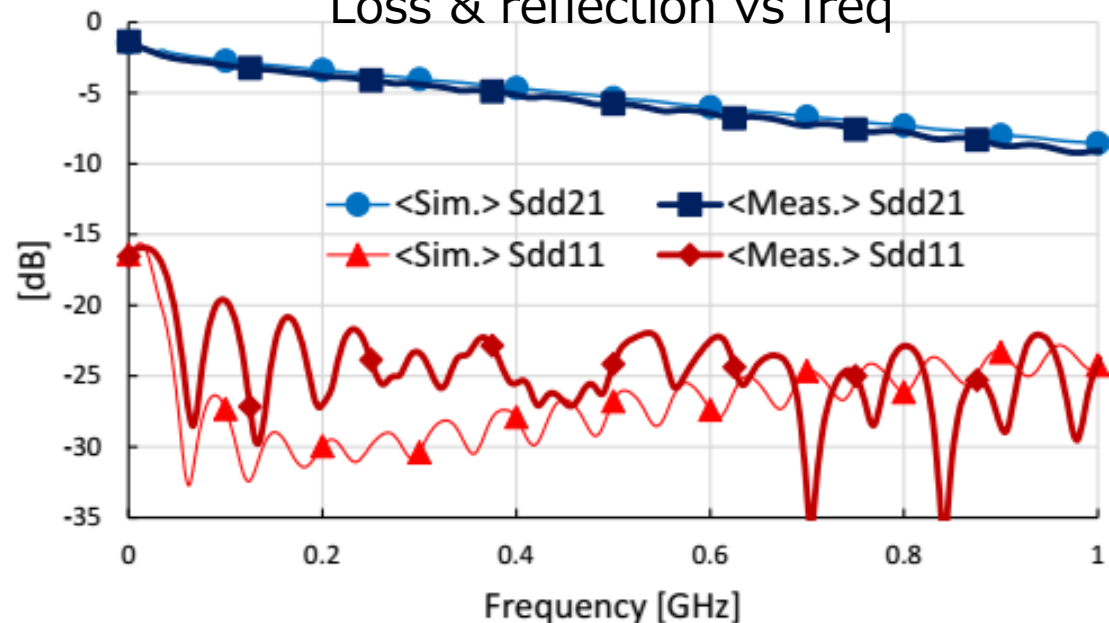
Loss & reflection vs freq

- Freq. dependence(s-parameter)
 - **Signal loss** : ~30%、
 - **Reflection**: < 10%

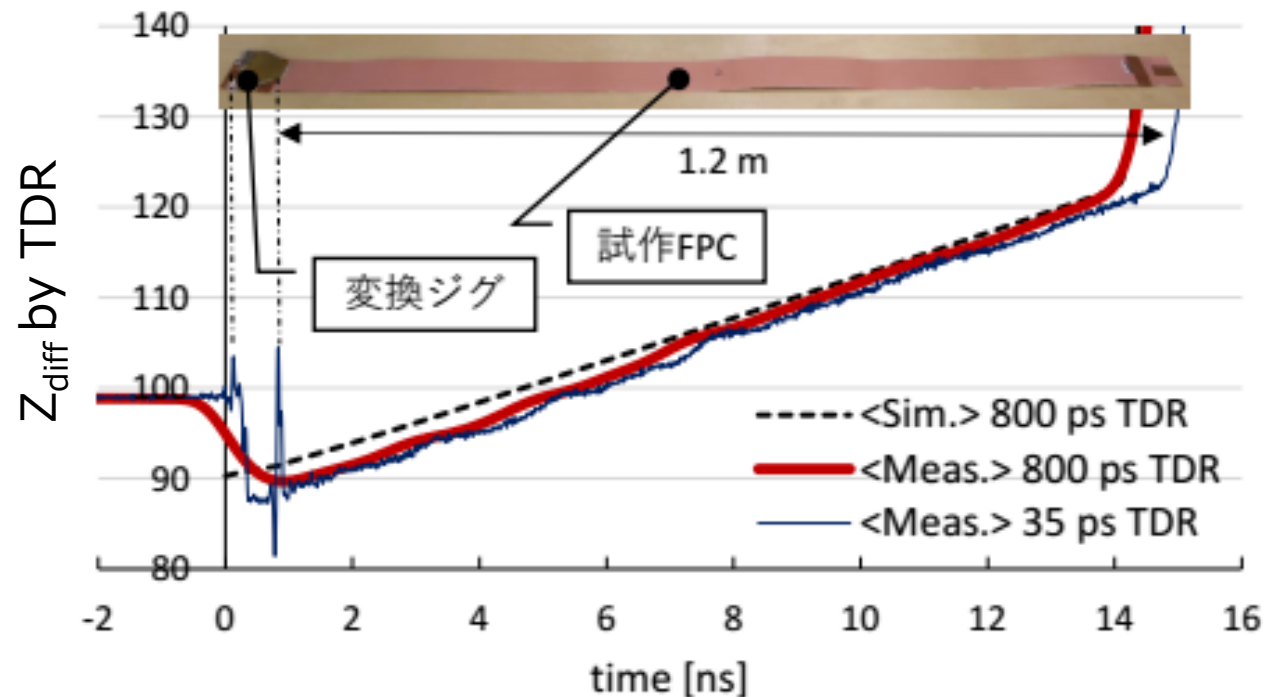
- Zdiff by TDR
 - $Z \sim 90\Omega$ (slight smaller than 100Ω)

Data is consistent with the EM field simulation

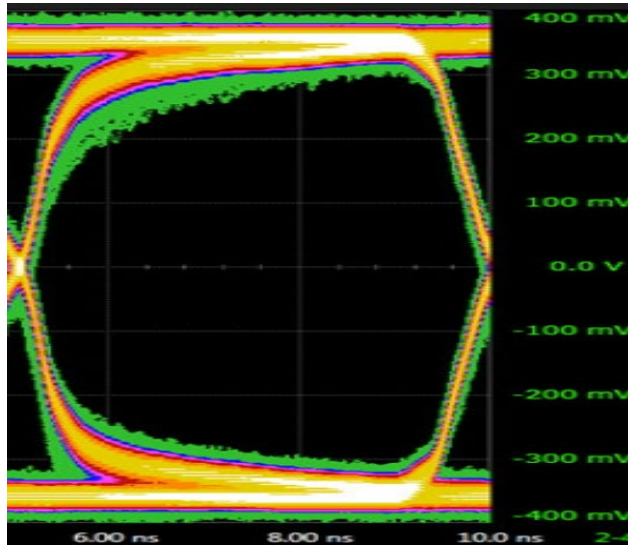
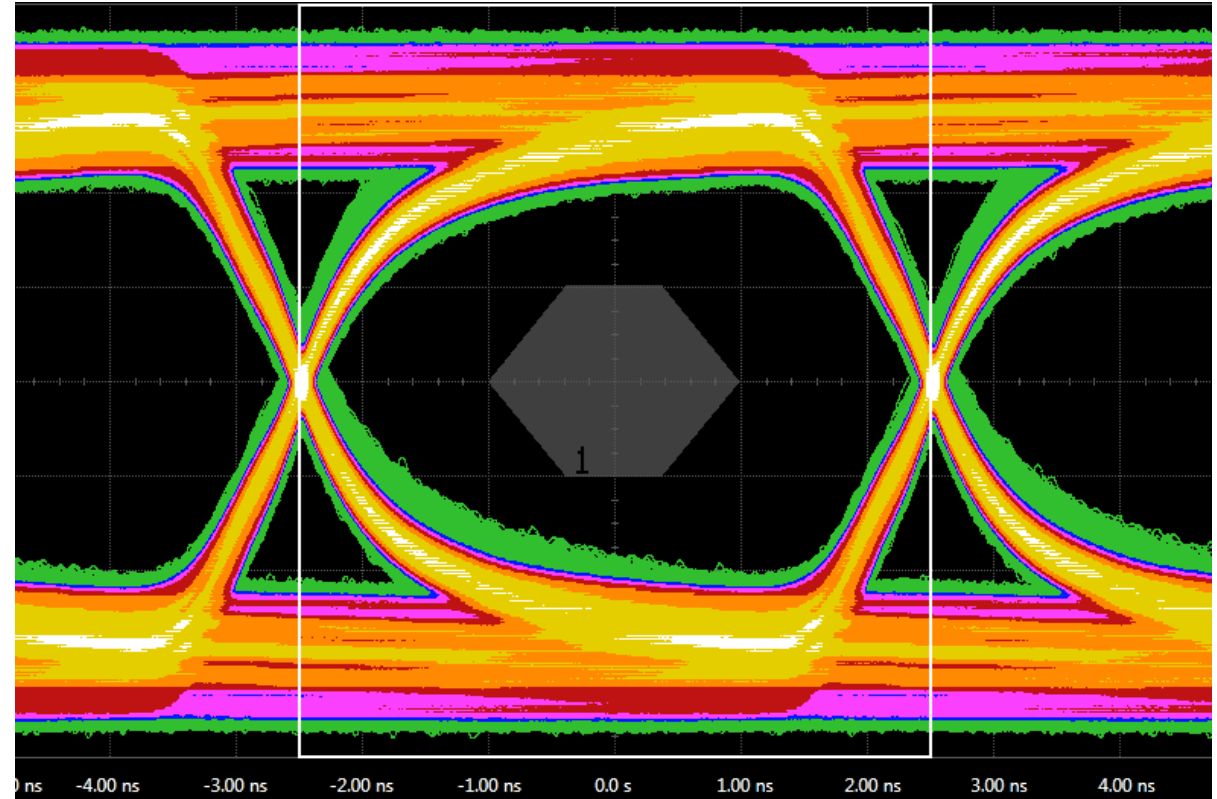
Eye diagram

Input : 200Mbps pseudo-random pulse with 500 ps rising time,

- The signal pulse is clearly separated from the mask
 - Pulse get distorted due to larger signal loss of hi-freq. component
 - Bit error rate $< 10^{-9}$

The performance of bus-extender is good enough for INTT

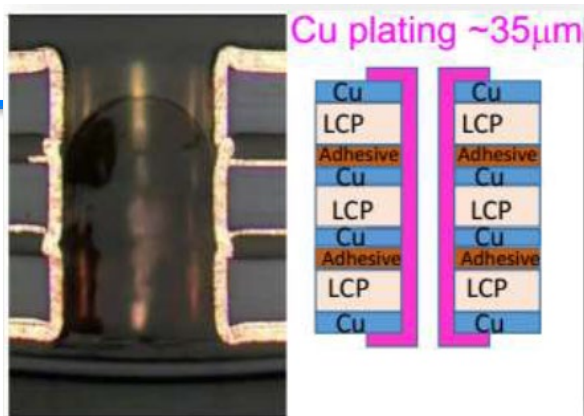
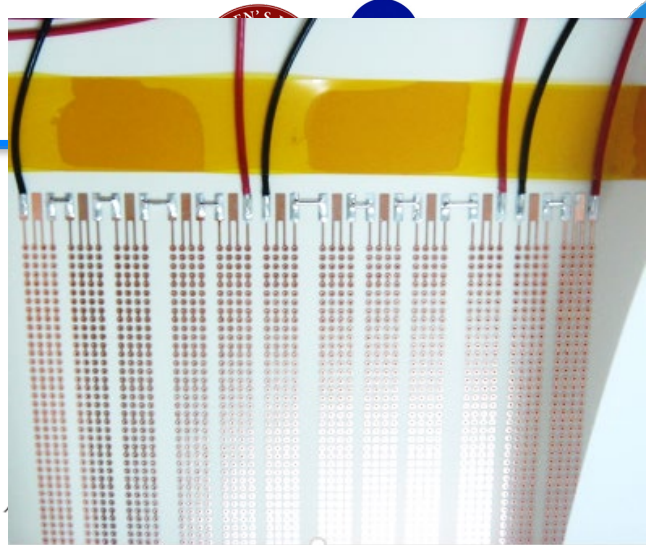
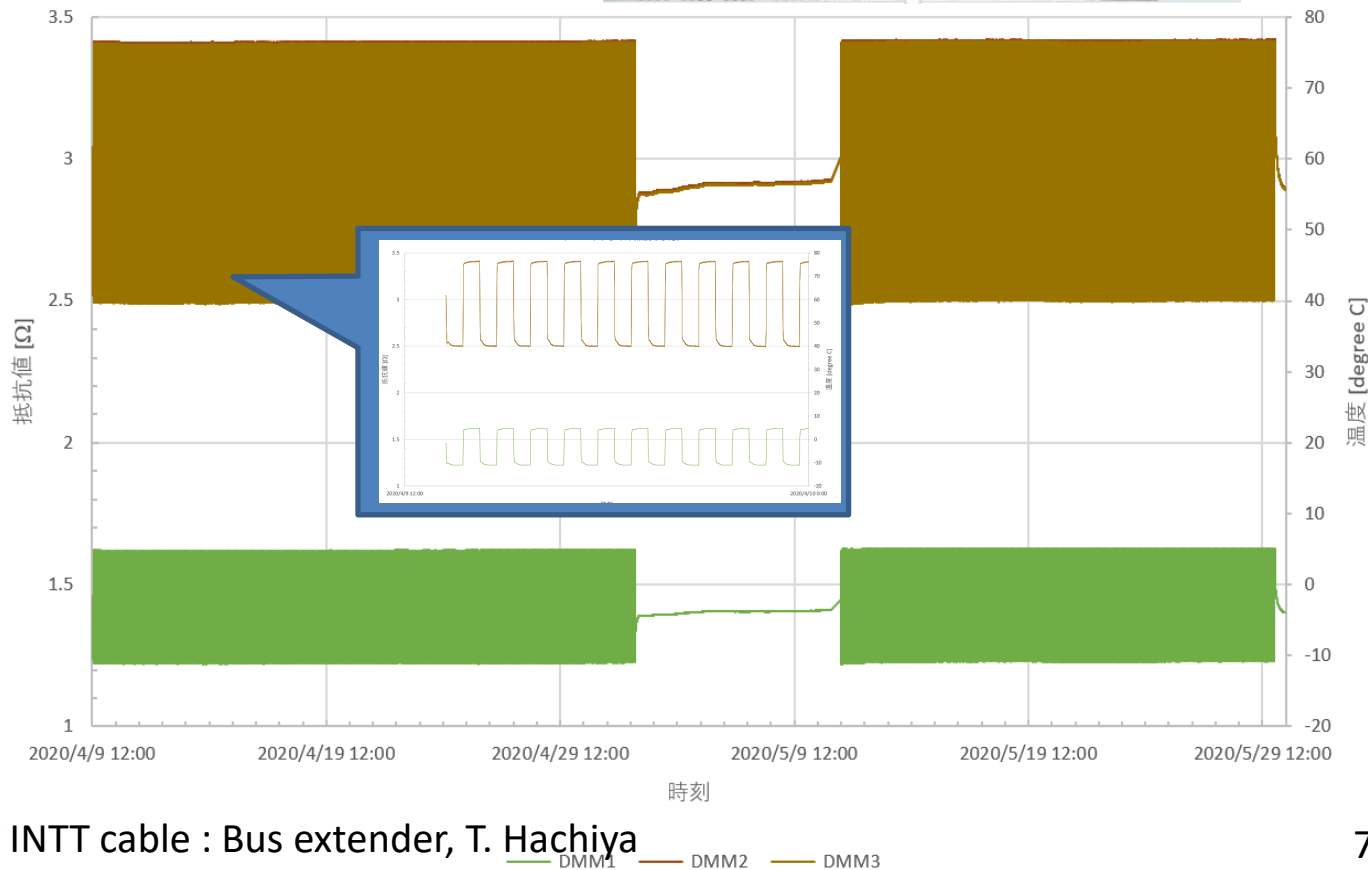
Aging Test

- Keep healthy at least 3 year operation
- Mechanical stress by temperate
 - LCP is expanded and shrunk
 - Thru-hole could be damaged.
- Temperature cycle
 - -15 (30min.) ~ 75°C (30min.) with 1~2min. transition.
 - 1000 cycles (40 days)
- Test FPC sample
 - 4 layers, same as bus extender
 - 400, 1000, 1000 thre-holes are daisy chained and its resistance monitored .
- Results
 - Resistances changed with temperature
 - **All FPC samples are healthy after 1000 cycles.**

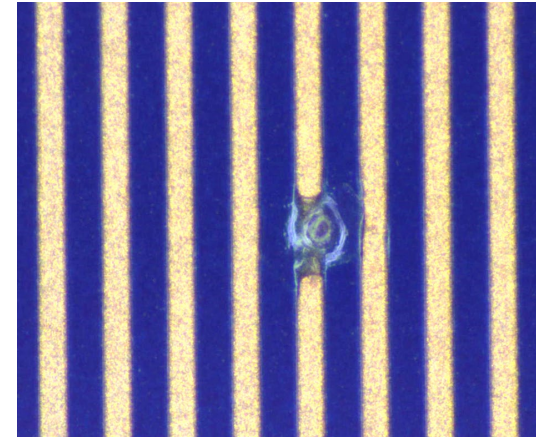
Short line by mis-exposure

- Improving the yield rate is necessary
 - Current yield rate was ~20~30%
 - Production parameters are best tuned
 - Pressure to make multi-layer & make thru-hole
- Inspected/discussed the production procedure with manufacturers
 - Contamination of small dusts is major cause when producing the FPC
- New procedures to remove the dust as much as possible
 - UV lights to look for remaining dust
 - Silicon roller to remove dust
- Check the continuity before laminating multiple layers

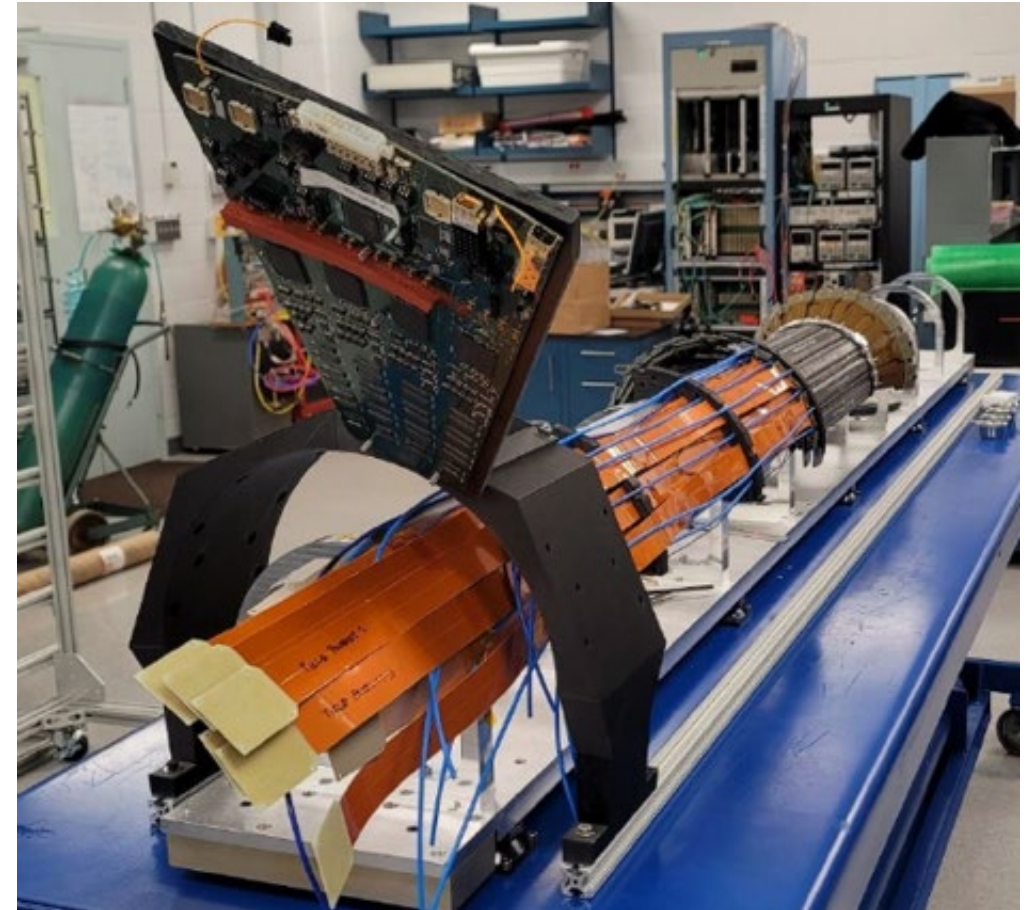
Bus-Extender in Barrel

- Barrel assembly is in progress
 - Checking the interfere of the ladders
 - Adjust the length of the bus extender.
 - Optimize the shape of the conversion cable

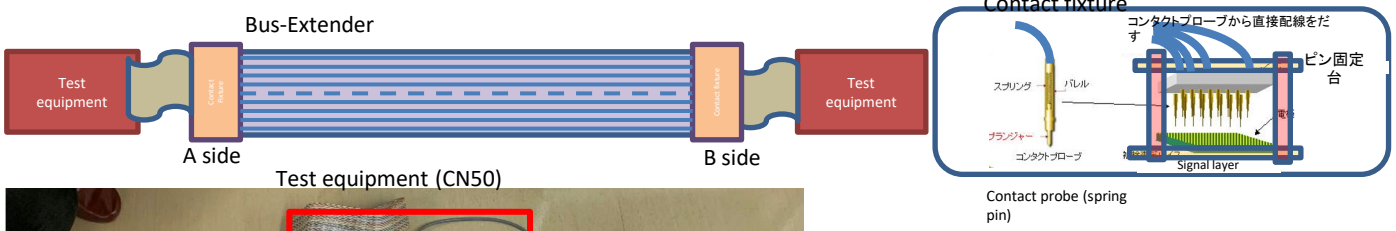
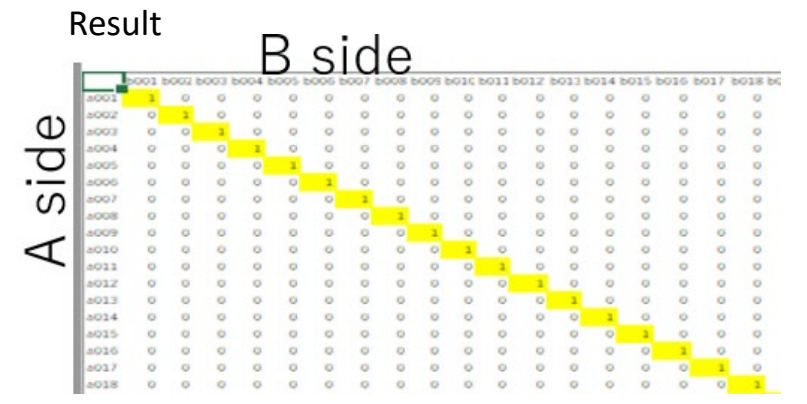
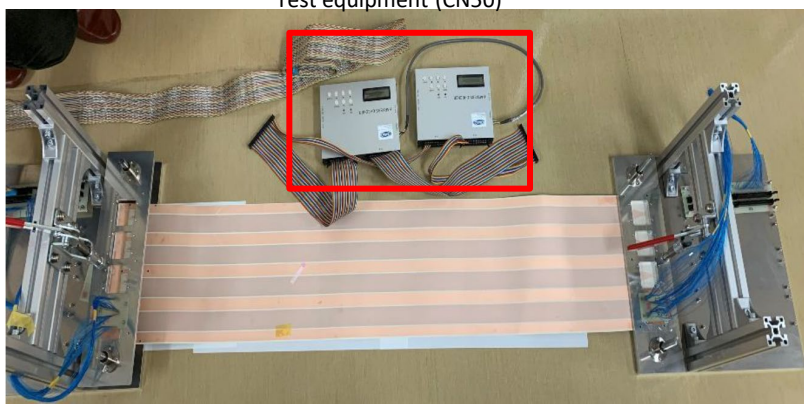
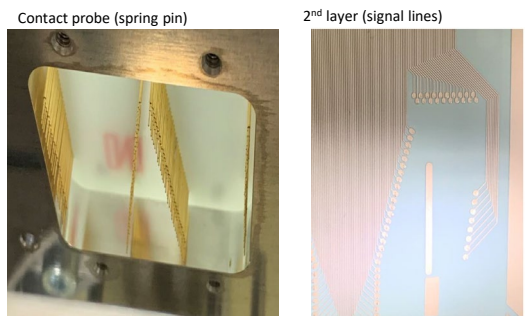
Test setup

- Yield rate issue
 - Yield rate is low because some signal lines gets short/open.
 - There could be one short/open line per the extender (out of 124 lines)
 - Check the continuity of all signal lines at L2 (signal) layer during the production
- Fixture & test equipment is almost ready to use
 - CN50 : Harness checker
 - Continuity of all signal lines is tested
- This setup will be used

1: connected (short),
0: disconnected(open)

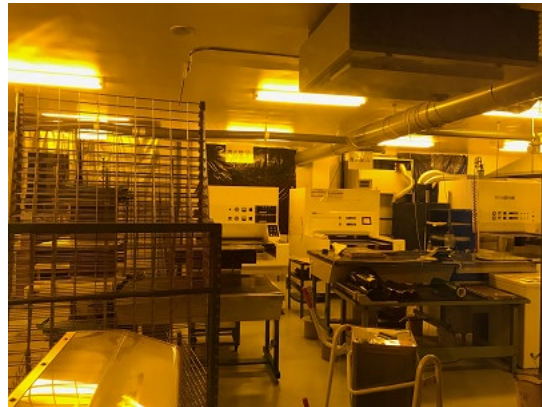
露光

露光マスクの配線パターンを
転写(クリーンルーム)

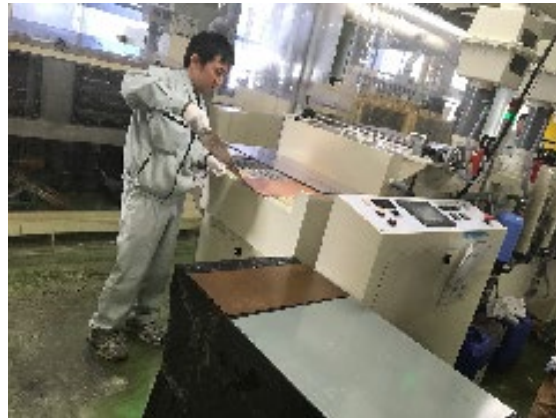
エッチング

エッチング液のシャワーを通過
不要な銅箔をはがす

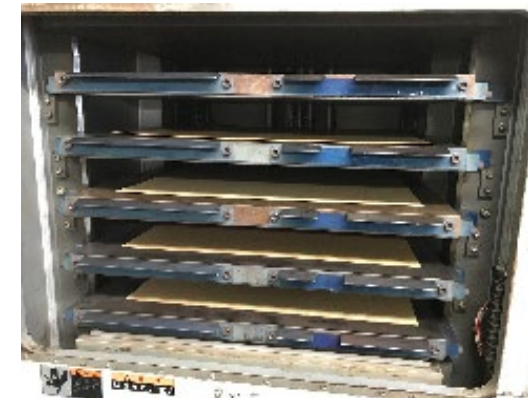
積層

単層FPCを接着剤で
張り合わせる。
高温で圧接する

- 製造装置の限界から長尺FPCの積層は、複数回に分けてプレスする
 - 一度のプレスで50cm程度。 3回プレスが必要。
 - プレス間の区切れ目が信号伝送に影響するか？

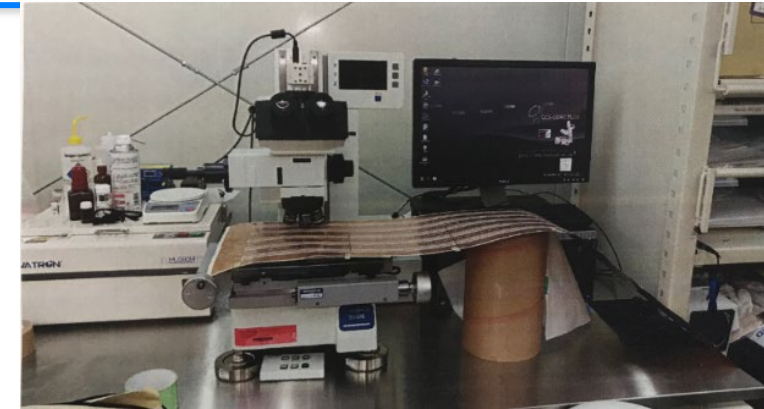
- 均一な高密度配線技術の検証
 - 従来の製造限界を超える微細加工
 - 100umの配線での歩留り向上
- 従来品にあった問題を解決
 - 露光マスクの製作精度が原因
 - マスクプリンタを変更することで改善した

新マスクによる改善後：配線精度±3um

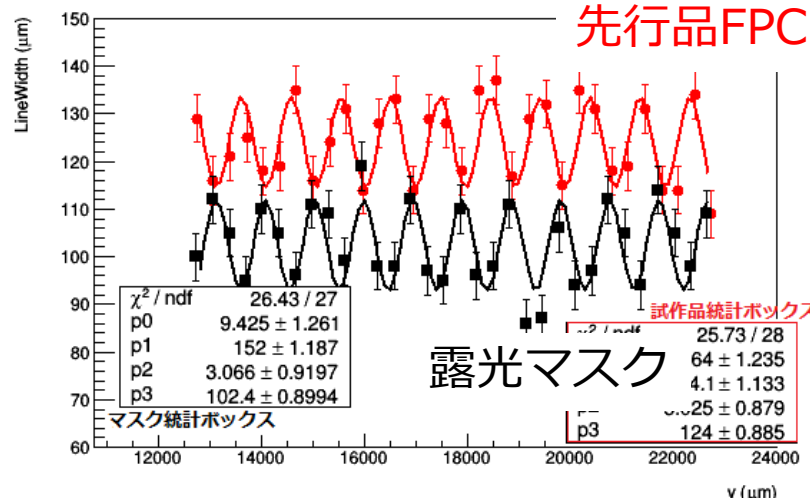
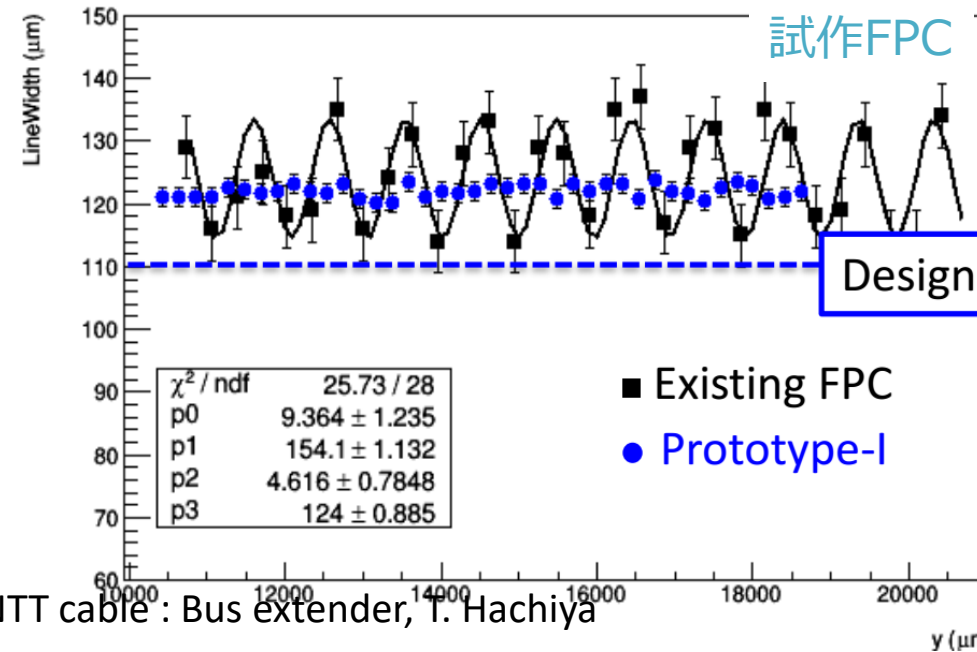
従来品の配線精度±15um

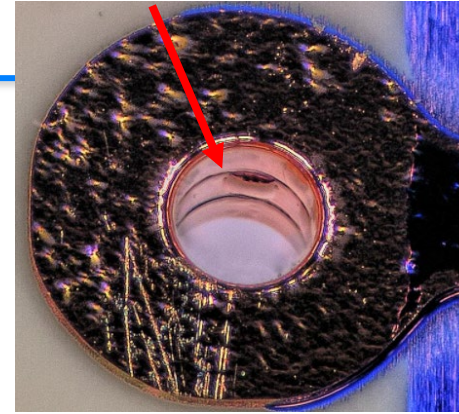
Small bump with new glue

- Issue:
 - Through hole issue was once fixed with new glue
 - Nodules and cracks with previous glue were disappeared
 - We recently found there are small bump with new glue
 - The cross section of the hole shows that LCP pushes the surface
 - To confirm if it is OK or not, we performed the thermal shock test again

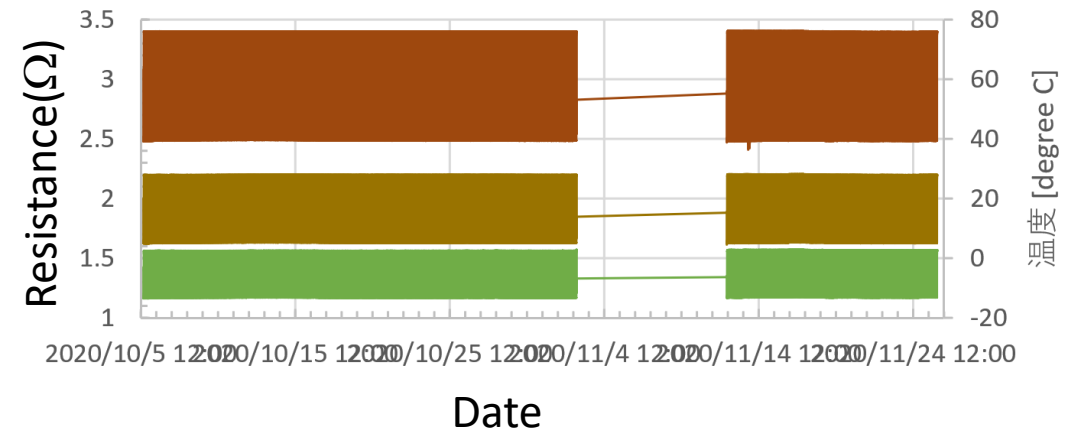
Thermal shock test result

- Setup
 - -15 (30min.) ~ 75°C (30min.) with 1~2min. transition.
 - 1000 cycles (40 days)
 - Monitor the resistance of the through holes where 400, 600, 1000 holes are daisy chained respectively
- Result:
 - All chains are healthy after 1000 cycles.
 - No change by the visual inspection before and after the test
