## Status of the INTT Barrel construction

G. Nukazuka (RBRC)

## The INTT barrel

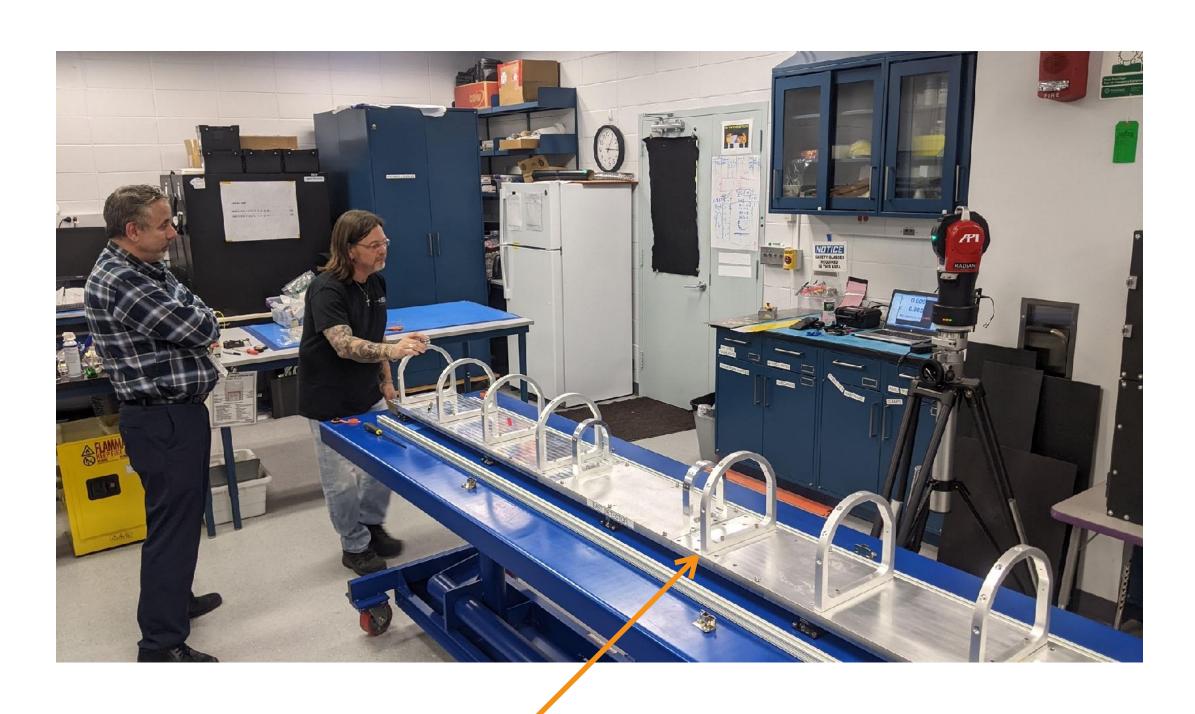
Supporting structure for the construction

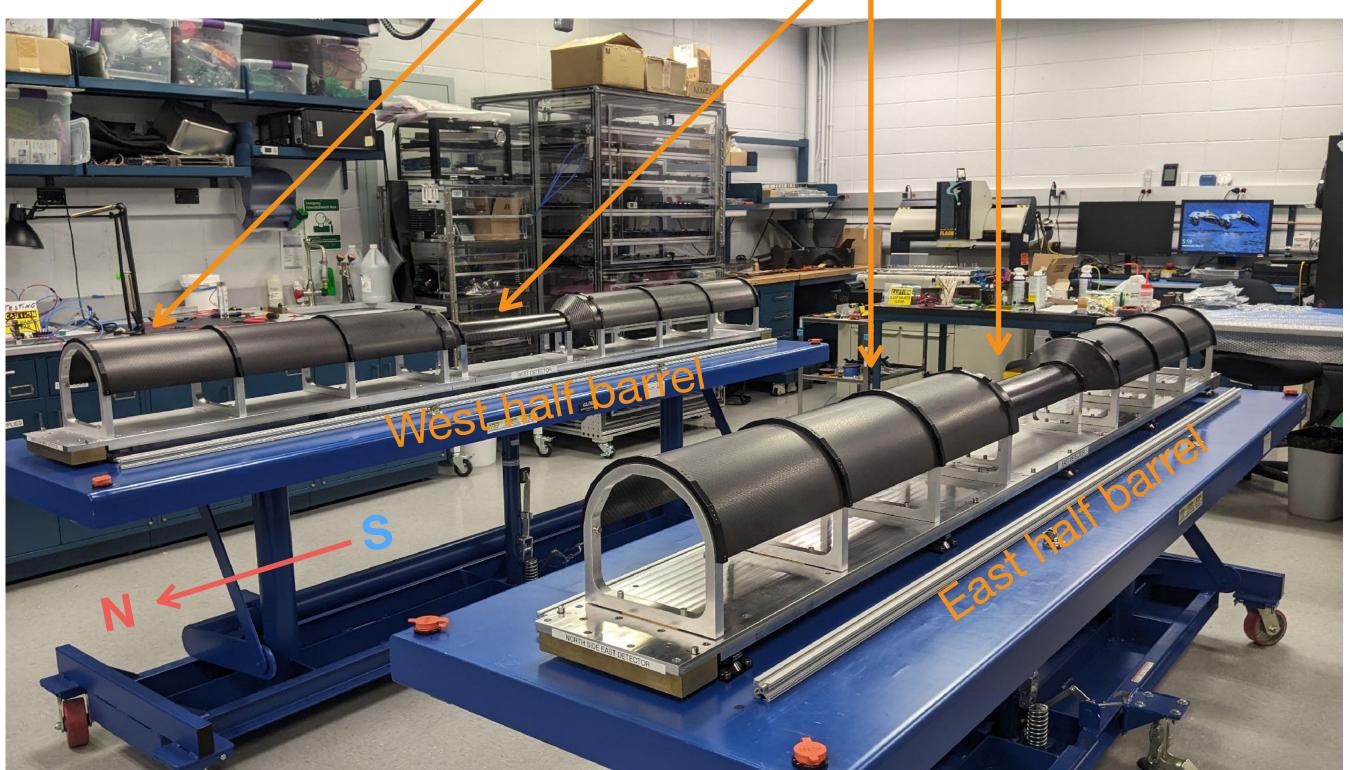
The inner surfaces made of CFRP

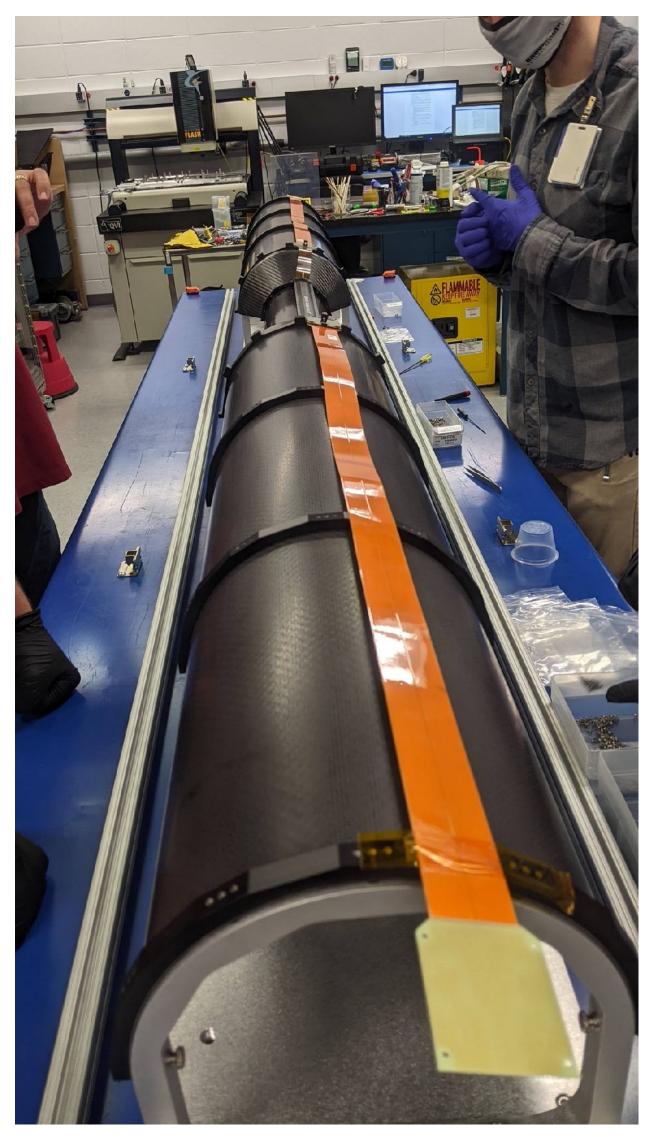
Bus extender installation
