# ROC SlowControl FPGAの 書換えの状況

# Readbackerの現状

# ROC-FPGA

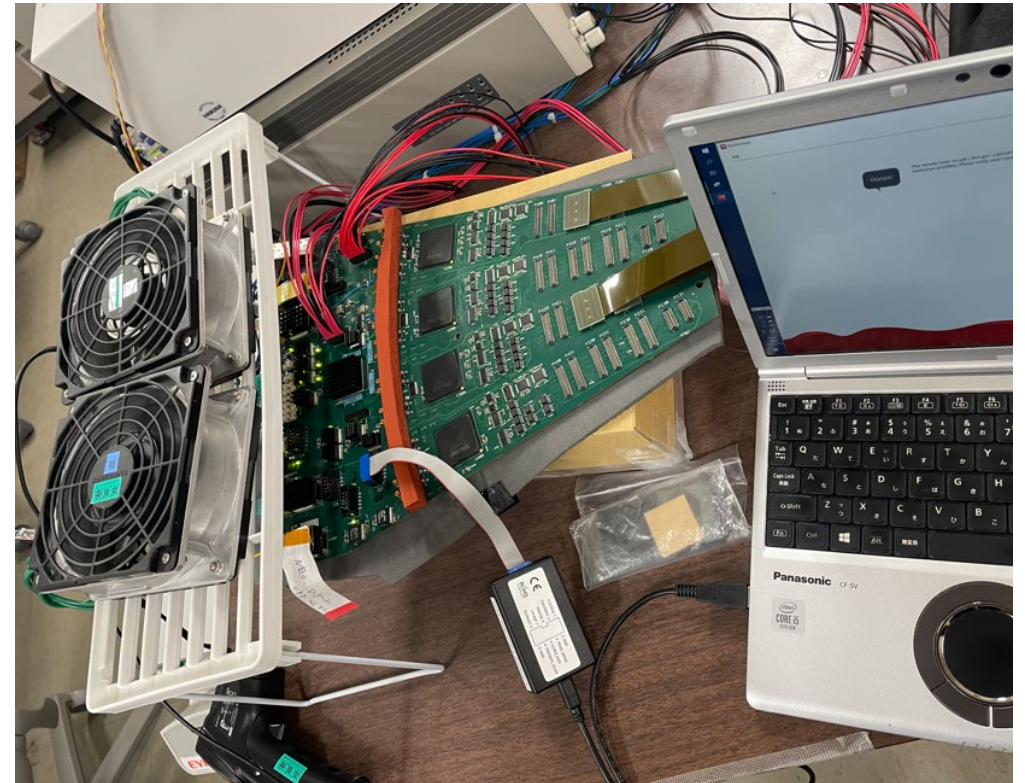
# セットアップ

- 開発環境
  - LIBERO SOC v11.9 (ProAsic3Eで使える)
    - 論理合成 + 配線ツール(Xilinx ISEに対応)
    - V11.9はProASIC3E用の最終版
    - 最新版(v12)はProASIC3Eが未対応。
    - FVTX開発にはv9.1が使われている
  - Win10
    - FVTXはWin7で開発したと思われる
    - Libero11.9のセットアップはそれなりに手間がかかる
      - ライセンスの入手と設定
      - ライセンスサーバーの登録など。
  - FlashPro(ソフトウェア)
    - FPGA書き込み用ソフトウェア (Xilinx iMPACTに対応)
- PCとの接続関係
  - プログラマー： FlashPro5  
MicroChip社製
